**ANNE ARUNDEL COUNTY
ILLICIT DISCHARGE DETECTION
AND ELIMINATION**

2017 ANNUAL REPORT

PERMIT NUMBER MD0068306

FINAL: January 2018

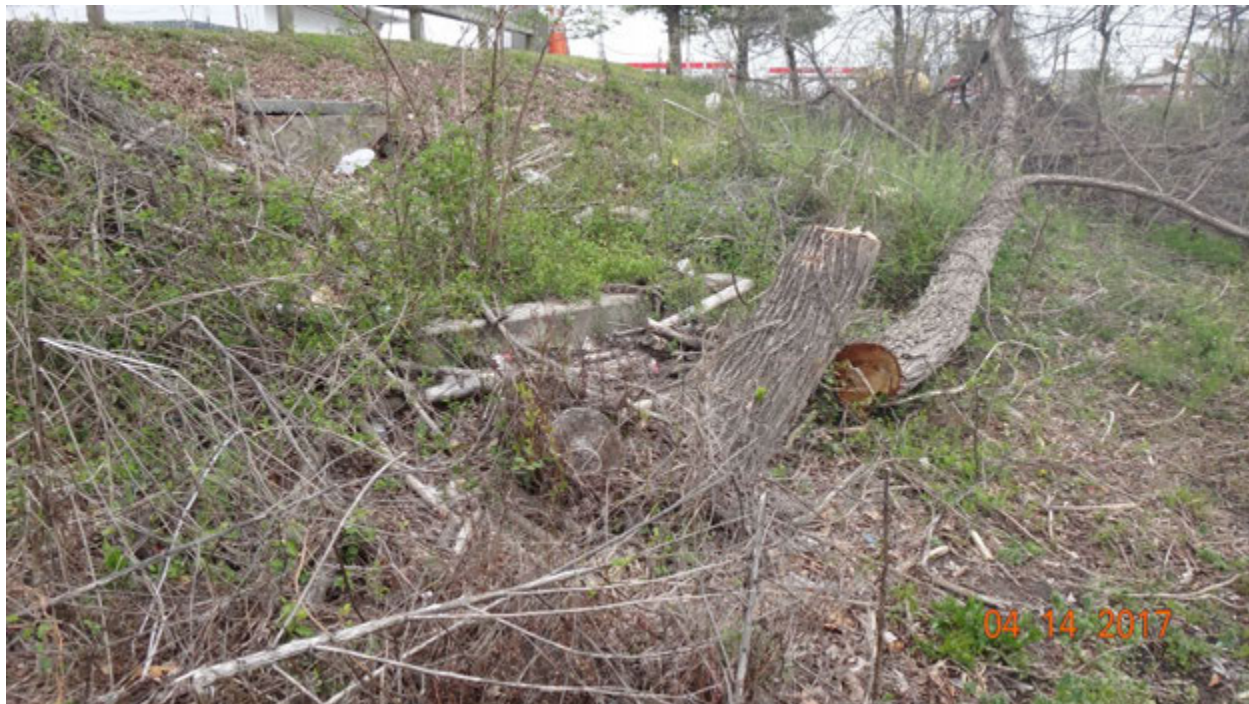
While investigating outfalls in the area, a Versar field team discovered blocked infrastructure near the Shell gas station and car wash, located at the above address. The team identified the headwall for the outfall (F09G5O001) and noted that the pipe opening was clogged with plant debris (Figure 1). The photo-documentation shows evidence that someone had intentionally placed sticks at the outfall opening, perpendicular to the direction of the pipe. The photograph also illustrates that someone had cut through a tree trunk near the outfall, but had let the tree fall without cutting the trunk into smaller sections. The team surmised that the extent of the blockage observed would effectively impede flow from the stormwater network, which was intended to drain the Shell station parking lot. The crew assessed that the pipe structure would require maintenance to clear the accumulated material and restore adequate flow to the system. Note that Versar staff reported this condition to the County in 2016, also, as an element of an illicit discharge report. An area map is provided in Figure 2.

Figure 1. View of the visible headwall of outfall F09G5O001 (center) and the arranged sticks placed at the pipe opening, which is effectively blocked by plant material; note that the tree trunk in the foreground had been sliced once with a saw, but not further divided into sections

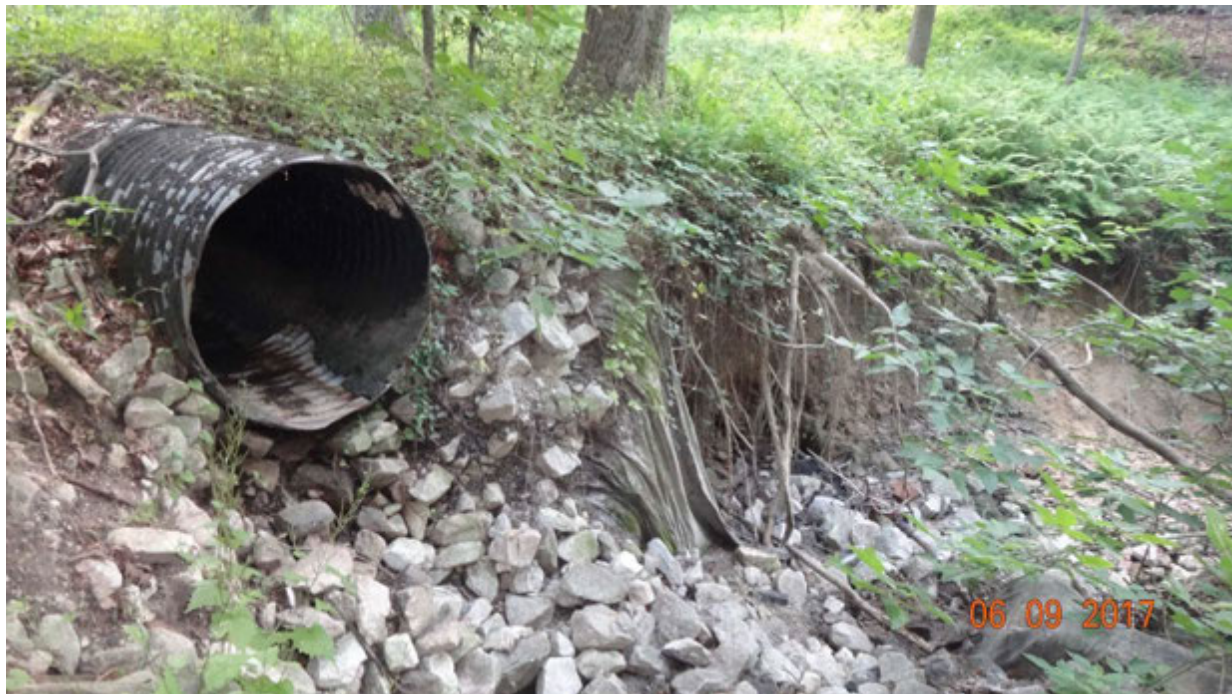
While investigating outfalls in the area, a Versar field team discovered evidence of severe erosion downstream of outfall M12E4O001, which is located behind the residence at 756 North Mesa Road. The team documented conditions near the outfall with photographs. Patterns of bank gouging in the area just downstream of the pipe opening suggested that this area had received significant runoff flows over time (Figure 1). There is significant down-cutting seen in Figure 1, to the right of the outfall pipe, where a sheet of plastic is now exposed. As the channel became established over time, the force and volume of water eroded the soil under the vegetation, exposing some roots (Figures 1 and 2). At the time of the field visit, the team documented that the channel had widened beyond the original path of riprap installed to slow the force of the discharge (Figure 3). The team observed other areas of erosion downstream, which suggests that the force of the discharge continues to be significant enough to cause damage further down the course (Figure 4). An area map is provided in Figure 5.

Figure 1. View of outfall M12E4O001 (left) showing an eroded channel (right) that has developed, probably from strong discharge flows; note the drop in elevation covered in a plastic sheet to the right of the pipe opening in the photograph

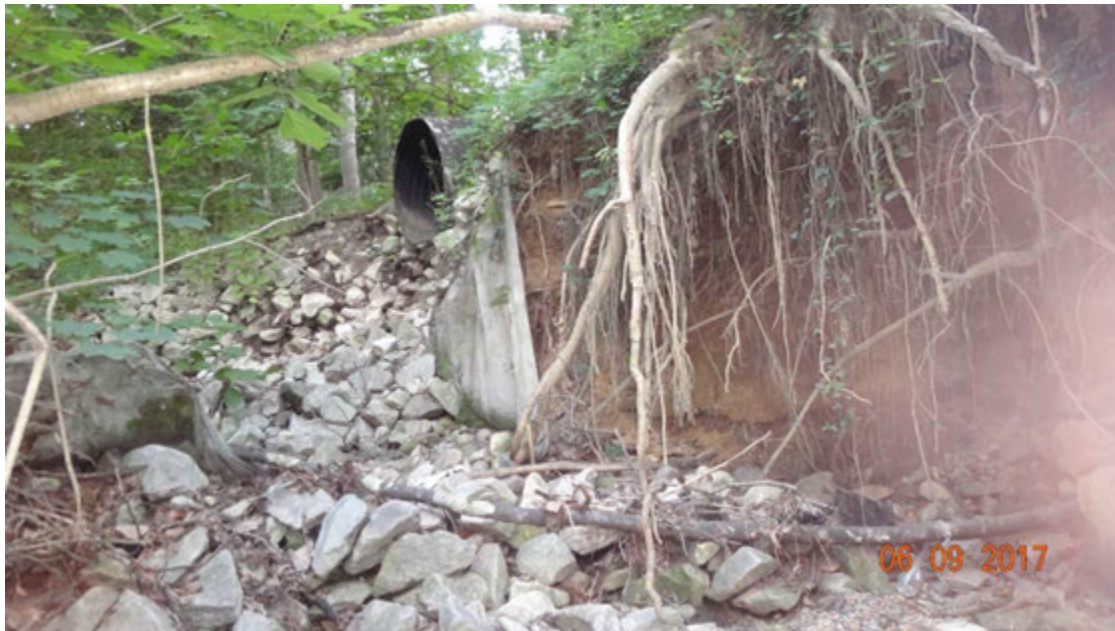
Figure 2. View of the eroded bank, showing exposed roots, that has developed to the right of the pipe (as seen looking at the pipe opening); note the plastic sheeting that covers the ground near the pipe which has developed into a channel guide for flows

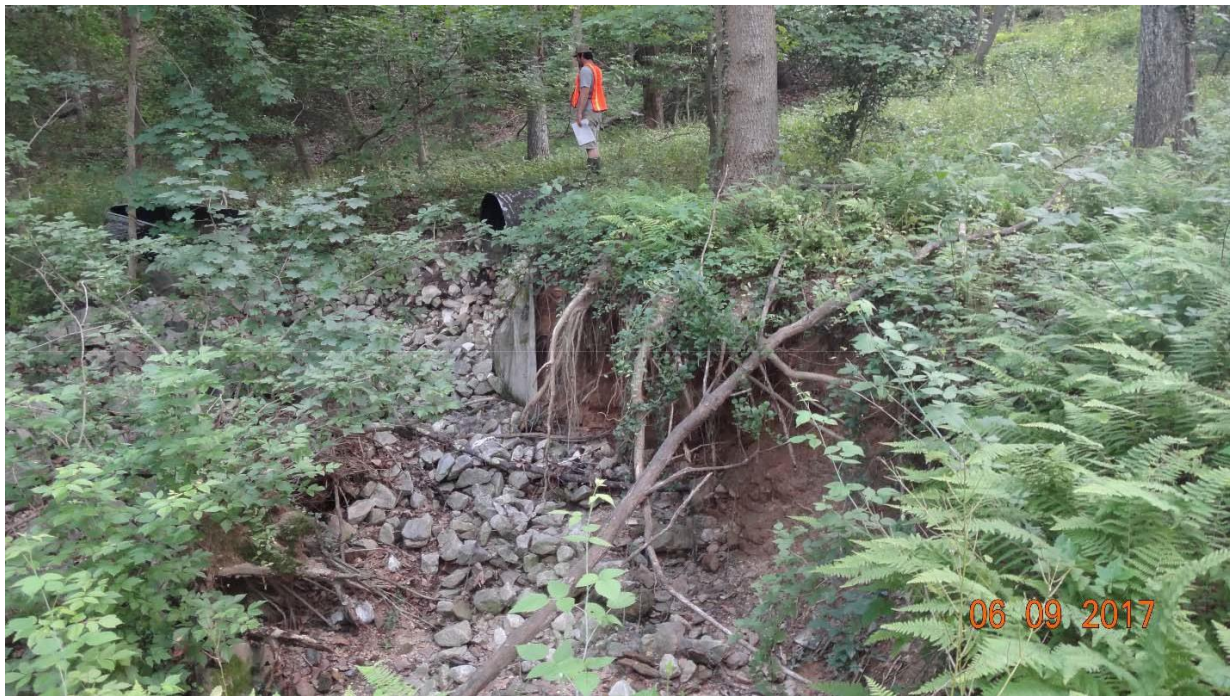
Figure 3. View of the eroded channel, looking toward the outfall pipe (the black pipe seen to the left of the person), which shows damage from soil removal on both sides of the widening channel

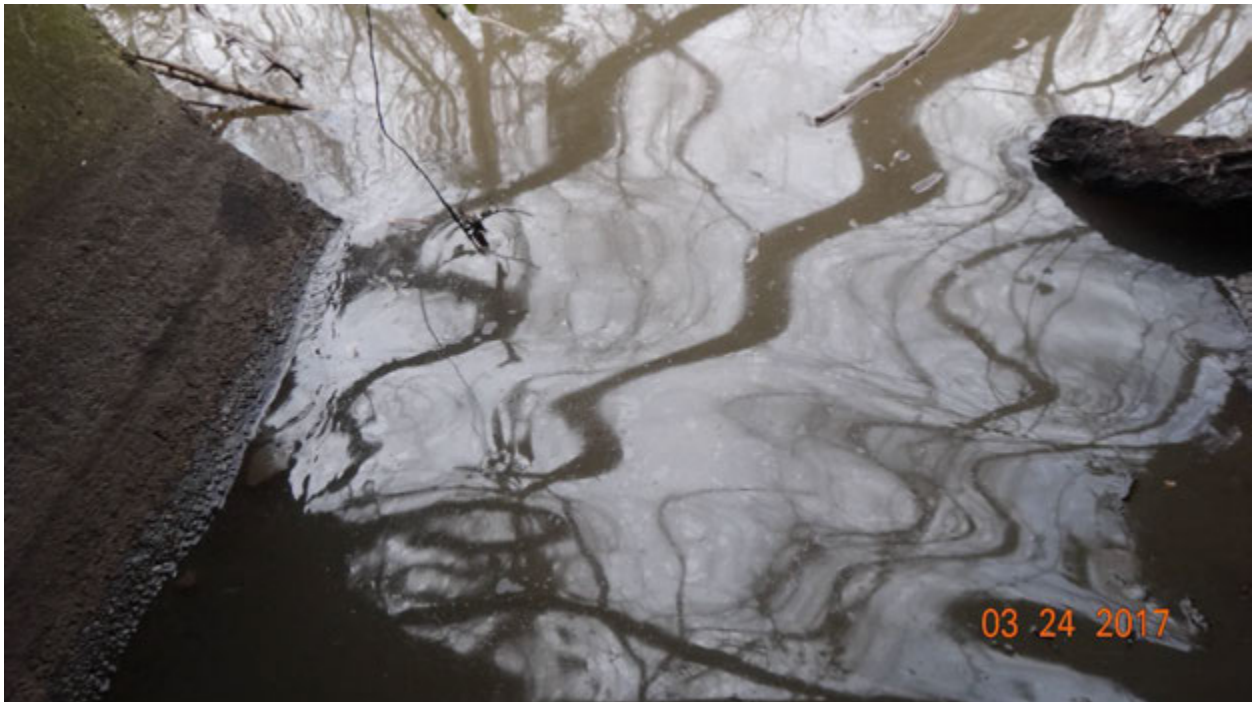
The field team returned the next day and assessed conditions at the outfall. The discharge was again faintly brown and opaque. The crew observed a distinct oil sheen on the surface of the water (Figure 2). The crew collected a sample of the discharge at the pipe opening. The results of the tests of this sample are provided in Table 1, as Test 2. The test results indicated a fluoride level of greater than 10.0 (out of range) and a detergent level of greater than 3.0 (above the range of the test's capabilities).

Figure 2. Evidence of oil on the surface of the discharge from the outfall on March 24

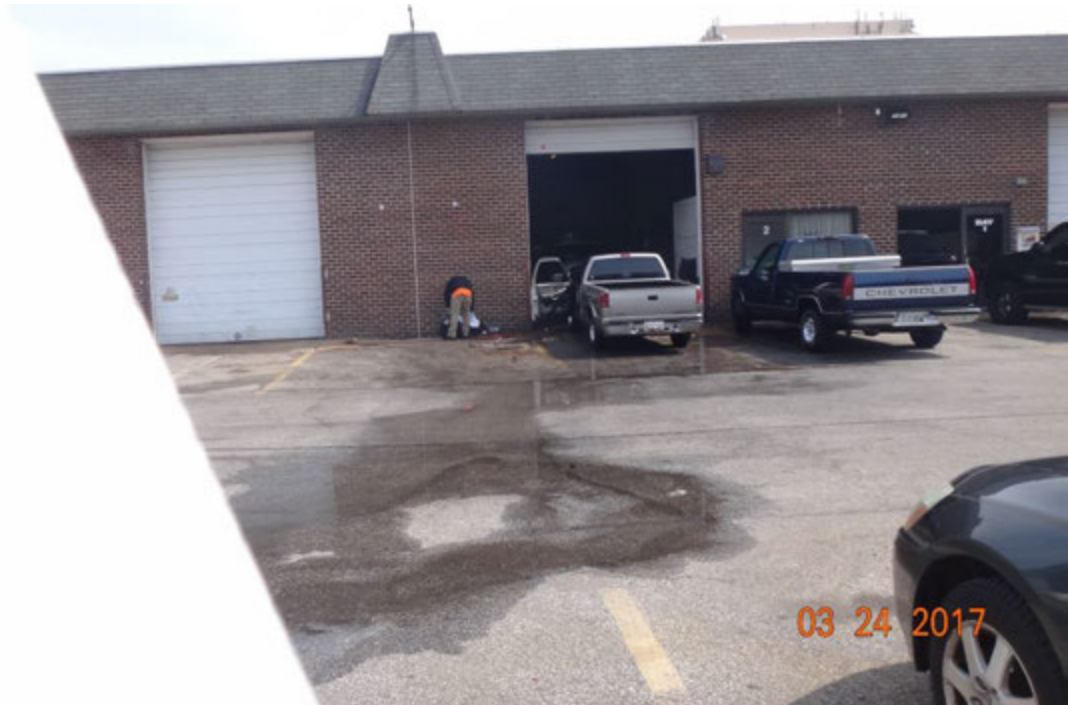
parking lot at Bays 1 and 2 of the 514 building arrangement (Figure 3; the crew did not ascertain the business using these facilities at the time). The team observed the sudsy waste water from the washing activity entering the nearby storm drain inlet (Figure 4). The team obtained a sample of the waste water. The test results indicated fluoride levels of 0.5 (below action levels) and detergent levels of 3.0. The team found dry conditions in all other access points along the network, except for the standing water observed in the last inlet on the line, which the team had observed during the previous visit.

Figure 3. Active vehicle washing observed and documented at a business facility on March 24

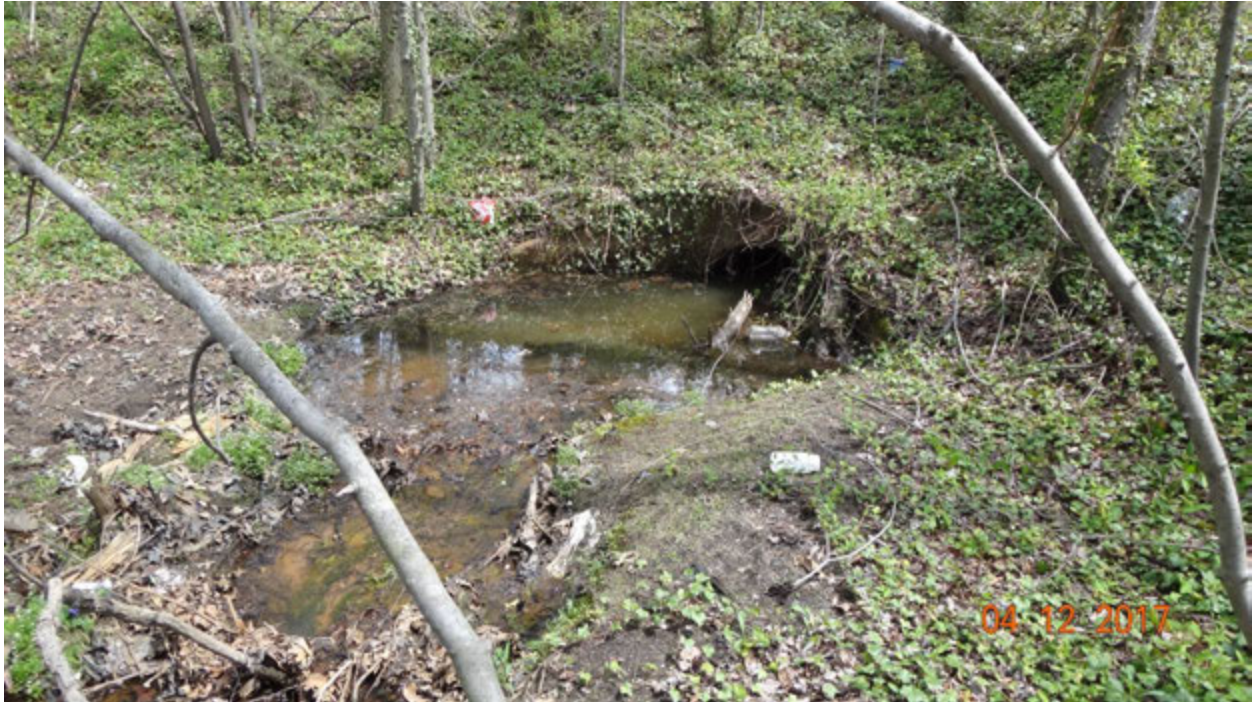
On April 12, 2017, a Versar field team inspected outfall M009E7O014 near the intersection of Oakwood and Elvaton Roads in Millersville, MD. On the first field visit, Versar staff found cloudy, brown water flowing at the 27-inch reinforced concrete pipe outfall (Figure 1). The crew obtained a sample of the discharge at the mouth of the outfall, to test for illicit discharge indicators. The results of the tests are provided in Table 1, as Test 1. The result for pH indicated a reading slightly below the acceptable range (6.4). The test for ammonia indicated an elevated level of 1.5 mg/l.

Figure 1. Conditions at outfall M09E7O014, showing cloudy, brown water on April 12

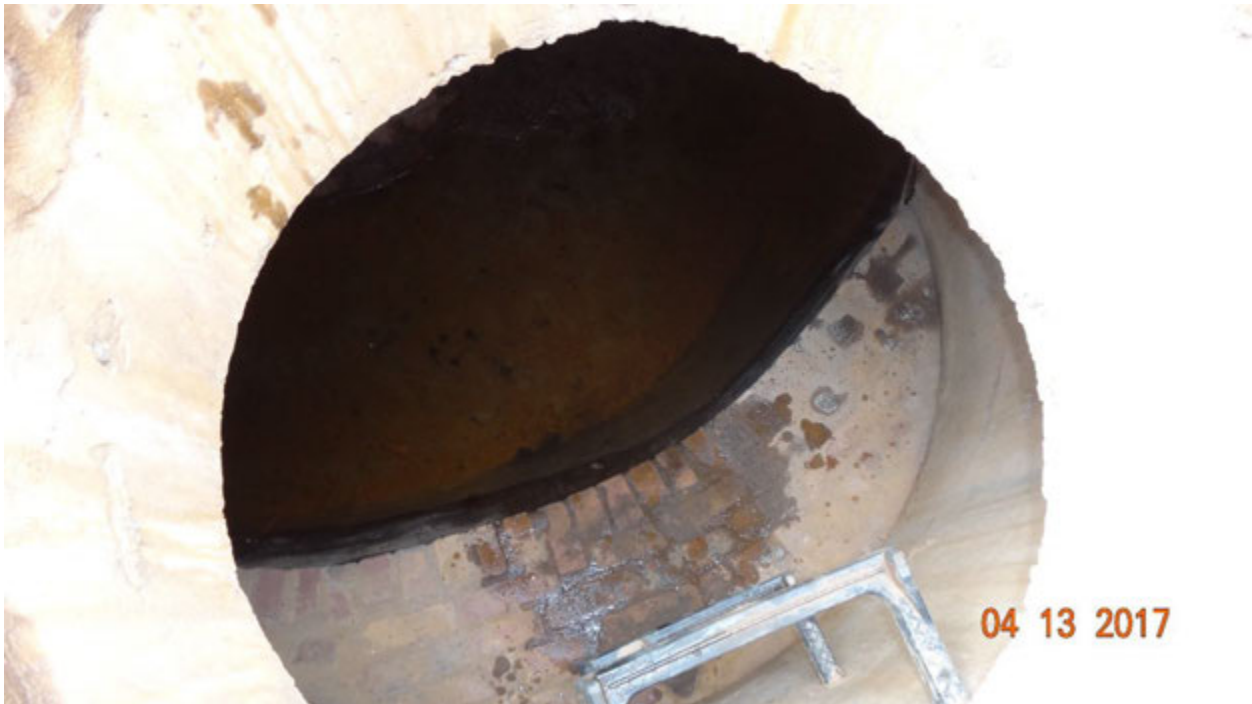
Figure 3. View inside the fourth manhole

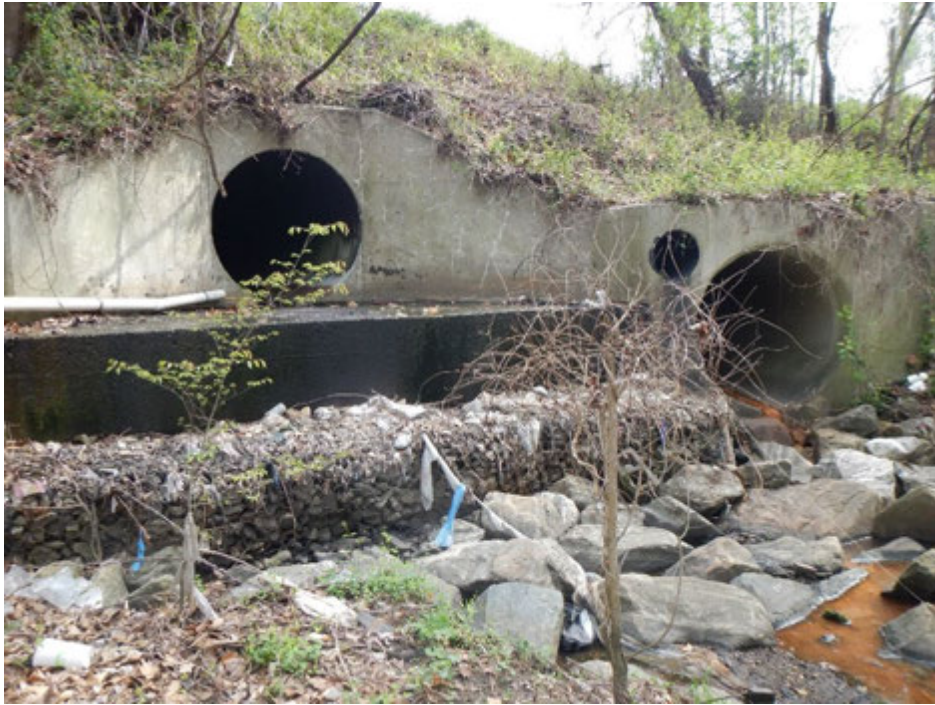
On April 13, 2017, a LimnoTech field team inspected outfall R20B5O001, near the intersection of Forest Drive and Solomon's Island Road in Parole, MD. The configuration of this outfall consisted of one headwall with three pipe openings (Figure 1). On the first field visit, at 10:44 a.m., staff found flowing water at the 48-inch reinforced concrete pipe outfall at the rightmost pipe opening (Figures 1 and 2). The team assessed the discharge as cloudy water with an orange silty deposit (possibly iron floc) and an oil sheen. The crew obtained a sample of the discharge at the mouth of the outfall, to test for illicit discharge indicators. The results of the tests are provided in Table 1, as Test 1. The result for pH indicated a reading below the acceptable range (5.9). The tests for ammonia and copper indicated elevated levels (7.5 and 0.4, respectively).

Figure 1. Conditions at outfall R20B5O001 where the team documented and collected samples of the flowing effluent seen in the rightmost pipe opening; the other two pipes discharging at the headwall (left and center) did not have flowing conditions at the time of the site visit

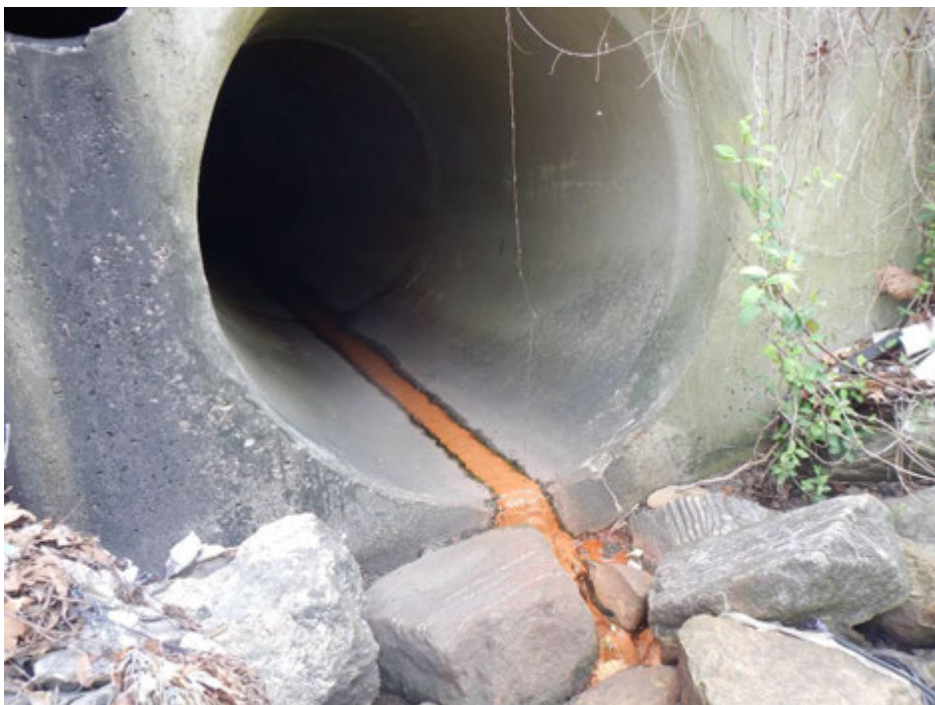
Figure 2. View of the orange silty effluent flowing in the rightmost pipe of outfall R20B5O001

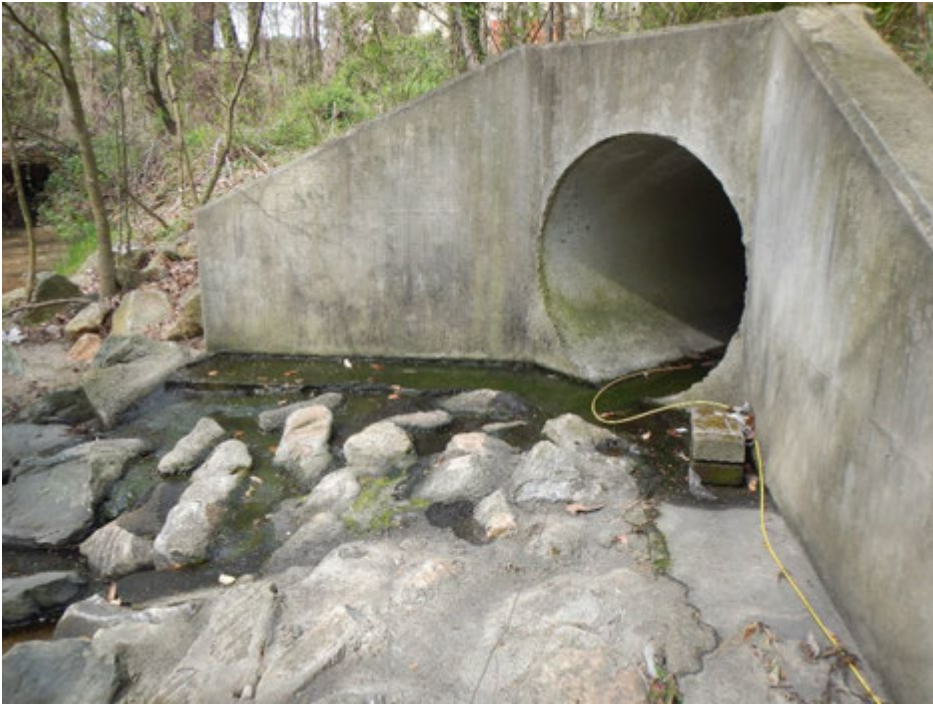
On April 13, 2017, a LimnoTech field team inspected outfall R20B5O005, near the intersection of Forest Drive and Solomon's Island Road in Parole, MD. On the first field visit, at 11:06 a.m., staff found flowing water at the 42-inch reinforced concrete pipe outfall (Figure 1). The team assessed the discharge as cloudy water with algae growth (Figure 2). The crew obtained a sample of the discharge at the mouth of the outfall, to test for illicit discharge indicators. The results of the tests are provided in Table 1, as Test 1. The result for pH indicated a reading below the acceptable range (5.9). The test for ammonia indicated an elevated level of 2.5 mg/l.

Figure 1. Conditions at outfall R20B5O005 (the secured wire was part of the apparatus in place for a different study); note the signs of green algae growth in the pipe and on the rocks in the plunge pool

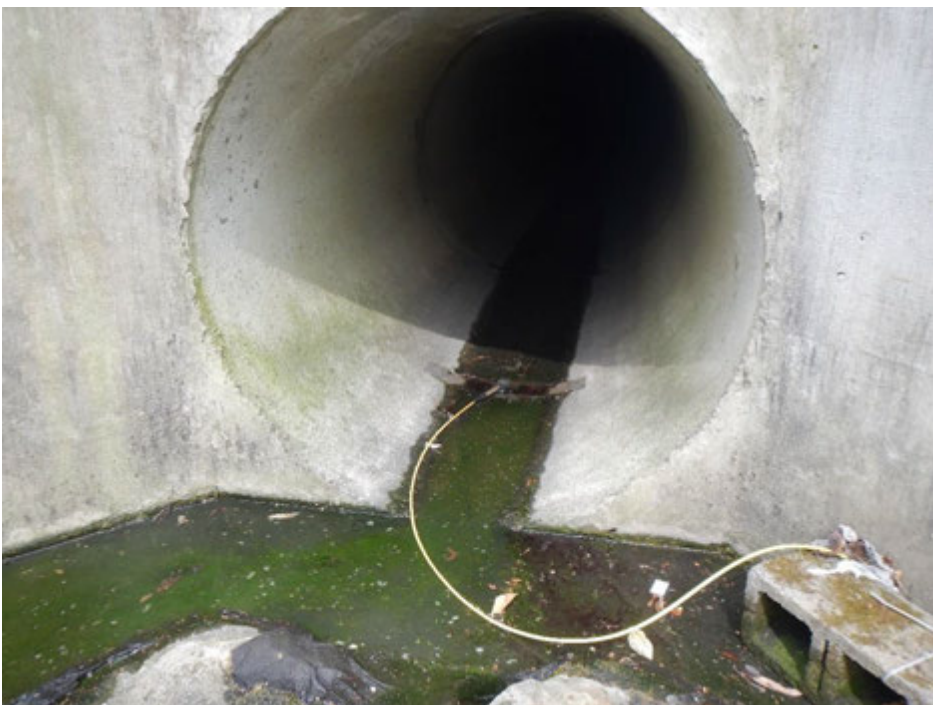
Figure 2. View of the flowing effluent at outfall R20B5O005 (the secured wire and sensor were part of the apparatus in place for a different study); note the signs of green algae in the pipe and the plunge pool

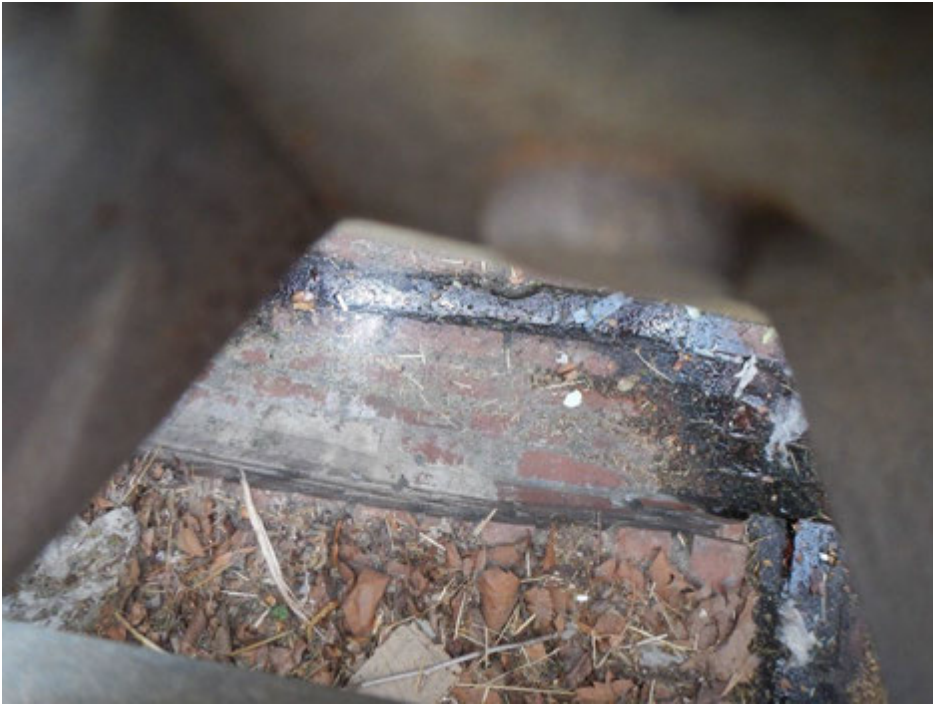
As a consequence of the second set of results indicating potential illicit discharge, the crew conducted a trackdown of the pipe network. At the first inlet up the network, the crew found the system wet but not flowing (Figure 3). At the nearby second inlet, the crew found dry conditions. An area map is provided in Figure 4.

Figure 3. View inside the first inlet up the network from outfall R20B5O005, showing wet conditions

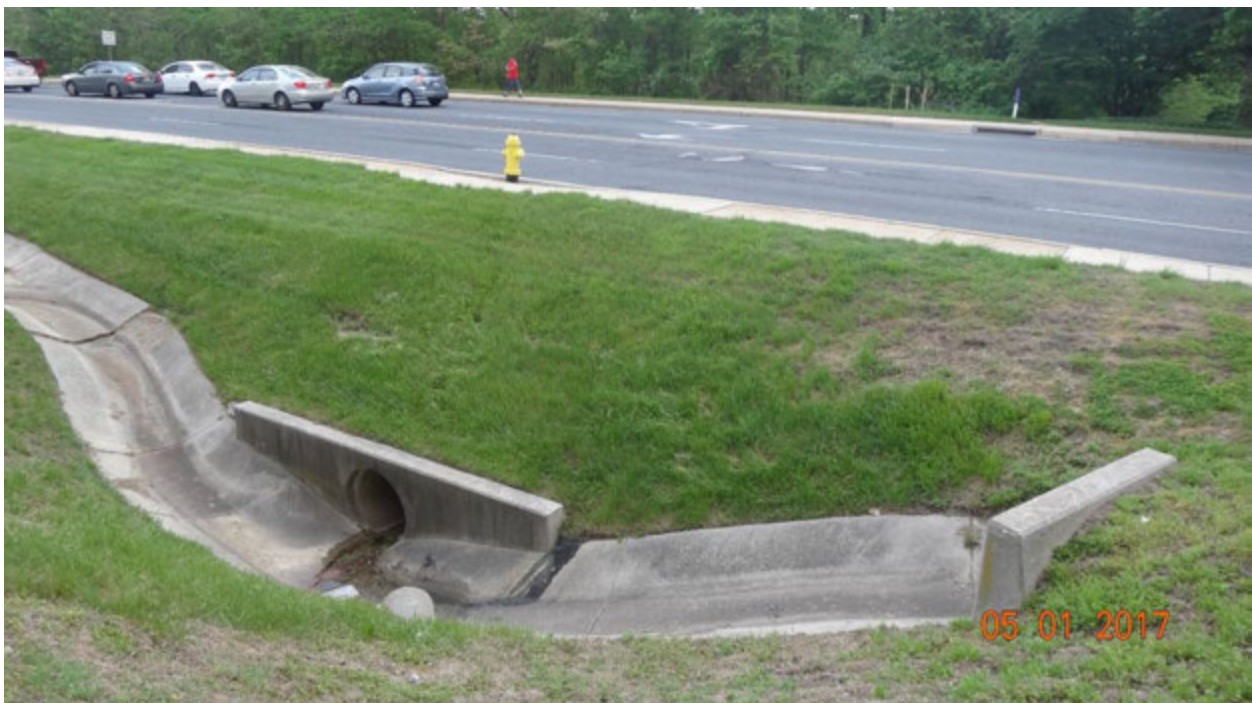
Figure 3. View of the channel relative to the culvert under Hospital Drive, note the small pipe jutting out of the side of the channel (lower left, facing away from the viewer) and releasing effluent that flows toward the culvert opening

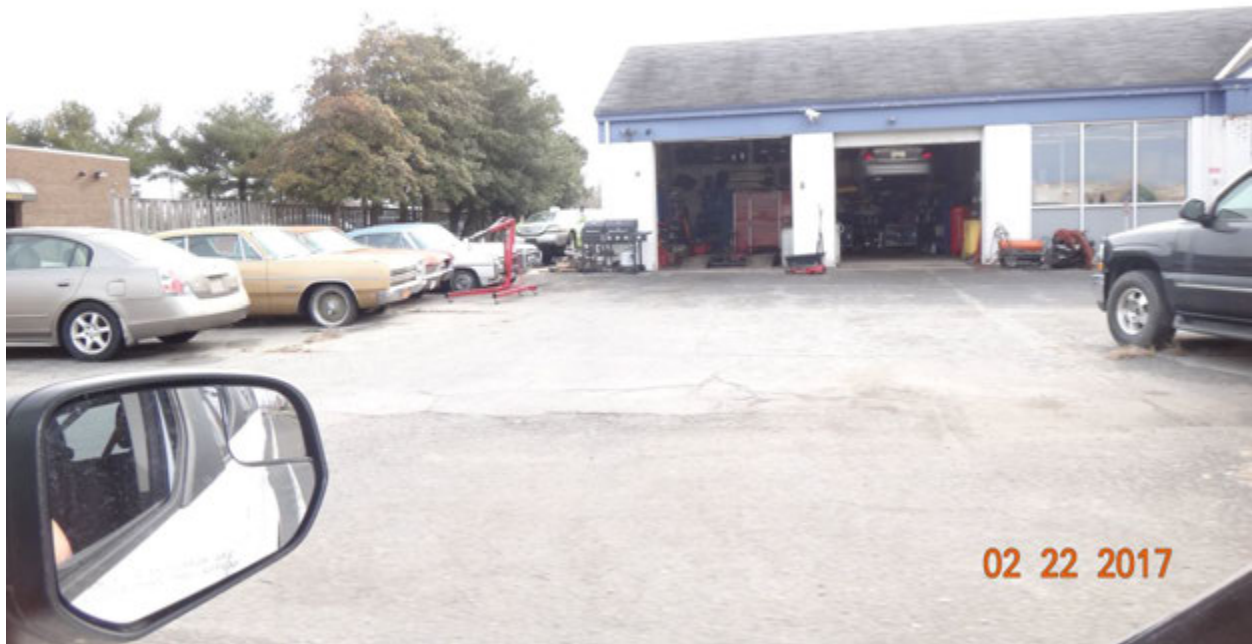
While investigating outfalls in the area, a Versar field team discovered waste management issues at the automotive service shop, Edgewater Service Center, at the above address. The field team documented that the business was storing numerous disabled vehicles on the lot (Figure 1). The team documented vehicle parts, such as engines, stored outdoors, without cover (Figure 1). Some of the vehicles had flat tires and other overt signs of neglect (Figures 1 and 2). As documented in the photographs, many of the stored vehicles did not have current registration tags; this implies that they were not part of an active service cycle (Figures 1, 2, and 3). The lot exhibited an open dumpster and debris scattered around it (Figure 4). Other signs of inadequate handling of materials included rusting fluid tanks (including one for used motor oil) and open drums (Figure 5). An area map is provided as Figure 6.

Figure 1. Vehicles in various stages of disrepair stored on the lot at the service center; note the partially covered engine on the ground seen on the right

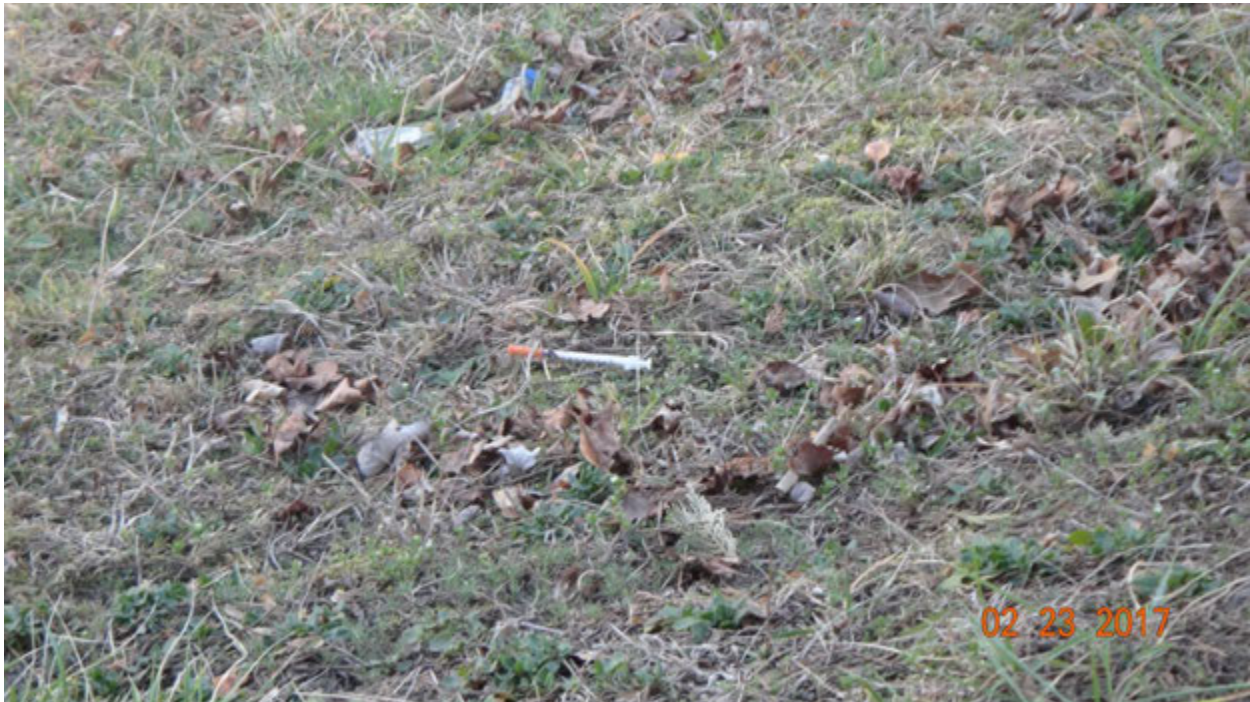
While investigating outfalls in the area, a Versar field team member discovered debris that included used hypodermic syringes and needles in an area near the stormwater pond, O08E3O00001, behind 391 Cork Road in Glen Burnie. The team member found several used drug delivery devices in the vicinity of the pond and the nearby sidewalk (Figures 1, 2, and 3). There is a concern that this area may be frequented by users of illegal drugs. An area map is provided as Figure 4.

Figure 1. One of the used hypodermic syringes and needles found during the site visit

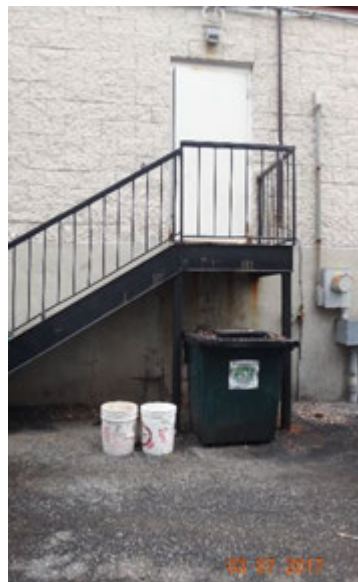
While investigating outfalls in the area, a Versar field team found signs of inadequate waste cooking oil and grease management associated with businesses at the Southgate Marketplace shopping center. The team found a small bin, which appeared to be a collection device for used cooking oil, with two dump buckets on the ground next to it (Figure 1). The dump buckets, with labels describing the original contents as soy sauce, contained some residual materials (Figure 2). The team members could not verify which restaurant was using the bin, but they presumed that the business was China House Restaurant (Suite U). The team found a larger bin for waste kitchen grease nearby (Figure 3). The team noted that the bin had a significant amount of waste residue on the top and trash on the ground near it. The team surmised that this bin may have been used by the Capri Pizza and Sub Express restaurant (Suite V). The rear doors for businesses in this section of the shopping center did not have labels to confirm the establishments, so the team used other information to inform the suggestions.

Figure 1. A small bin for used cooking oil and two dump buckets found behind the China House restaurant (not confirmed)

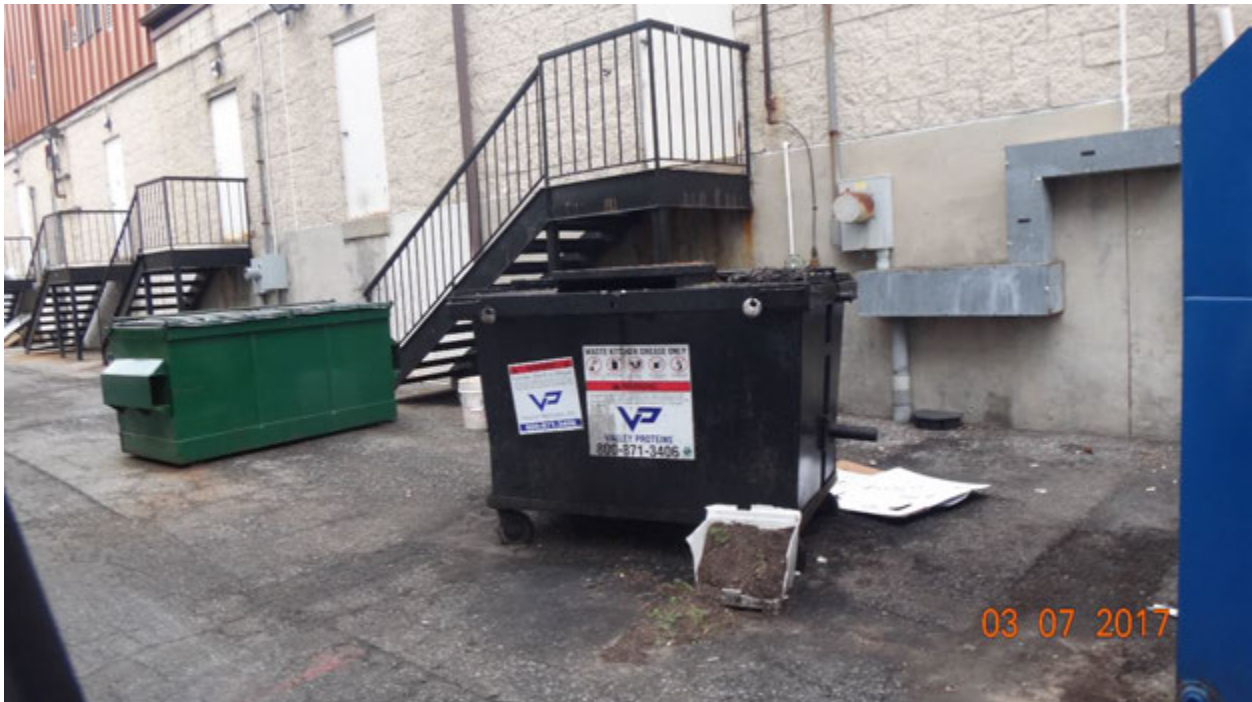
Figure 3. A waste grease bin found behind the Capri Pizza and Sub Express restaurant (not confirmed); note the dark stains on the ground around the bin, and the loose debris

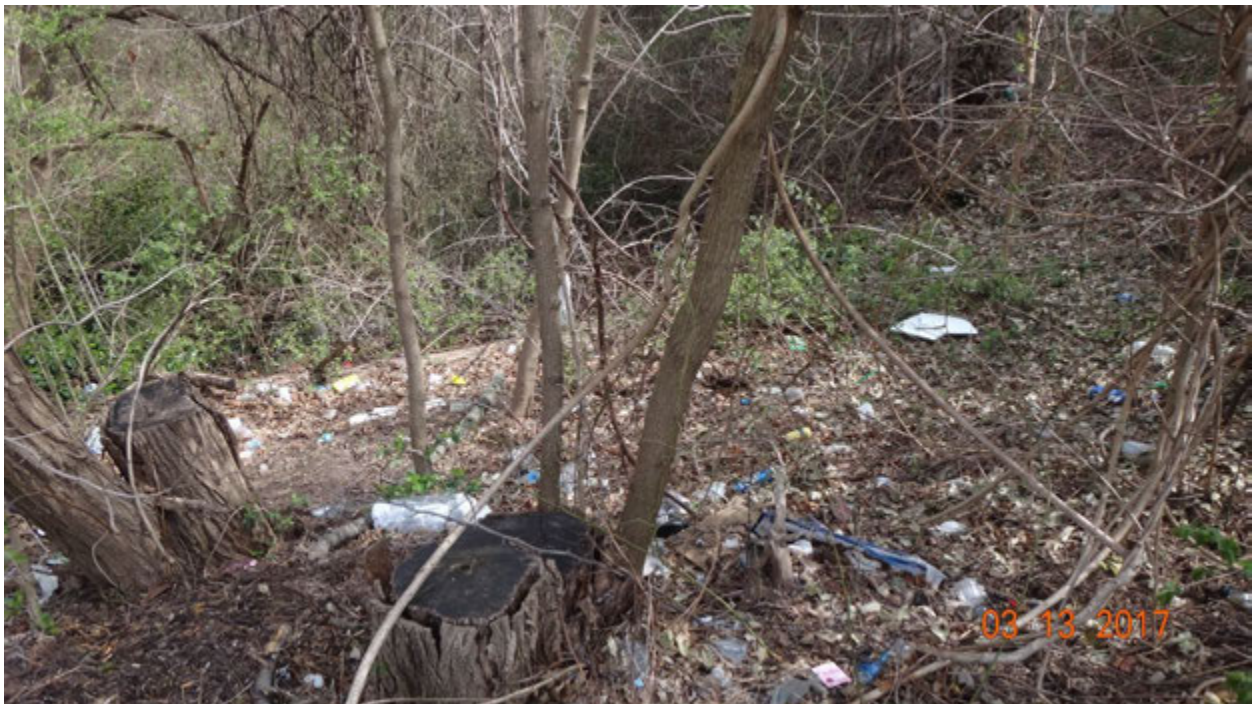
Figure 3. Another view of some of the debris scattered throughout the wooded area; this photograph looks southeast

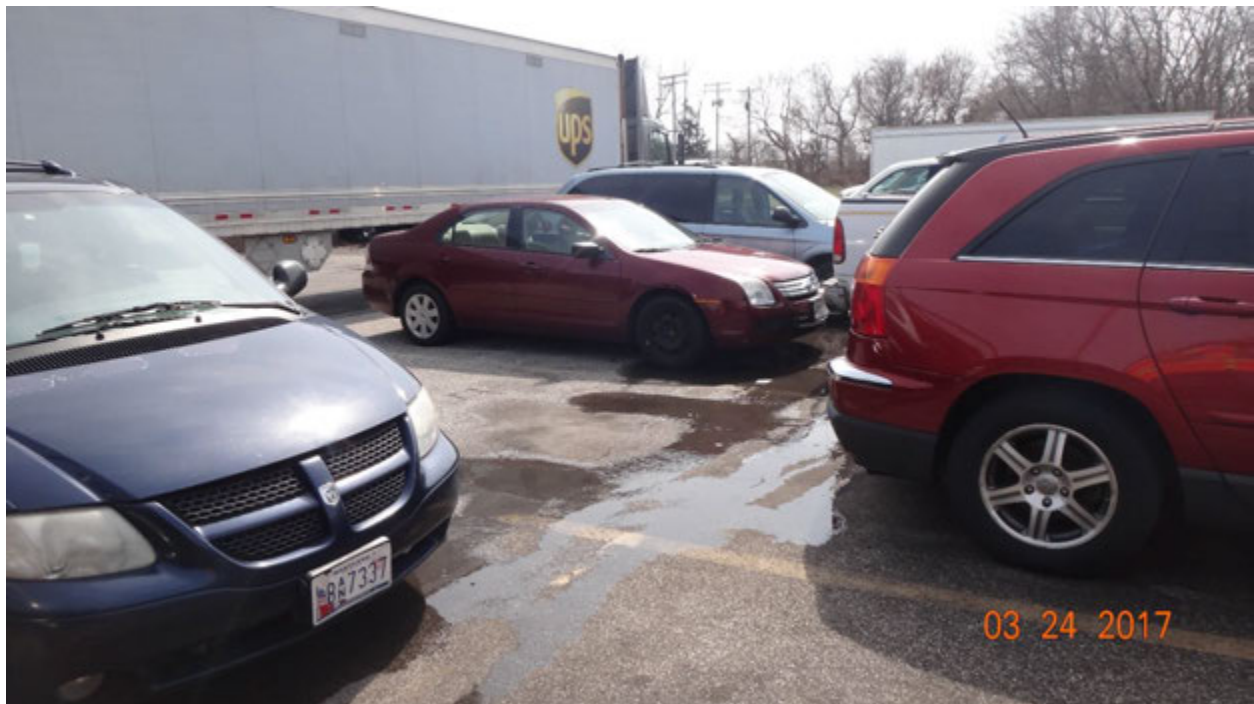
In the adjacent parking area to the west, associated with businesses in the buildings at the 512 address, the team observed more evidence of possible washdown activity. On the center-west side of the parking lot, the team members discovered fresh runoff tracks apparently emanating from a service bay door (Figure 4), although they did not observe the washing activity presumed to have created the water. The team noted that the runoff had sufficient volume to reach a grate inlet in the parking lot; the stains at the inlet provided signs that tainted runoff had entered the inlet from the southwest in the past, also (Figure 5). On the parking lot near the southwest end of the same building, the team also documented a substantial trail of sediment associated with runoff. This residue suggested drainage from a separate washing activity that had involved dirt which was then transported via runoff toward an inlet in the corner of the lot (Figure 6). Evidence of accumulated light sediment on the southwest edge of the lot suggested that this type of runoff may have occurred more than once (Figure 7).

Figure 2. Excessive runoff from the Bay 2 washdown activity flowing across the pavement

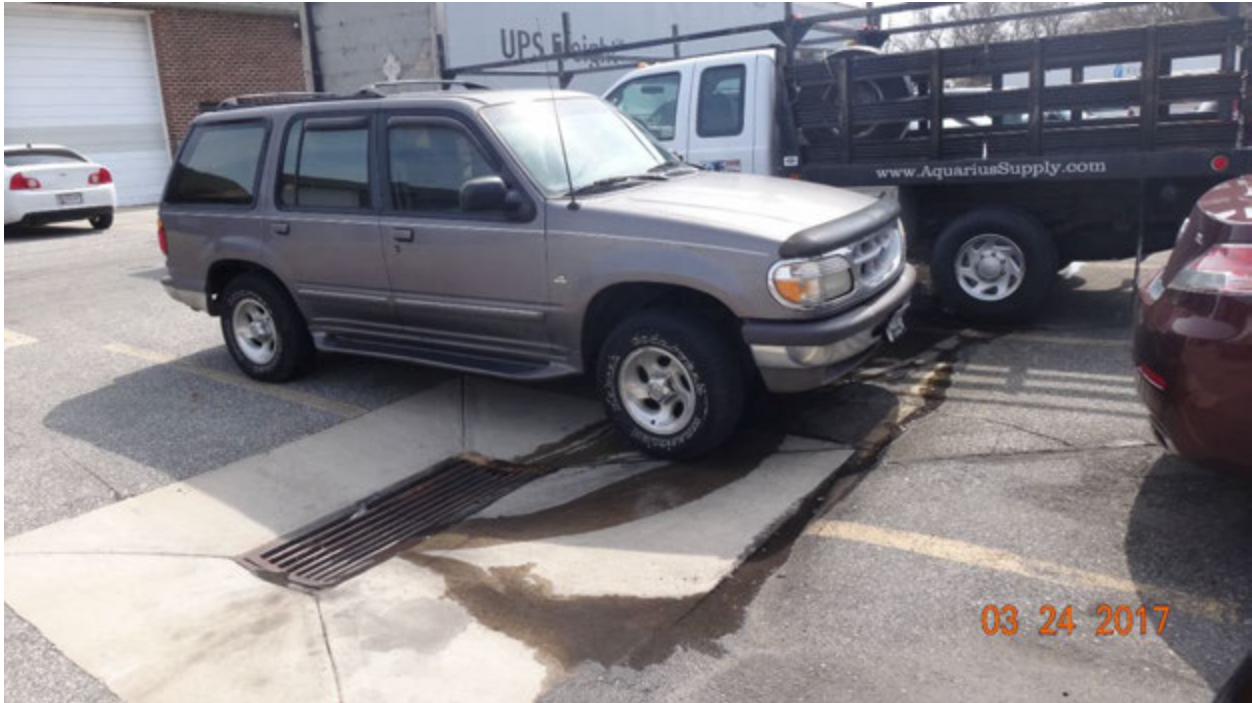
Figure 3. Excessive runoff from Bay 2 washdown activity entering a grate inlet

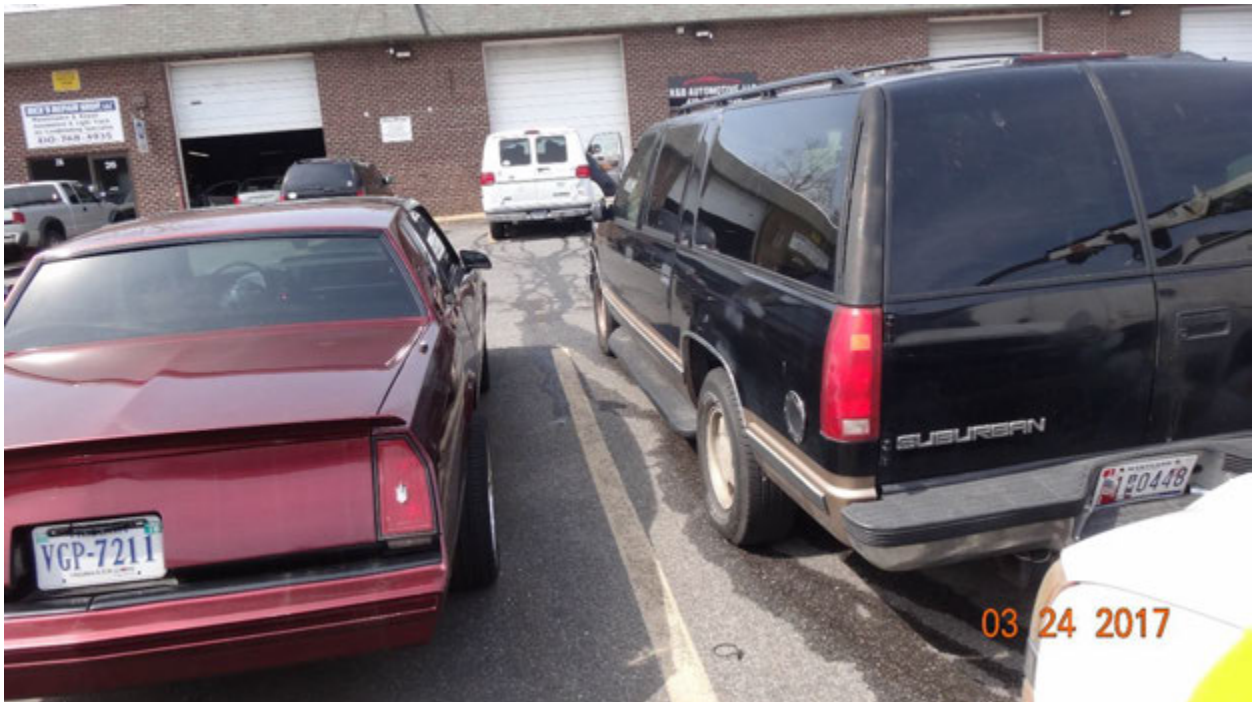
Figure 4. Fresh wet stains suggesting recent washdown activity (not observed) on the center-west side of the 512 building

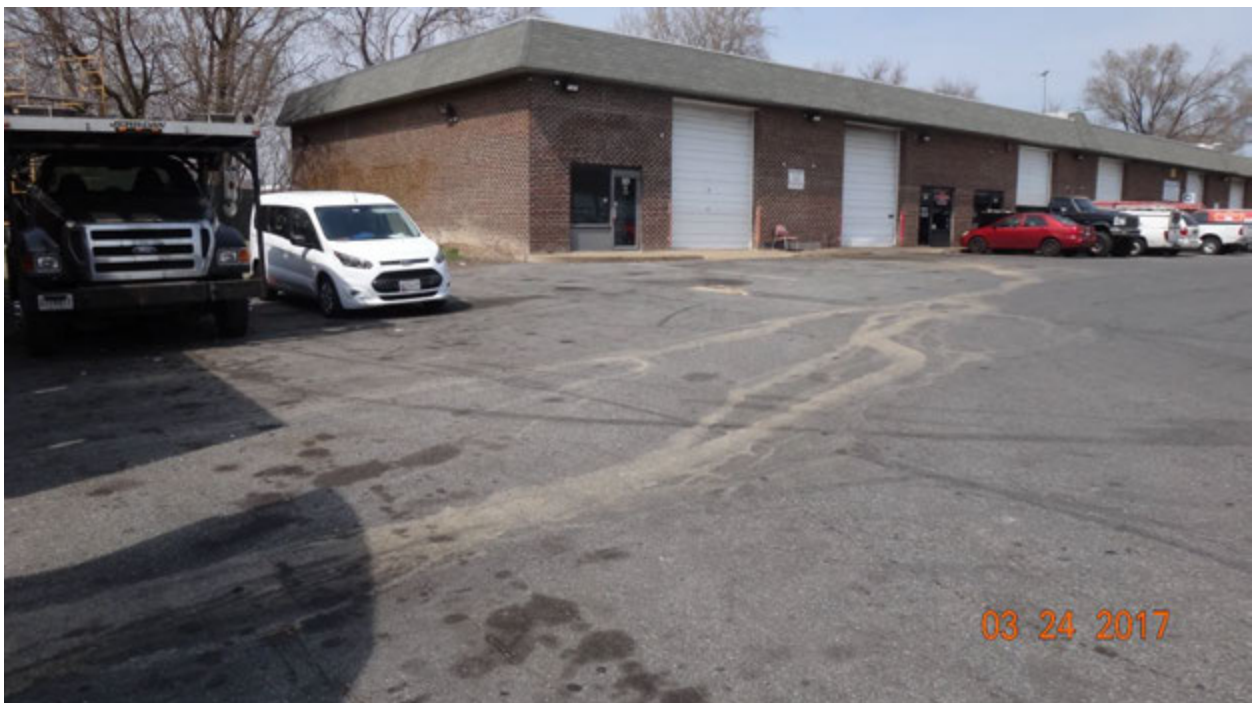
Figure 6. Evidence of runoff from a previous washdown activity that carried sediment; the grate inlet receiving this runoff is at the southwest corner of the lot (off the left side of the photograph)

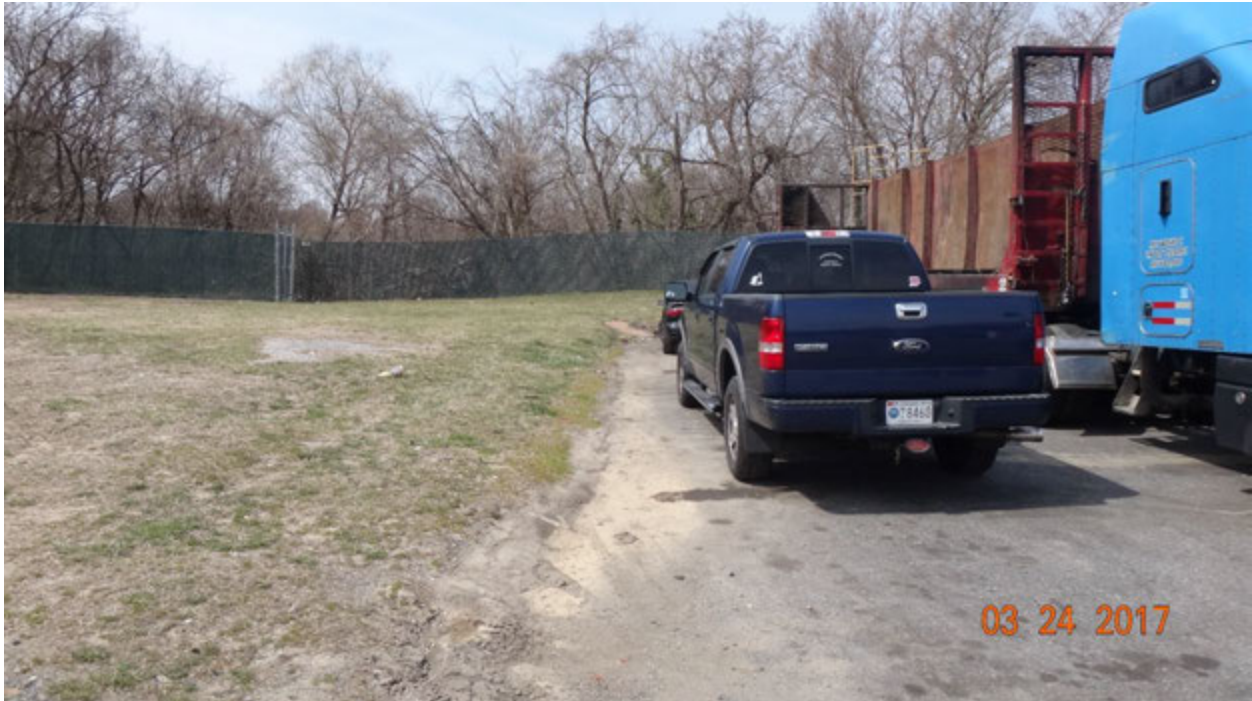
Figure 7. Evidence of accumulating sediment at the southwest edge of the parking lot; the flows associated with the stain reported in Figure 6 passed under the blue tractor-cab (right)
