**ANNE ARUNDEL COUNTY
ILLICIT DISCHARGE DETECTION
AND ELIMINATION**

2017 ANNUAL REPORT

PERMIT NUMBER MD0068306

FINAL: January 2018

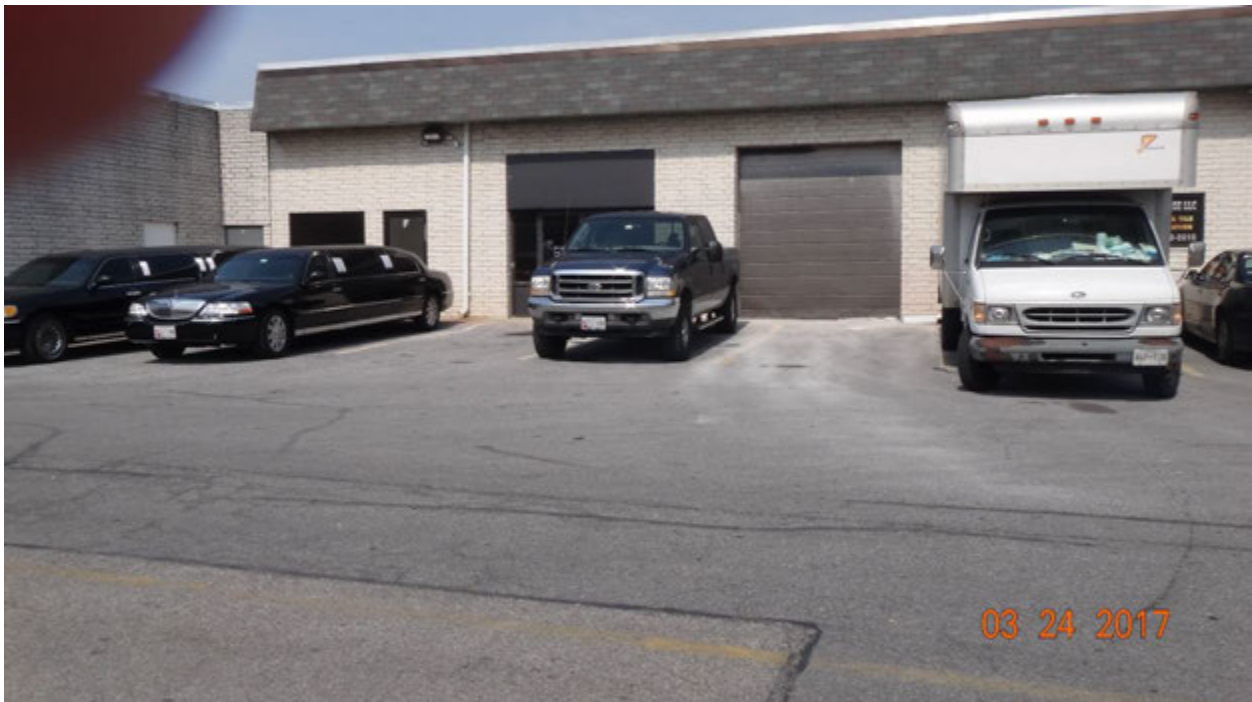
In an area of the complex near the southeast end of the stormwater infrastructure network, the team found another stain (Figure 8). The white residue appeared to be associated with runoff from a commercial bay used by the Maryland Bullnose LLC business (514 address) that processes stone and tile. Although only the residue was evident, the flow line from the bay door toward a nearby grate inlet suggested that excessive flows from washdown activities may have the potential to transport mineral particulates and other substances to the storm drain system.

Figure 8. Evidence of possible previous washdown activity, associated with a tile fabrication business, which carried and deposited white particulates (leading away from the closed bay door; right center)

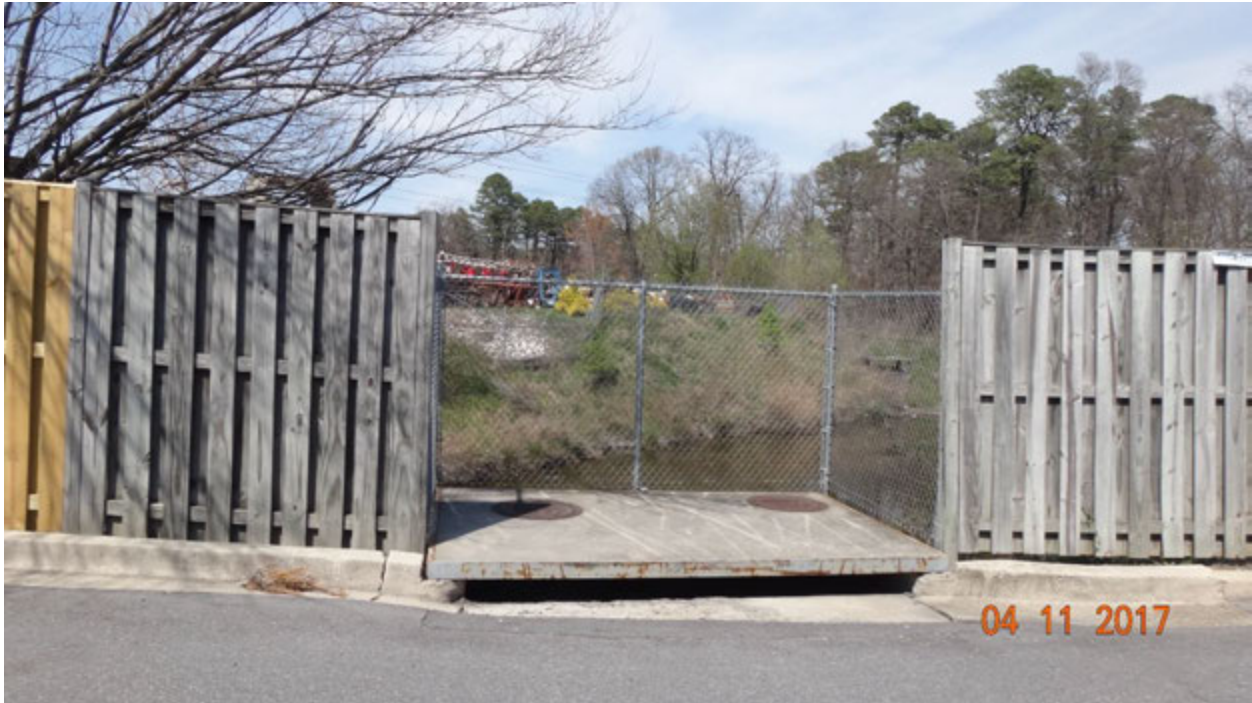
Figure 2. A view looking across the stormwater pond at the edge of the business lot; note the steep hill between the lot and the pond

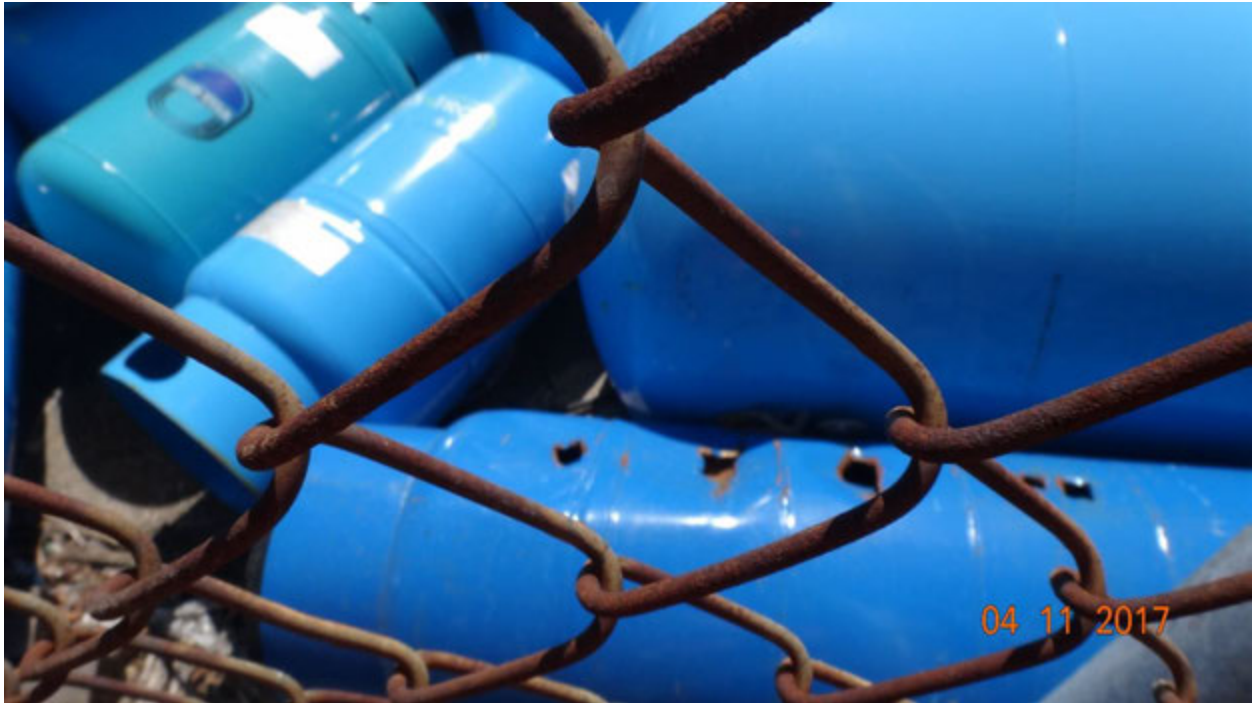
Figure 2. A detail view of one of the pressure tanks seen with rusting holes from previous punctures

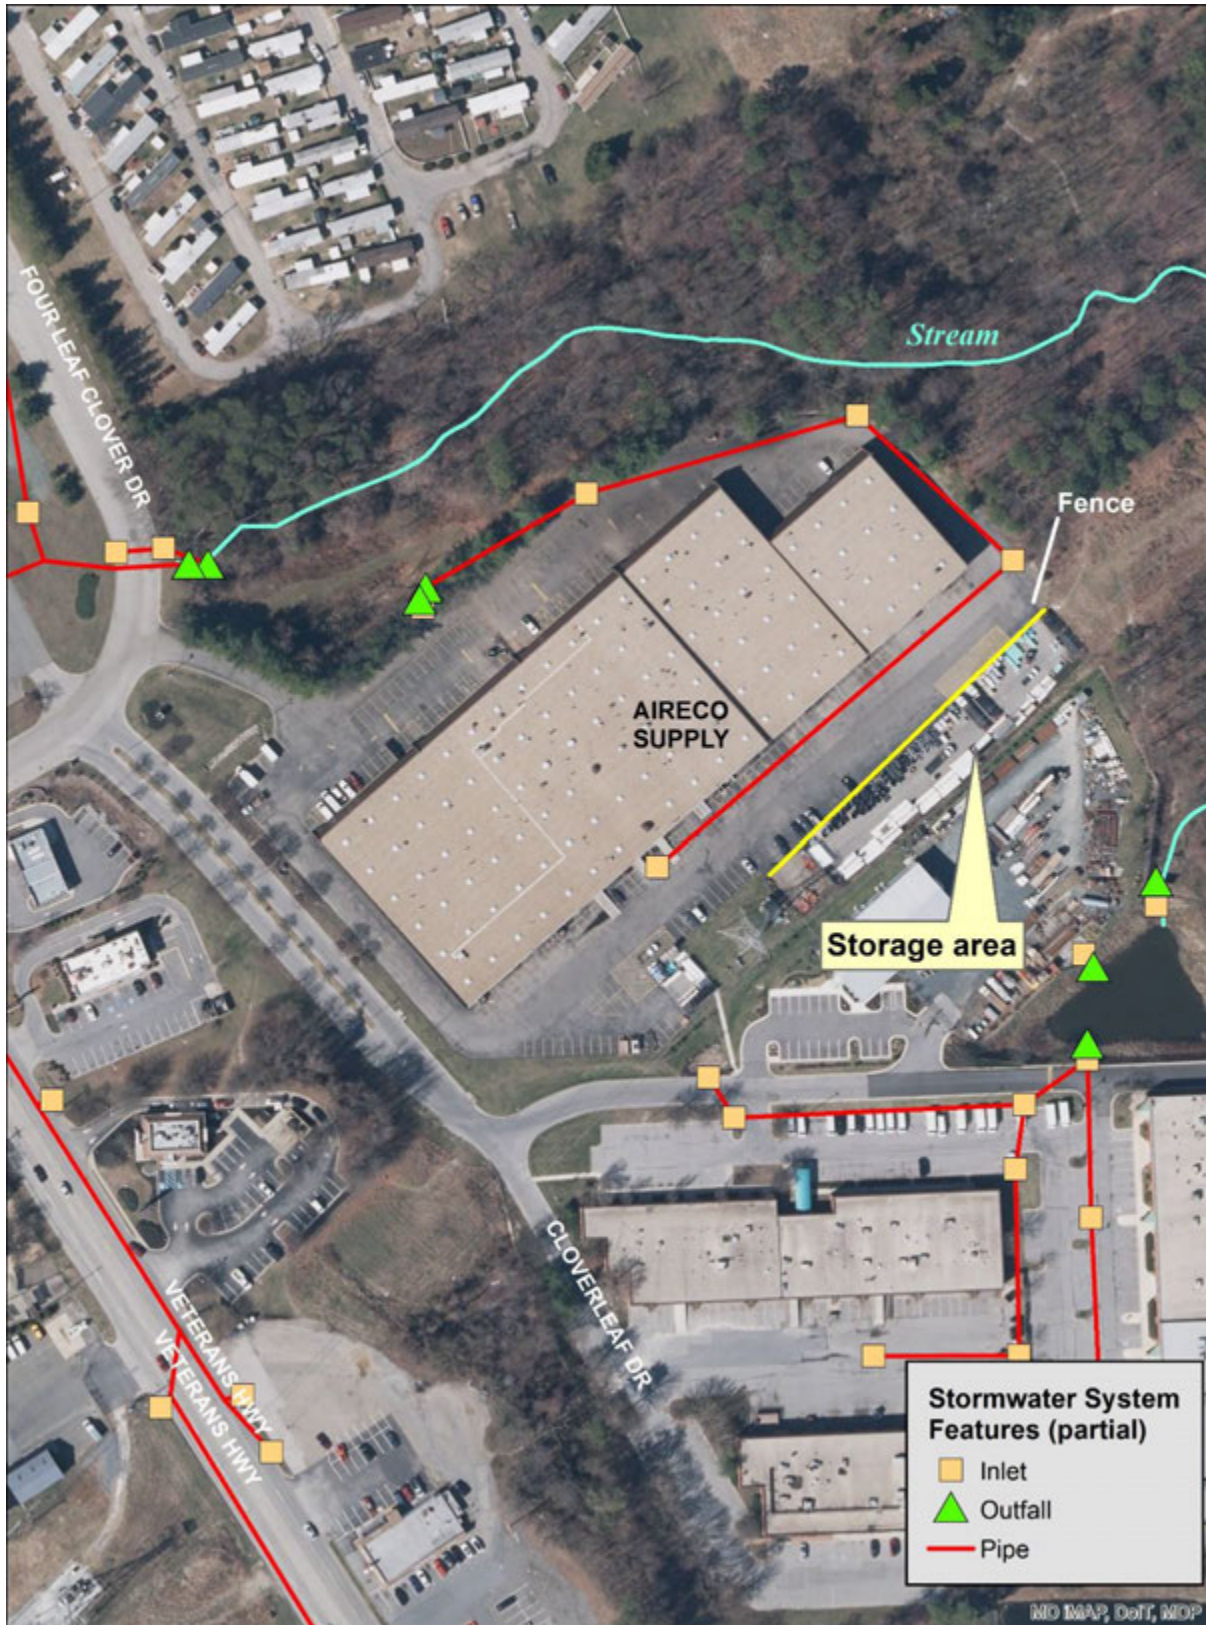
Figure 3. View inside the storage area showing an open bin for discarded materials (center), pressure tanks, bulk rolls of tubing, and stacks of pipes

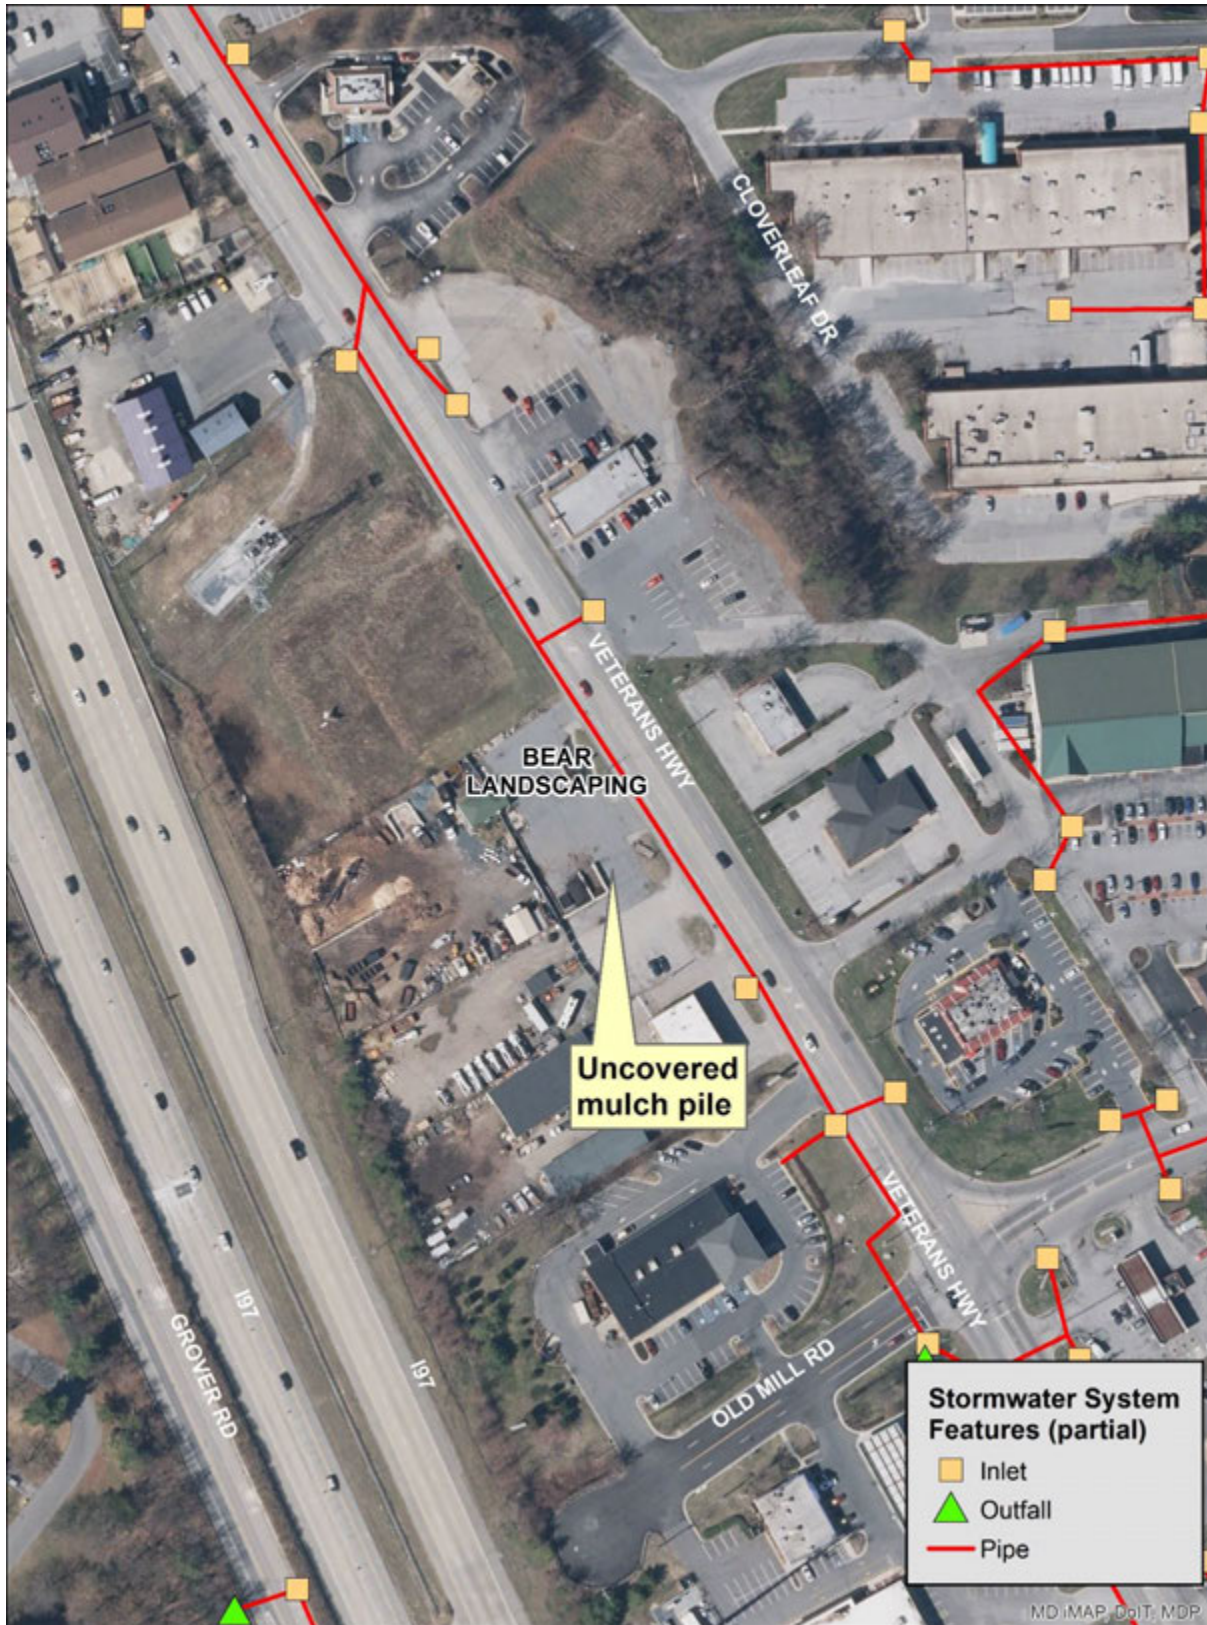
Figure 1. An uncovered pile of mulch found outside the enclosures in the front of the lot near the main road

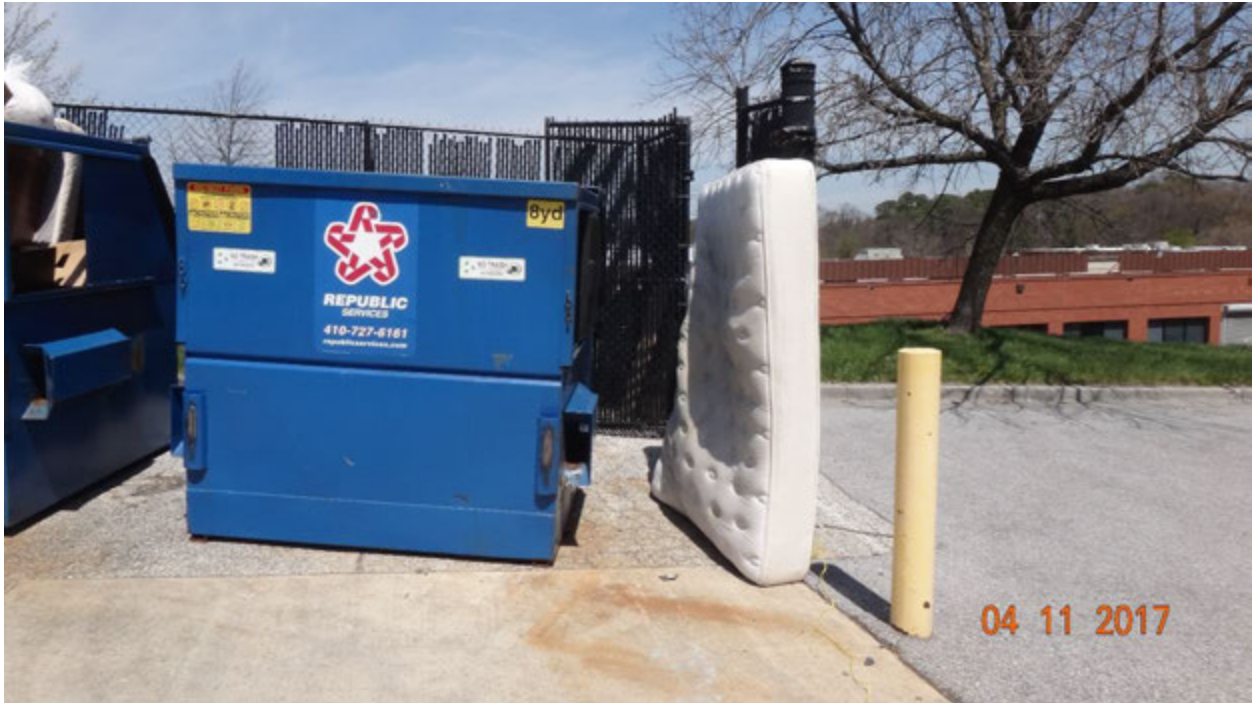
Figure 1. An overfilled dumpster found in a pen behind the Goodwill thrift store

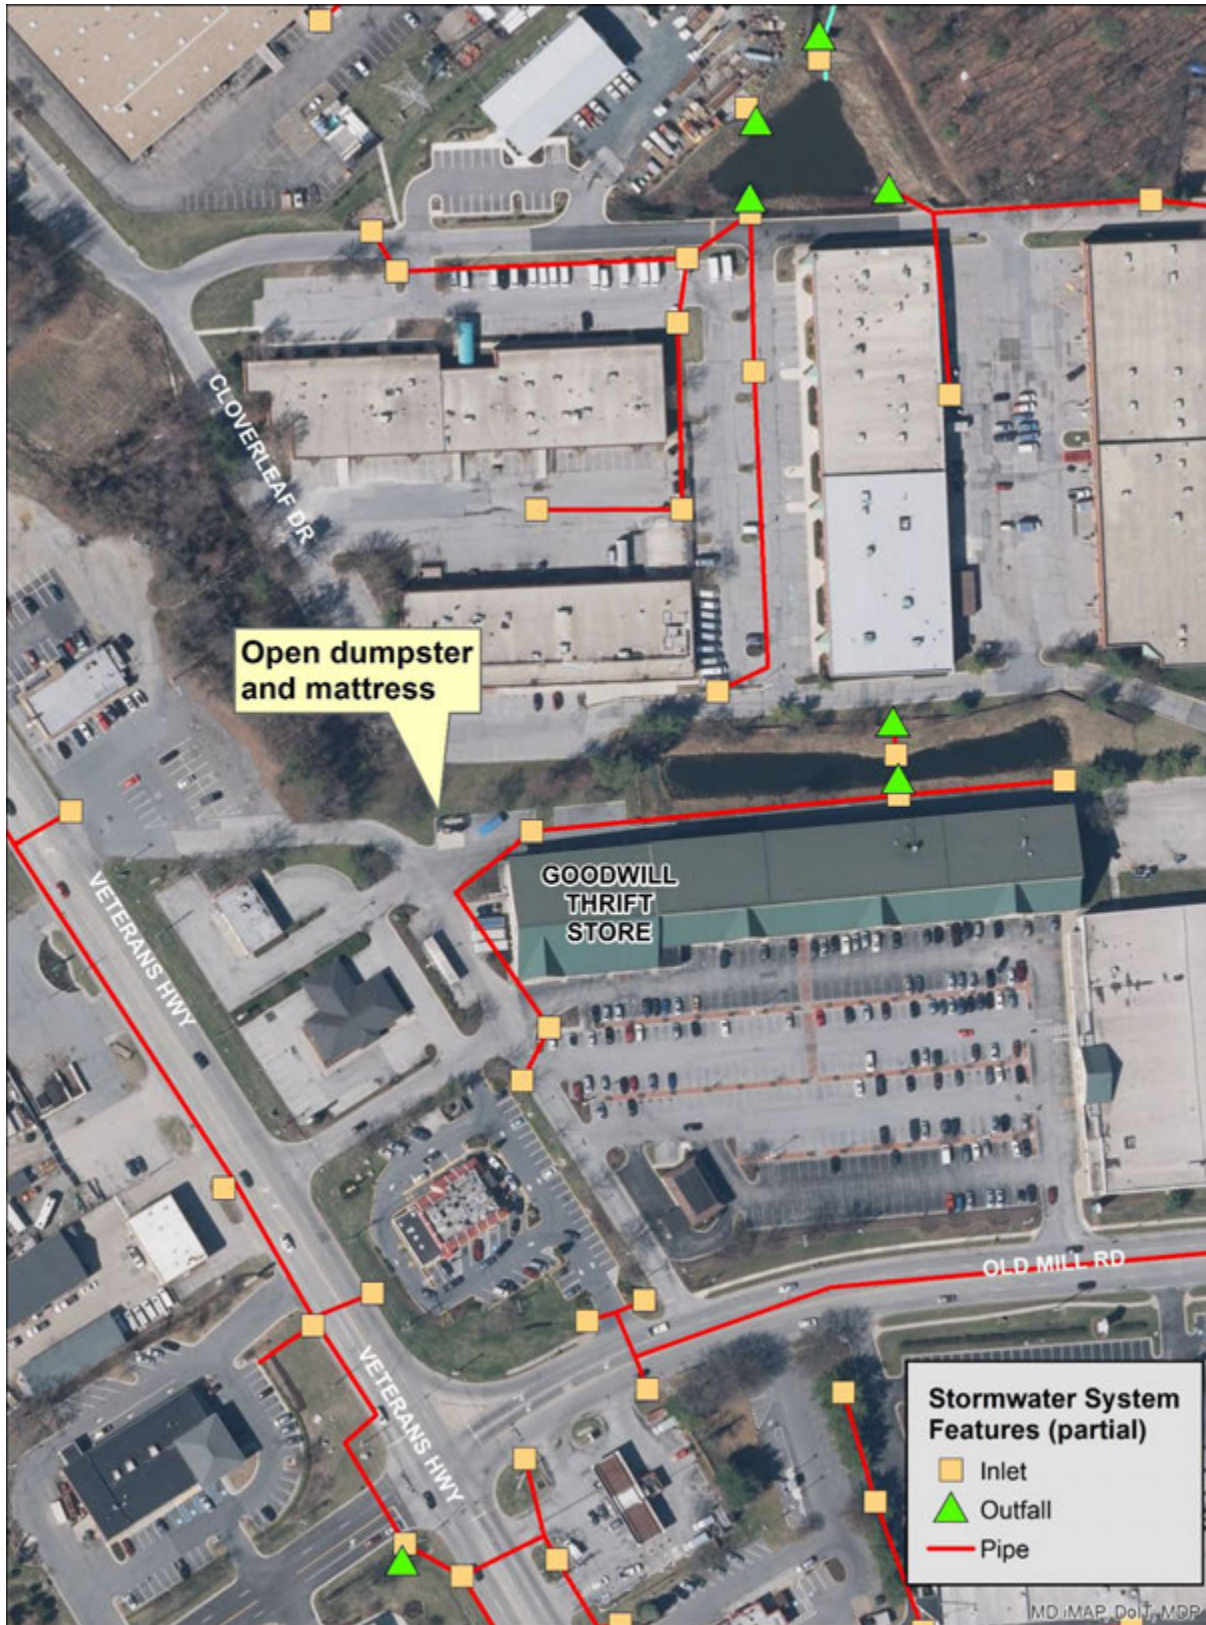
Figure 4. A discarded floor fan found on the hill behind the dumpsters

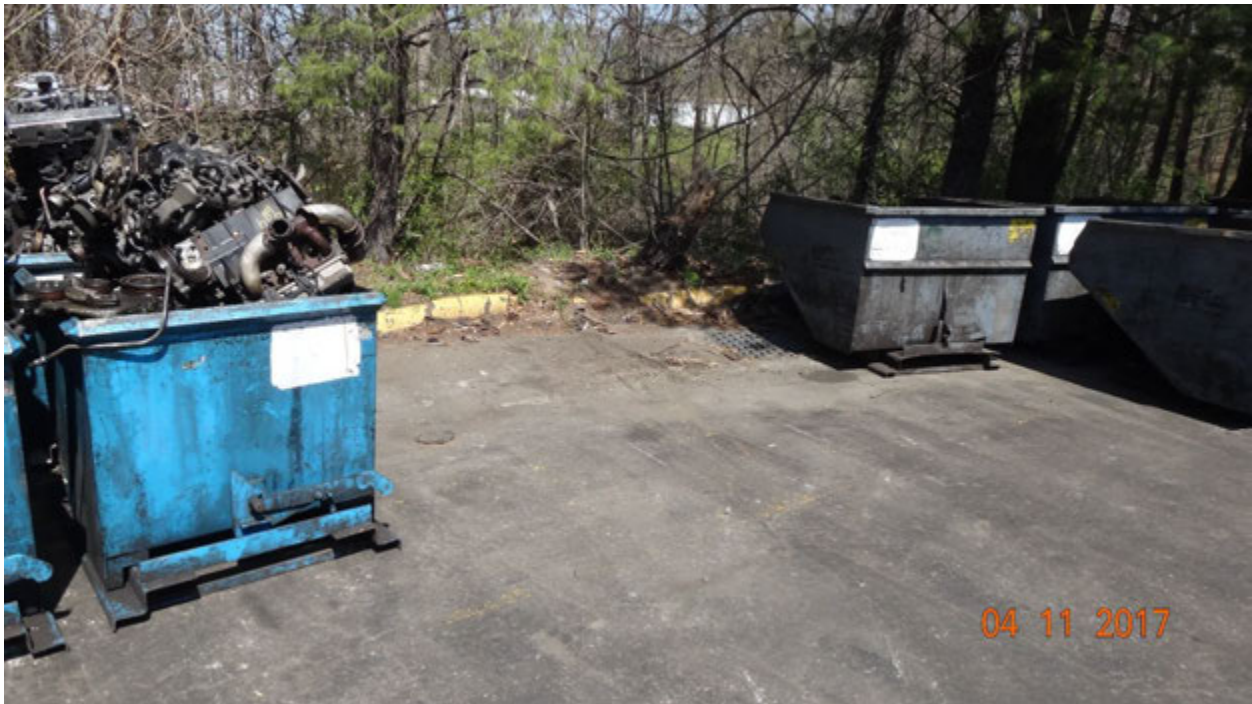
Figure 3. Overfilled bins with large automotive components stored on the pavement

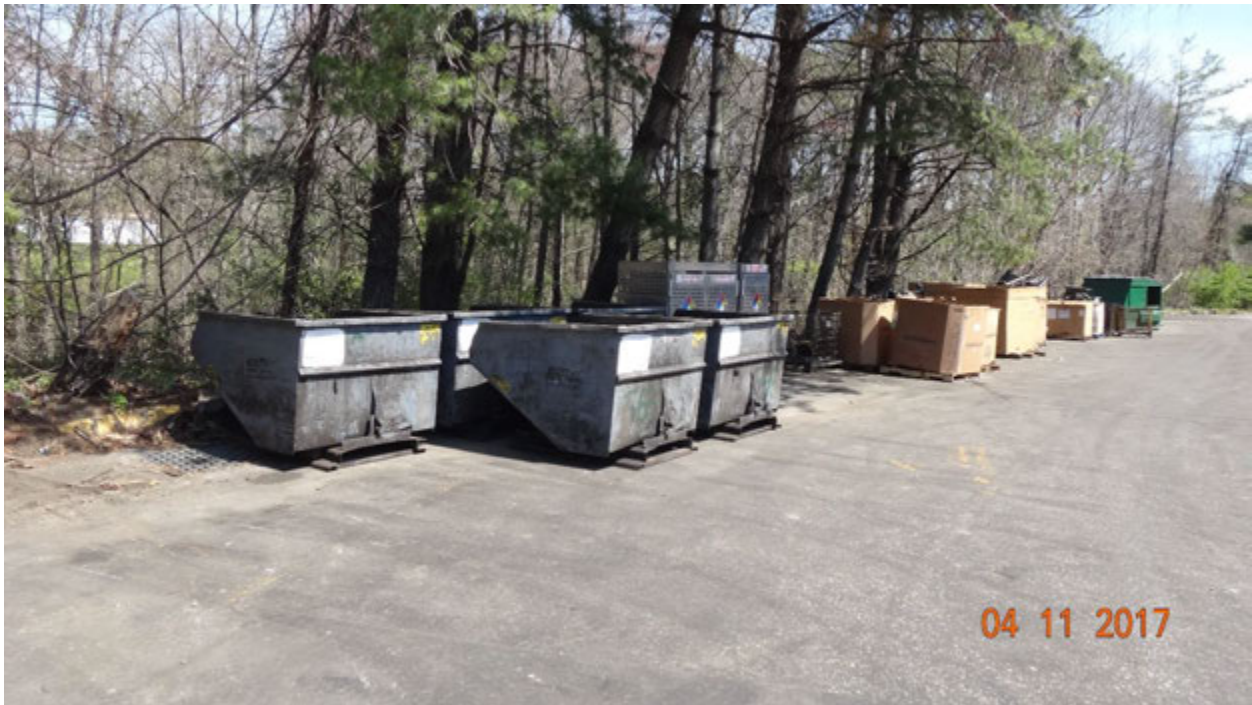
While investigating outfalls in the area, a Versar-LimnoTech field team discovered bulk solid storage and waste management issues at the ROK Brothers automotive parts recycling center, located at the above address. According to the company's Web site, <http://rokbrothersllc.com/>, the business buys and recycles automotive parts and scrap metal. The field team documented that the business used bins and boxes to segregate and store used auto parts outdoors, on pavement and without cover (Figure 1). The team documented that some of the receptacles contained rusting parts (Figure 2). The crew found many of the bins overfilled (Figure 3). A cluster of bins and the end of a long line of bins were both near a stormwater inlet (Figures 4 and 5).

Figure 4. View showing the relative location of the bins used to store automotive parts to a stormwater inlet (center right)

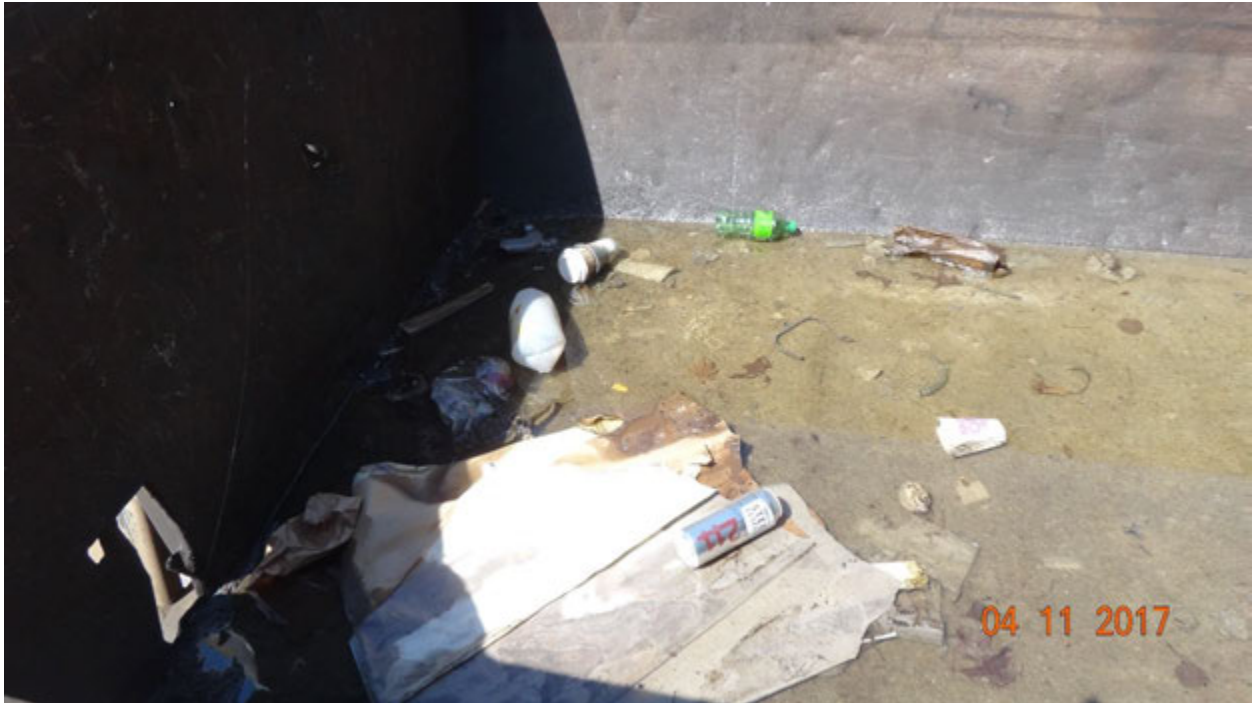
The conditions on the lot also demonstrated inadequate waste management practices. The team found several open rollaway dumpsters that showed signs of damage and deterioration. One dumpster had a rusting shell with signs of damage (Figure 6). Another dumpster had a large gash on one end that would allow liquids to escape the enclosure (Figure 7). The team documented that one dumpster had what appeared to be an oil stain on the underlying pavement near one corner (Figure 8). Generally, the team observed oil odors, discarded kitty litter (commonly used to soak up automotive fluids), and material associated with automobiles (glass, metal, and plastic) in these debris bins. The team also identified a pallet of used batteries and bins of radiators and engine belts placed on the impervious surface. Site conditions also included a coating of oil-grit over a wide area of the parking lot and a clean-up procedure that appeared to include dumping of deposited material adjacent to the parking area and upslope of the adjacent stream. The team assessed the site as a severe hotspot during the investigation, due to the number of concerns, the proximity of open bins to stormwater inlets, and the perceptions indicating motor oil discharge associated with open bins and apparent leaks on the pavement. Figure 9 provides an area map showing the relative locations of bins to the stormwater system.

Figure 6. A rusting rollaway dumpster exhibiting a puncture hole on the side and a tear at the bottom; note stains on the pavement (left)

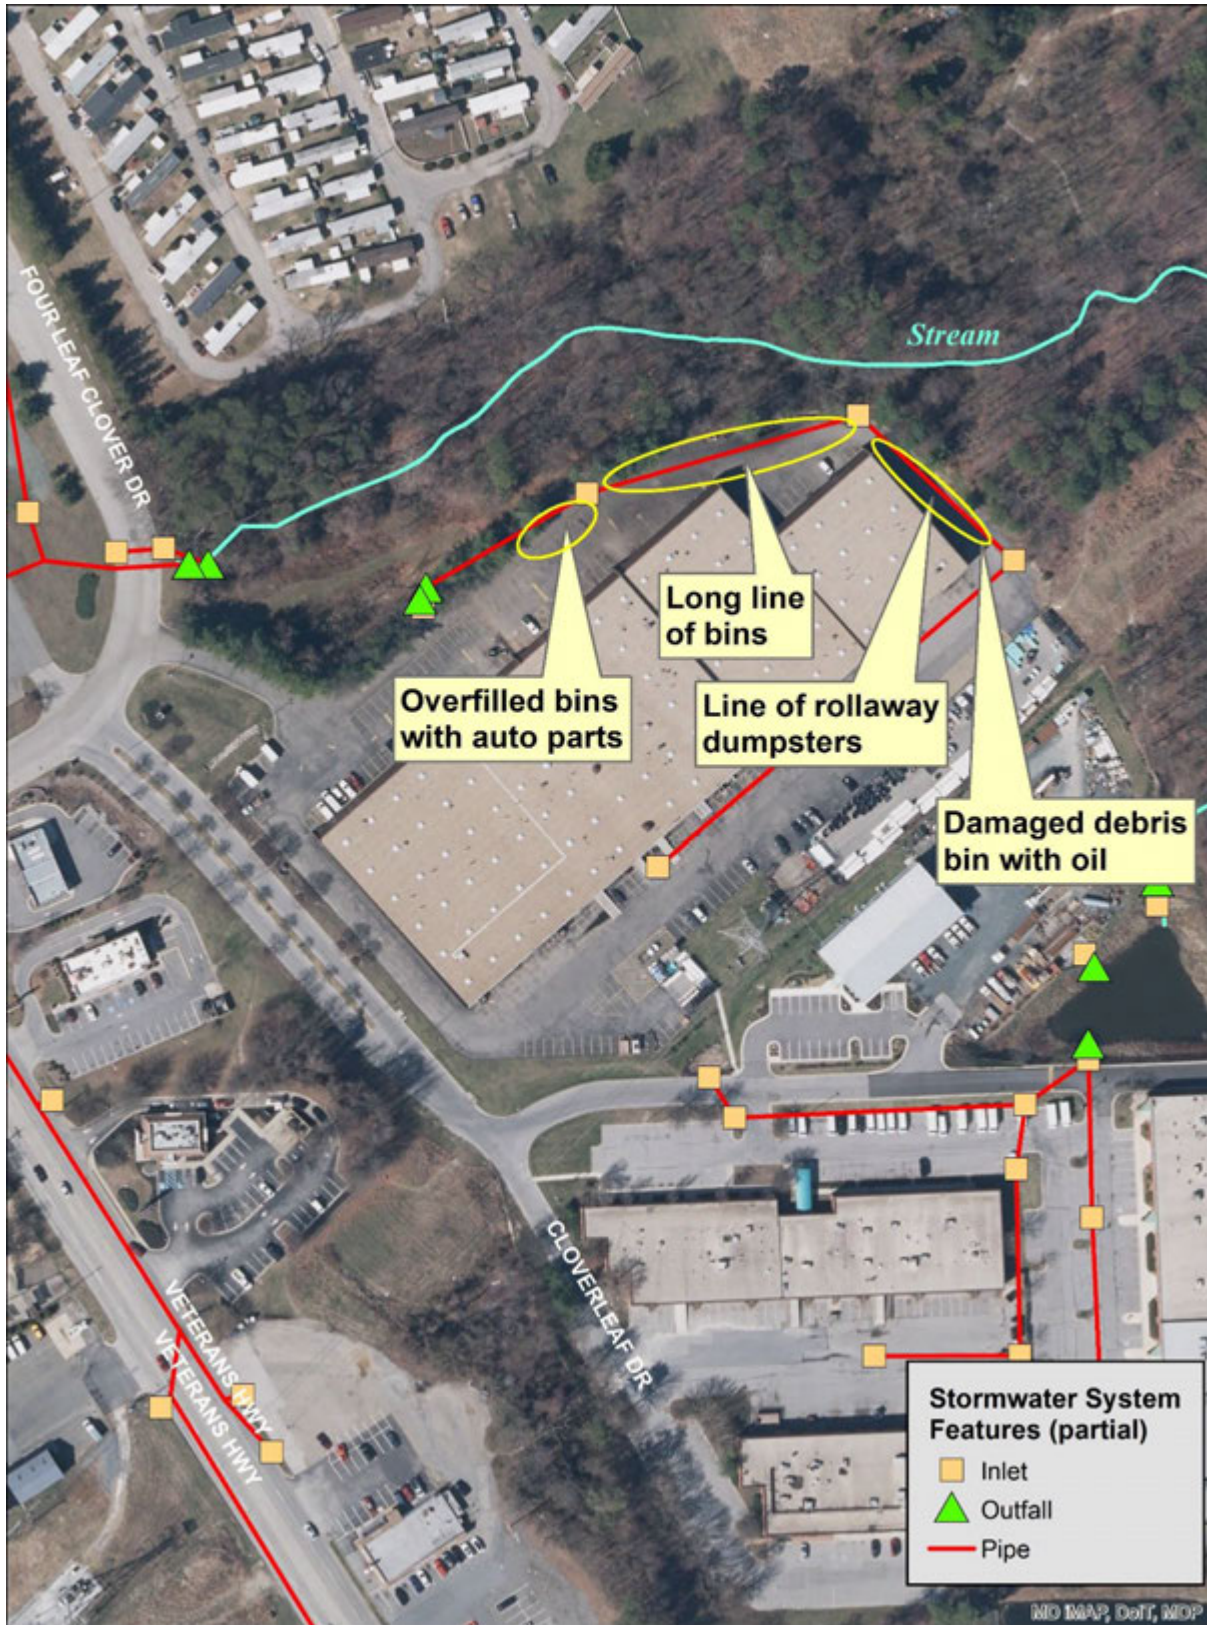
Figure 8. A dark oily discharge appeared to emanate from under a rollaway dumpster

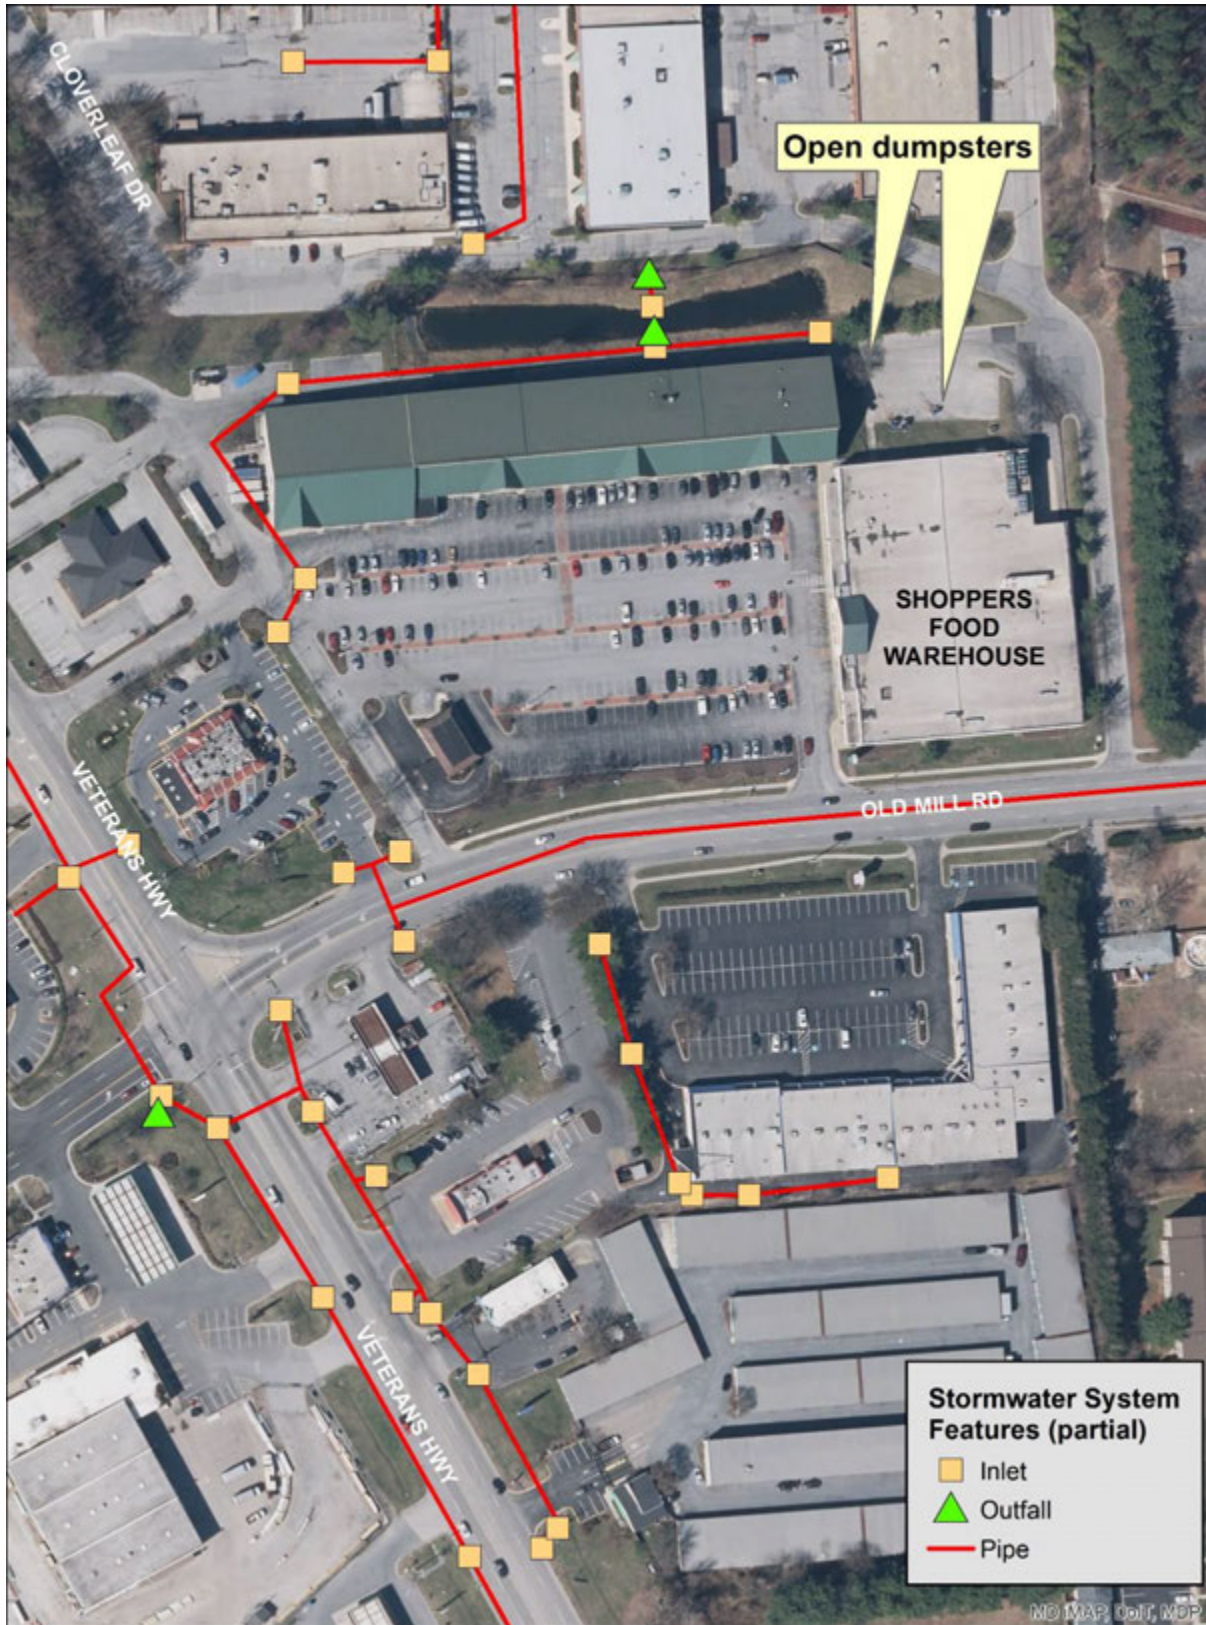
Figure 3. A second overfilled dumpster found near a curb cut-out; note the curb inlet across the side street

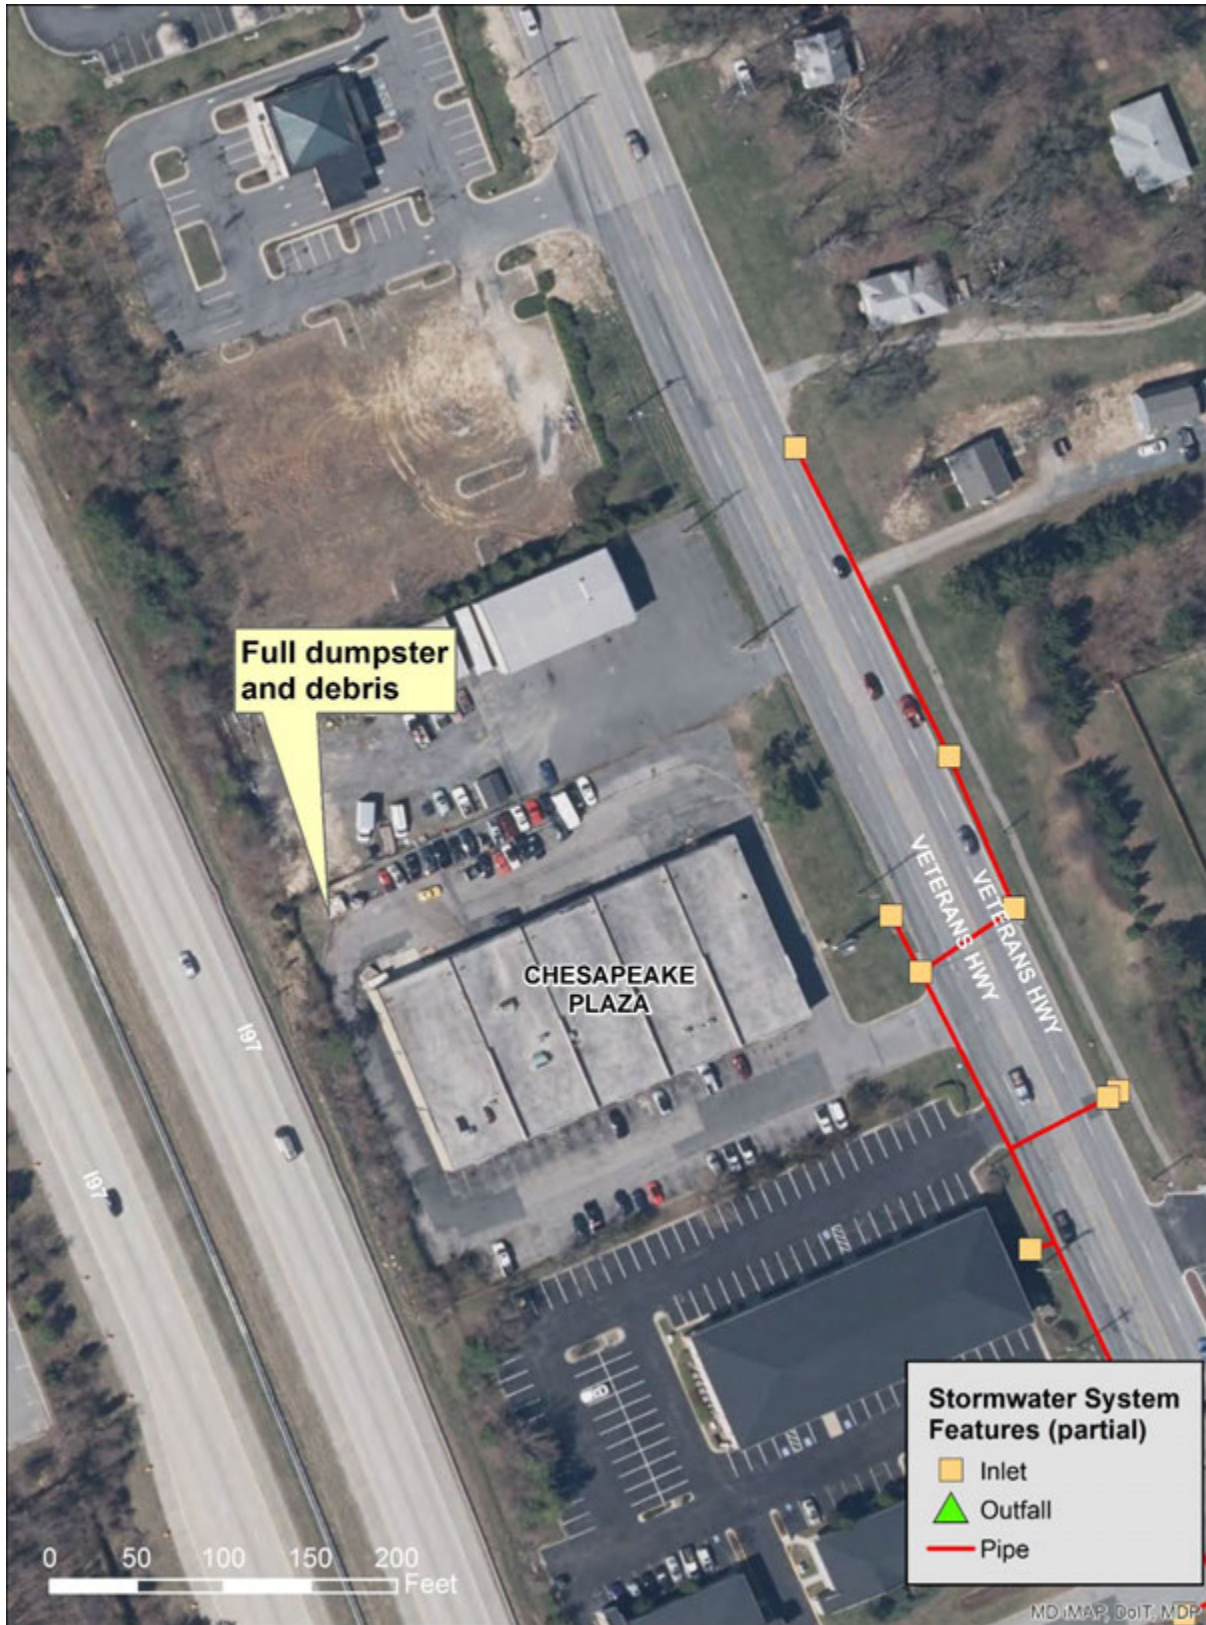
Figure 1. An overfilled dumpster with debris on and around it found on the parking lot of the Chesapeake Plaza; note the hand-written sign that reads "X-Press Floors"

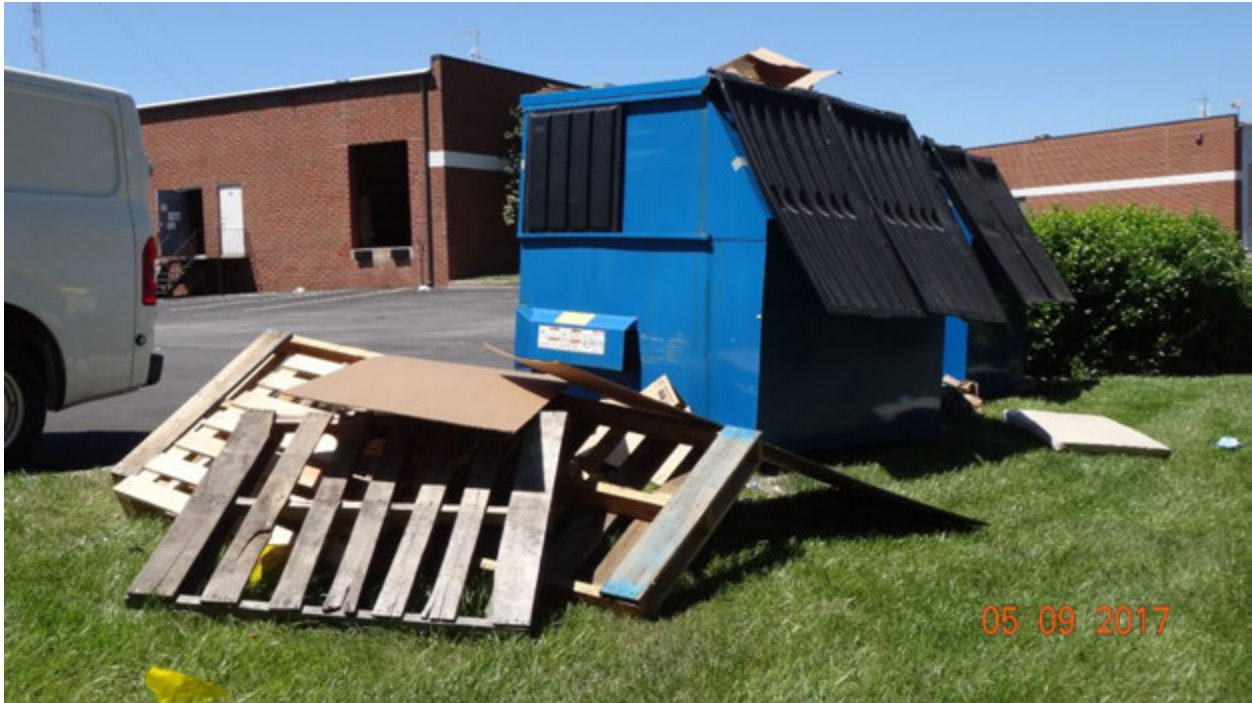
Figure 1. Two open and overfilled dumpsters found on a gravel pad adjacent to the parking lot near 413 Headquarters Drive
