**ANNE ARUNDEL COUNTY  
ILLCIT DISCHARGE DETECTION  
AND ELIMINATION**

**2019 ANNUAL REPORT**

**PERMIT NUMBER MD0068306**

August 2019

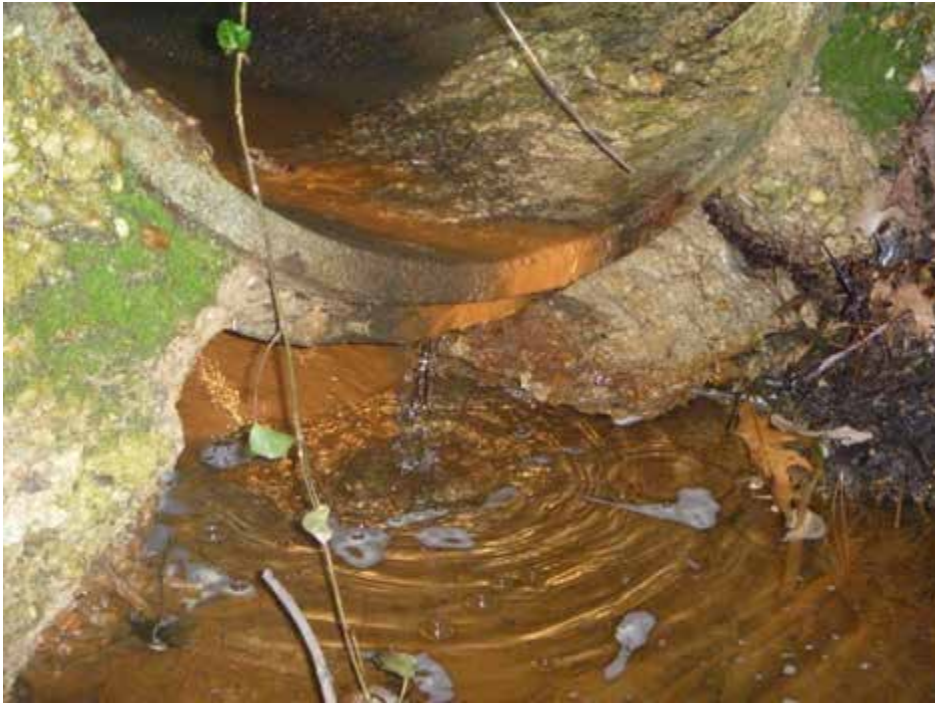
While investigating target outfalls in the vicinity, a Versar team found evidence of collapsing infrastructure at a manhole in the network associated with outfall S14O014. The team observed the conditions at 3:35 p.m. on Tuesday, February 5, along Via Amorosa. A homeowner alerted the crew to significant ground subsidence around a manhole approximately 30 feet up-network from the outfall (Figure 1). The crew observed that the outfall was also being undercut by water flowing under the end segment (Figure 2). The team estimated the undercut depth to be approximately 18 inches. An area map, indicating the location of the manhole and the outfall, is provided in Figure 3.

Figure 1. Evidence of soil subsidence immediately adjacent to the manhole

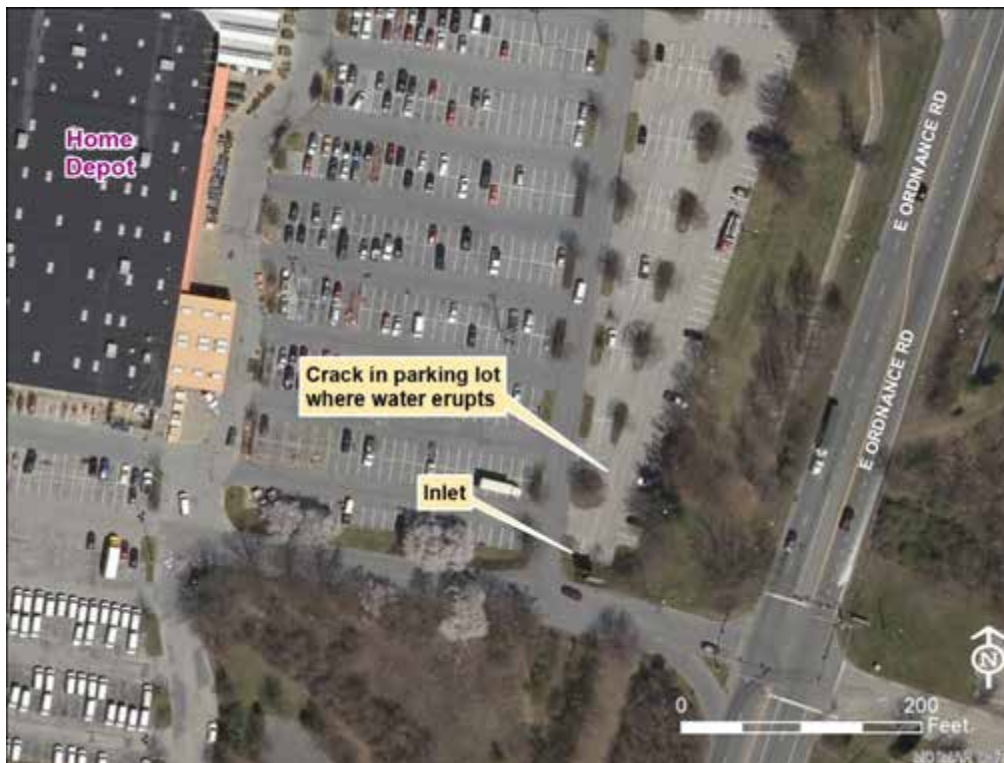
Figure 2. Evidence of water escaping from cracks in the parking lot; this appeared to be the source of the flooding

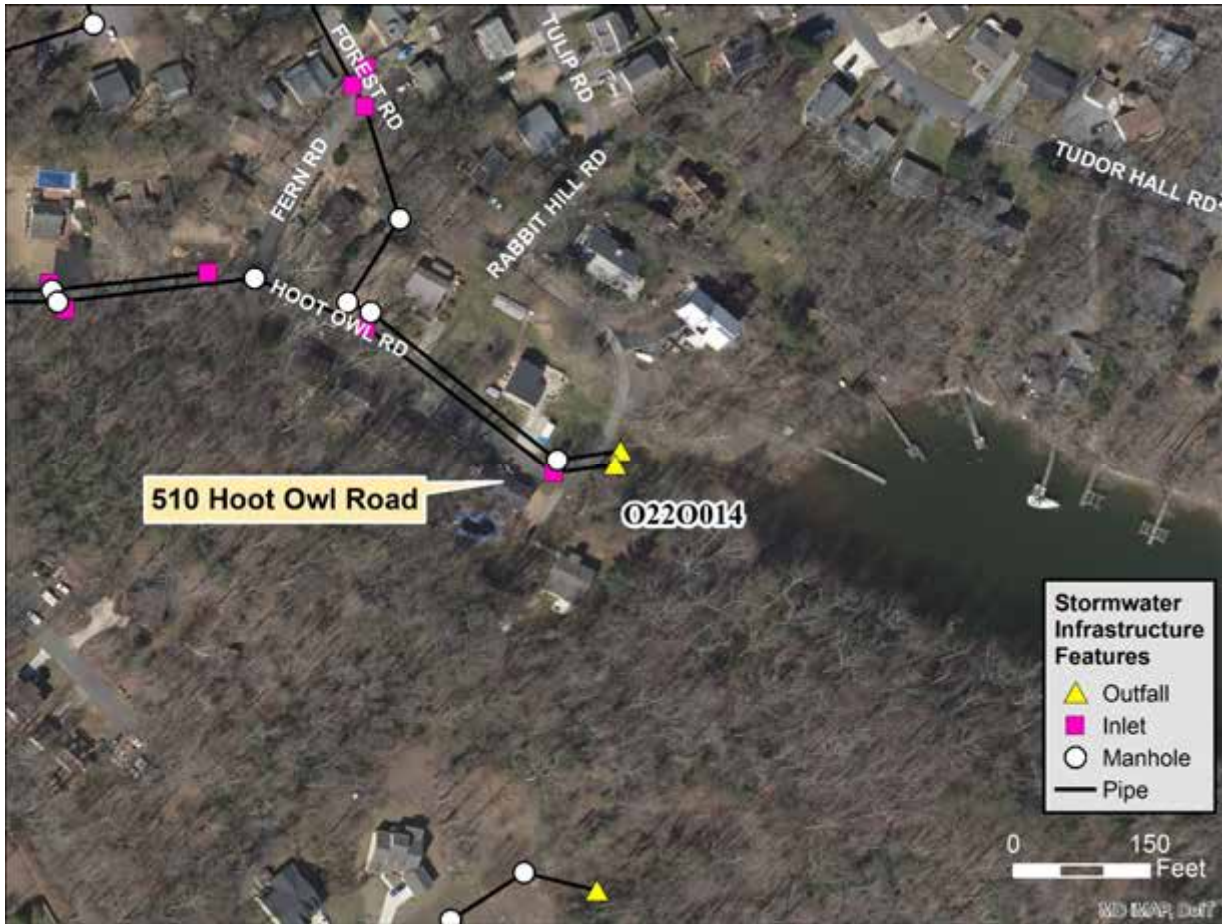
Figure 2. Evidence of a hose discharge (from the residence on the left) entering an inlet near 510 Hoot Owl Road; the source of the water was a backyard pool

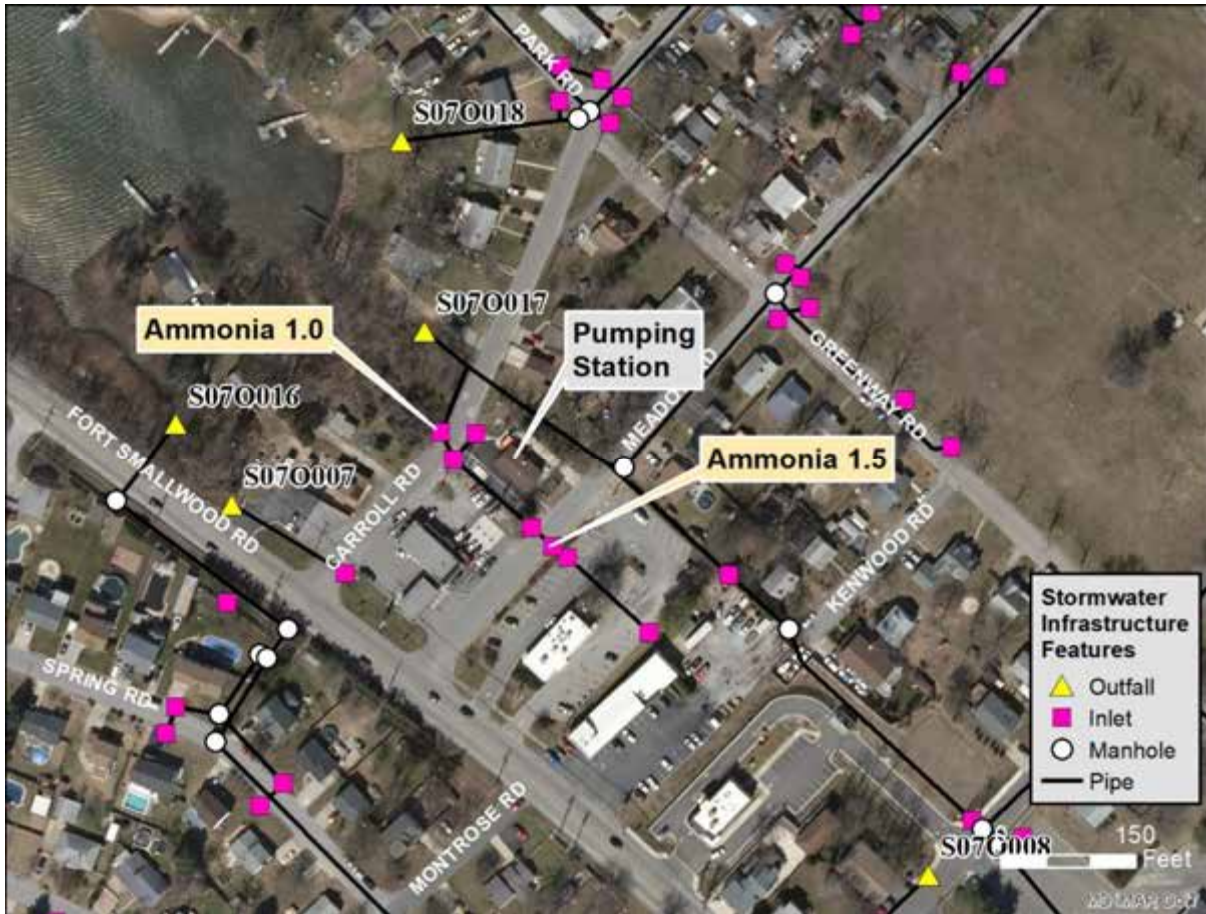
Figure 1. A view of conditions at Outfall S07O017 on April 24, 2019

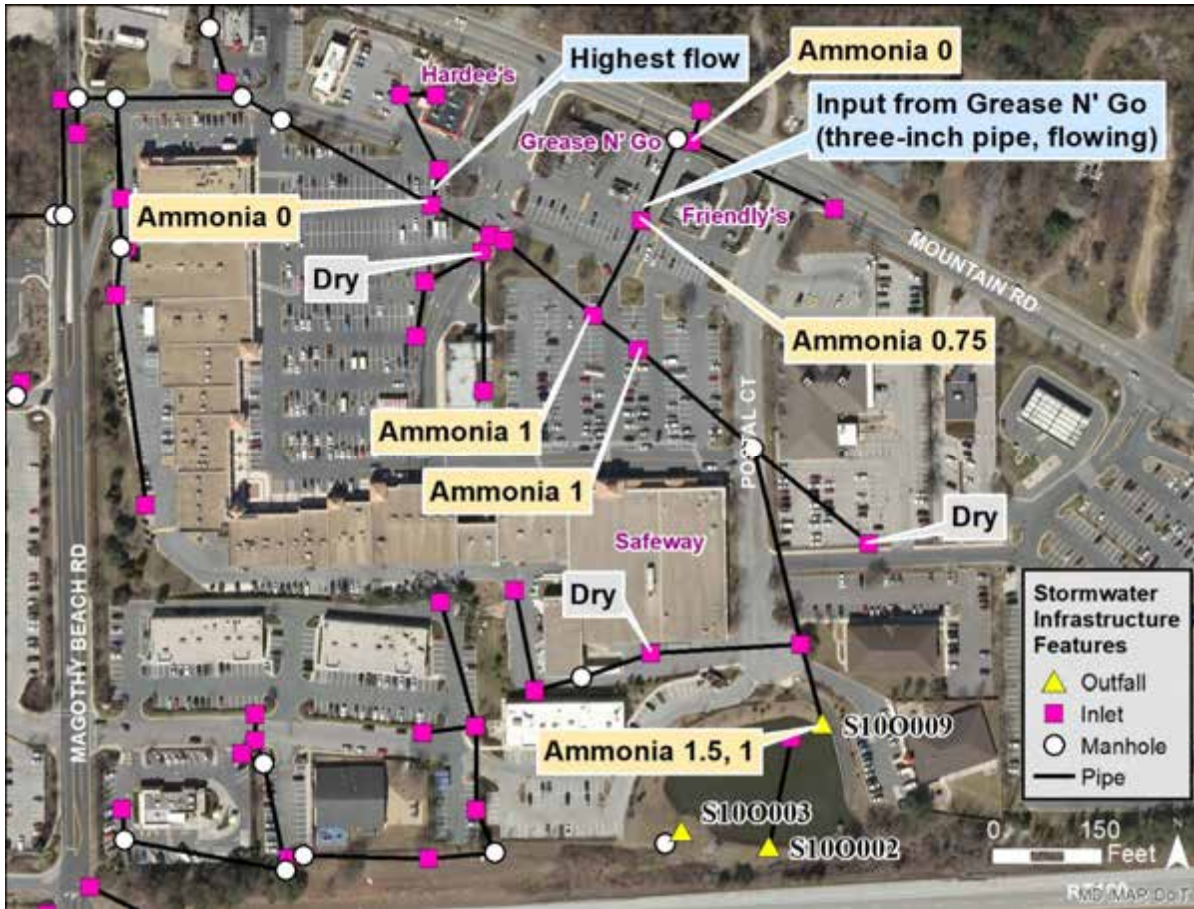
Figure 1. A view of conditions at Outfall S10O009 on April 24, 2019

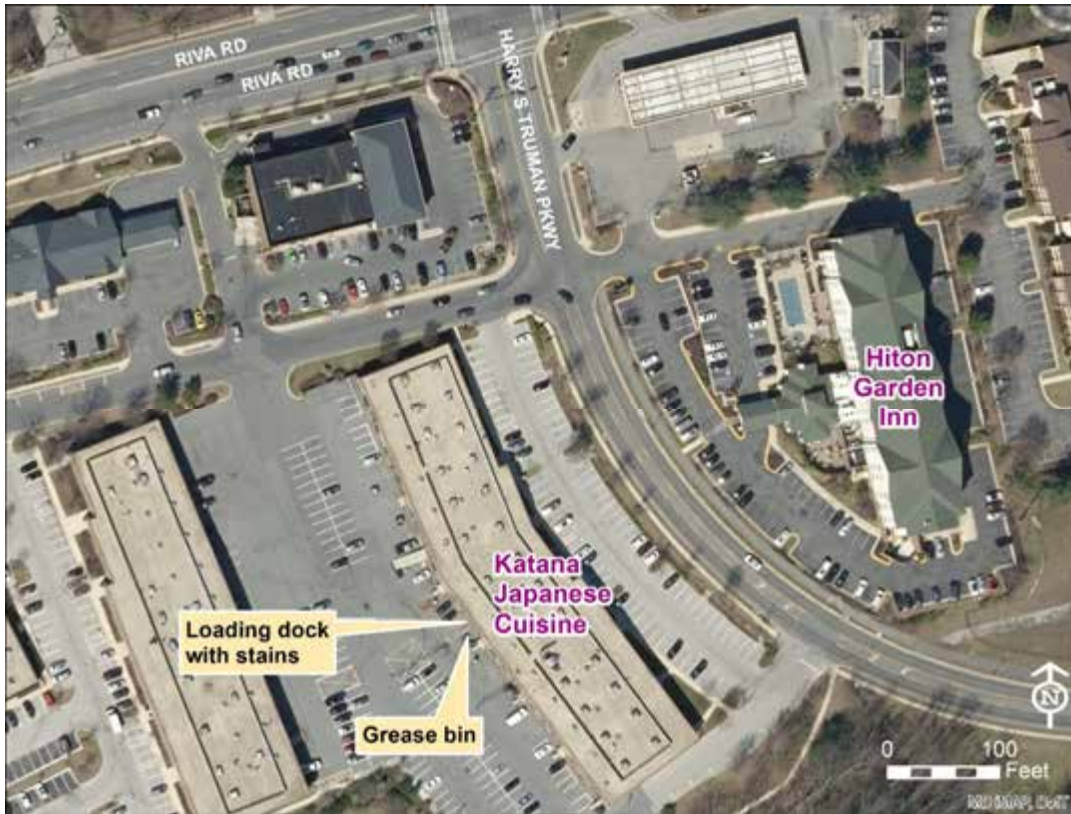
Figure 2. A view of stains on the pavement that extended from a loading dock door; this section of the parking lot was immediately adjacent to the area shown in Figure 1 (upper right edge)

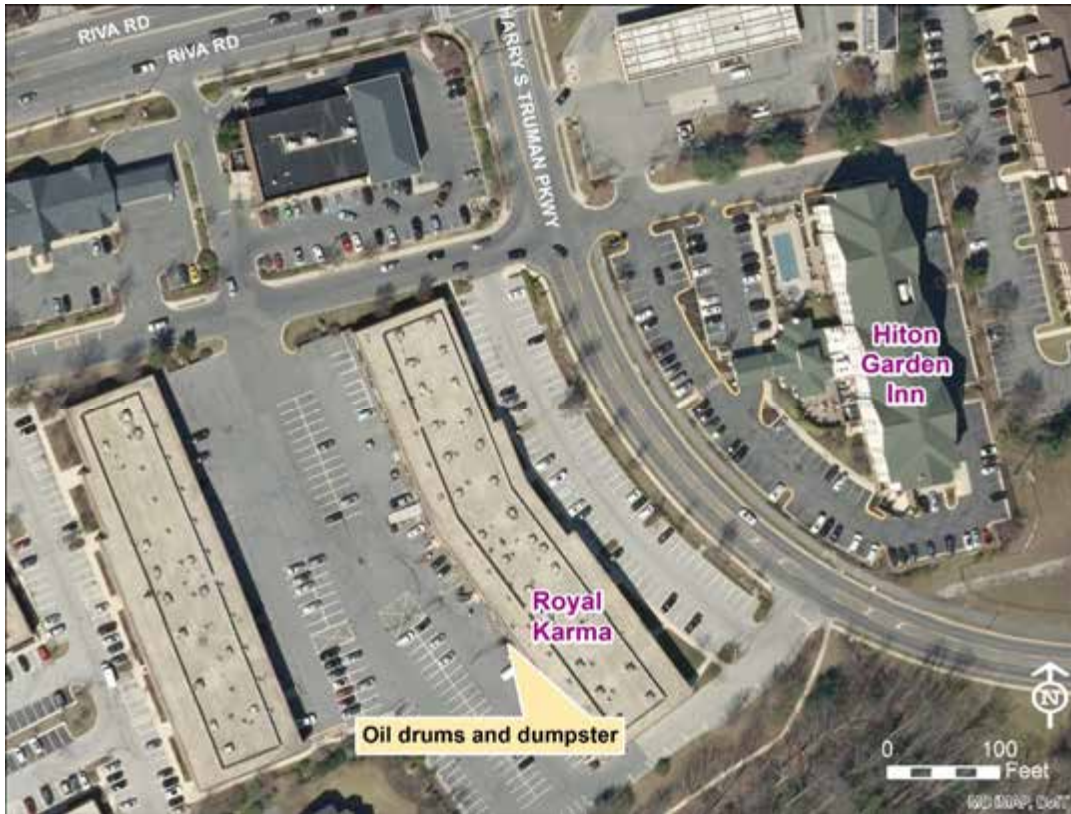
Figure 2. View of stain pattern near the dumpster; note the dark, shiny patches near the foreground edge and the right corner

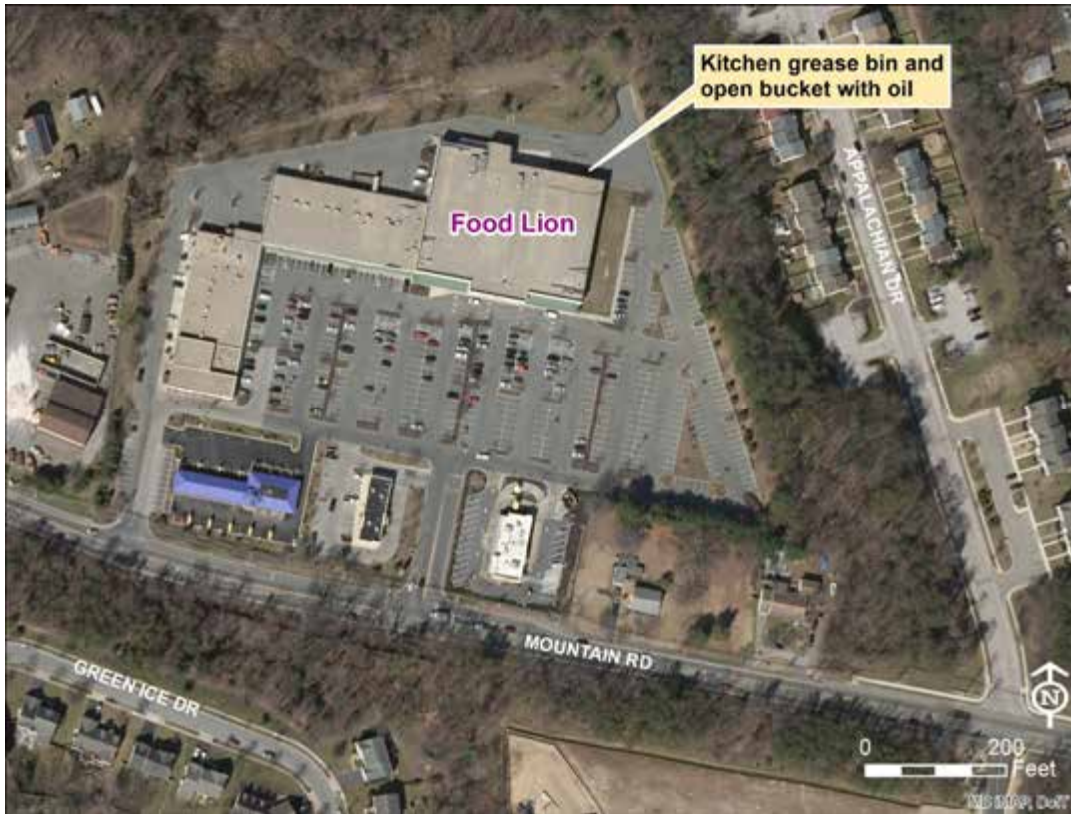
Figure 1. An open bucket containing waste kitchen oil, seen to the right of the grease bin, and evidence of recent washing activity at the parking lot associated with the Food Lion grocery store on November 1

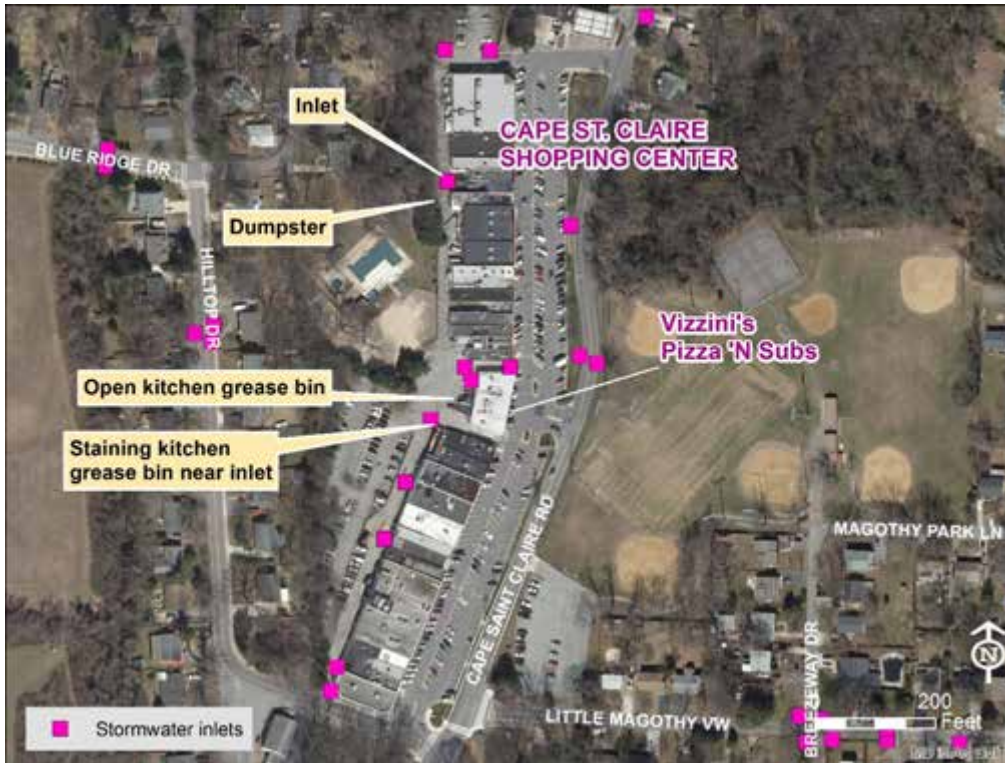
While investigating commercial establishments associated with target outfall screening areas, a Versar team found signs of improper cooking oil storage as the primary concern associated with several businesses occupying the Cape St. Claire Shopping Center (address range 1320–1396 Cape St. Claire Road). The team investigated the site at 4:15 p.m. on Tuesday, March 19. The team found an open kitchen waste grease container on the lot, behind the Vizzini's Pizza 'N Subs restaurant; the team also documented the presence of two buckets, possibly used to carry food waste, near the bin (Figure 1). The team noted that the pavement around the bin was stained, indicating insufficient care by staff during transfer of grease. The team found several grease bins in the lot with signs of dark grease stains on the surrounding pavement; the lot drained to numerous inlets, so grease and oils could be transported to inlets easily (Figure 2). The crew also found a dumpster stored in the rear lot that had signs of staining from the storage pad to the inlet (Figure 3). An area map, indicating the general location of the grease bin, is provided in Figure 4.

Figure 3. Evidence of residue from dumpster operations flowing to a nearby inlet

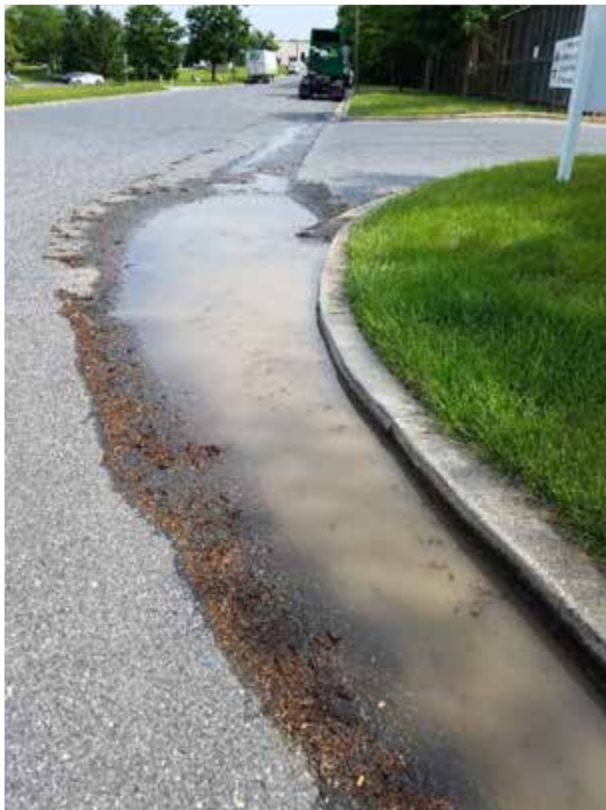
Figure 3. A view of flow entering the inlet from the east side of Waterview Court

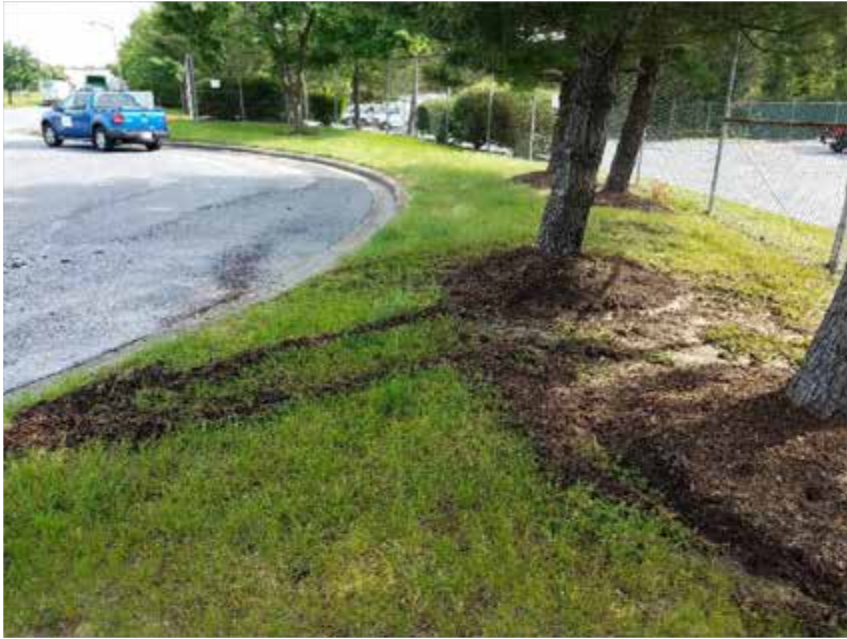
Figure 4. A view of accumulated water on the east side of the cul-de-sac

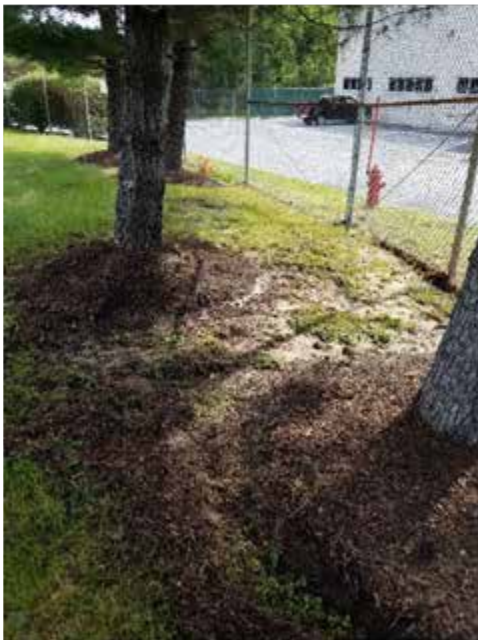
Figure 5. A view of disturbed mulch at the cul-de-sac; the mulch appears to have been pushed from the right side of the photograph, at the fence line

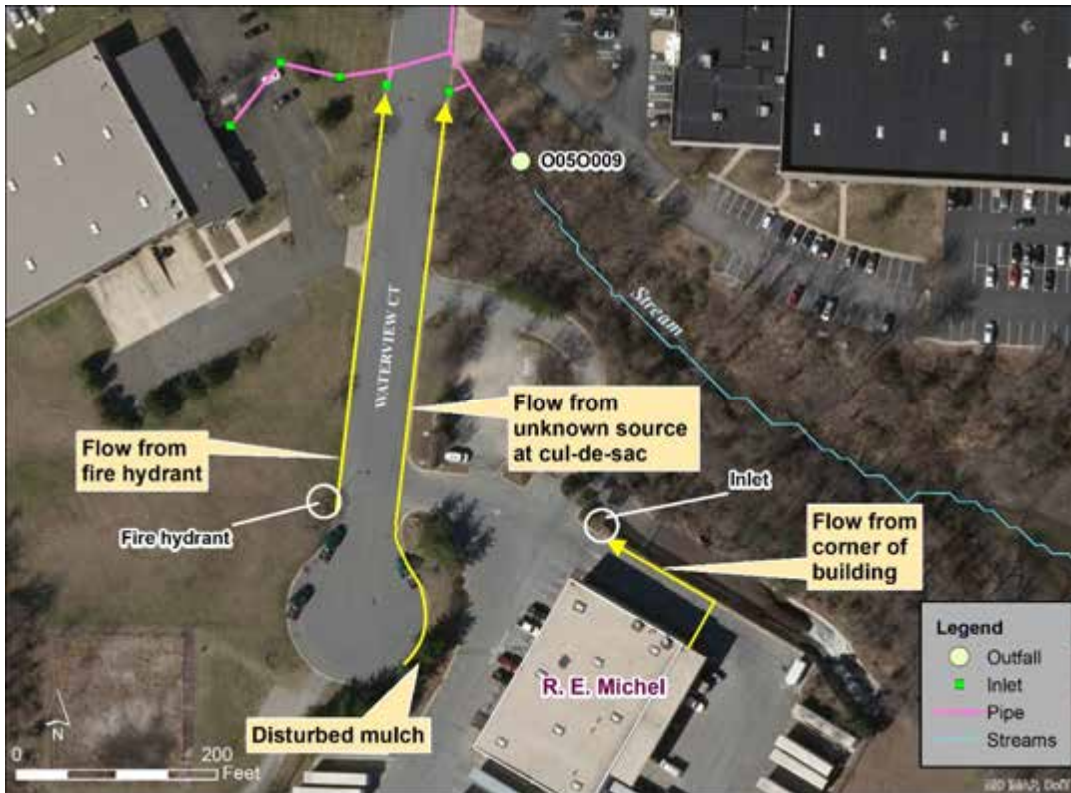
While investigating a target outfall, O05O008, a Versar team found signs of flowing water on both sides of Waterview Court, leading to two inlets up-network of the outfall (Figure 1). The team traced the two flow paths to investigate the sources. On the west side of the street, the source was a leaking fire hydrant (Figure 1). The hydrant had foam around its base (Figure 2). The crew did not find a definitive source for the water flowing on the east side of the street (Figure 3). There was a significant amount of water at the cul-de-sac (Figure 4), and evidence of mulch disturbance near two trees (Figure 5). The pattern of the disturbance suggests that the source of the water may have been on the east side of the fence. The crew documented a fire hydrant near the disturbed mulch (Figure 6). While the crew was conducting the investigation, there was a loud noise accompanied by a large amount of flowing water coming from the northeast corner of the building at 6761 Waterview Court (Figure 7). The sign at the lot entrance described the lot as a trailer drop lot for the R. E. Michel Company (according to the company Web site, it is a wholesale distributor of heating, ventilation, air conditioning, and refrigeration equipment, parts, and supplies). The Versar team did not attempt to gain access to the facility, due to high fences around the property and a mechanical gate. The water from the corner of the building flowed for a few minutes before stopping. The receiving inlet was not a feature in the County's digital infrastructure. The short stream leading from the outfall and past the northeast side of the R. E. Michel lot leads immediately to Furnace Creek. An area map, indicating the general location of the observed conditions, is provided in Figure 8.

Figure 7. A view of a discharge as it was being released from the building at 6761 Waterview Court; the source of the water was to the right of the white van (upper right); the receiving inlet is in the center left of the photograph

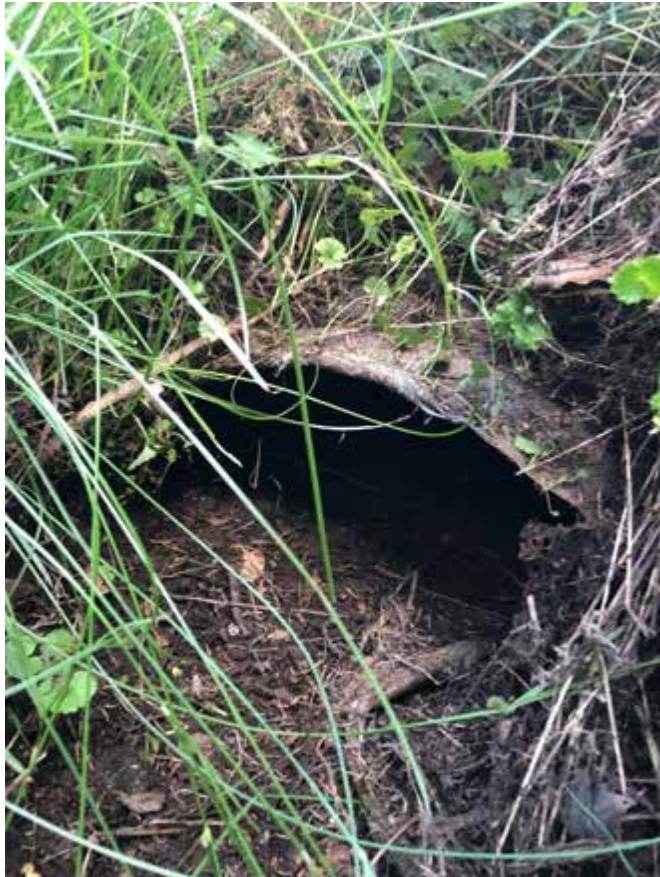
Figure 1. A view of the outfall Q34O002

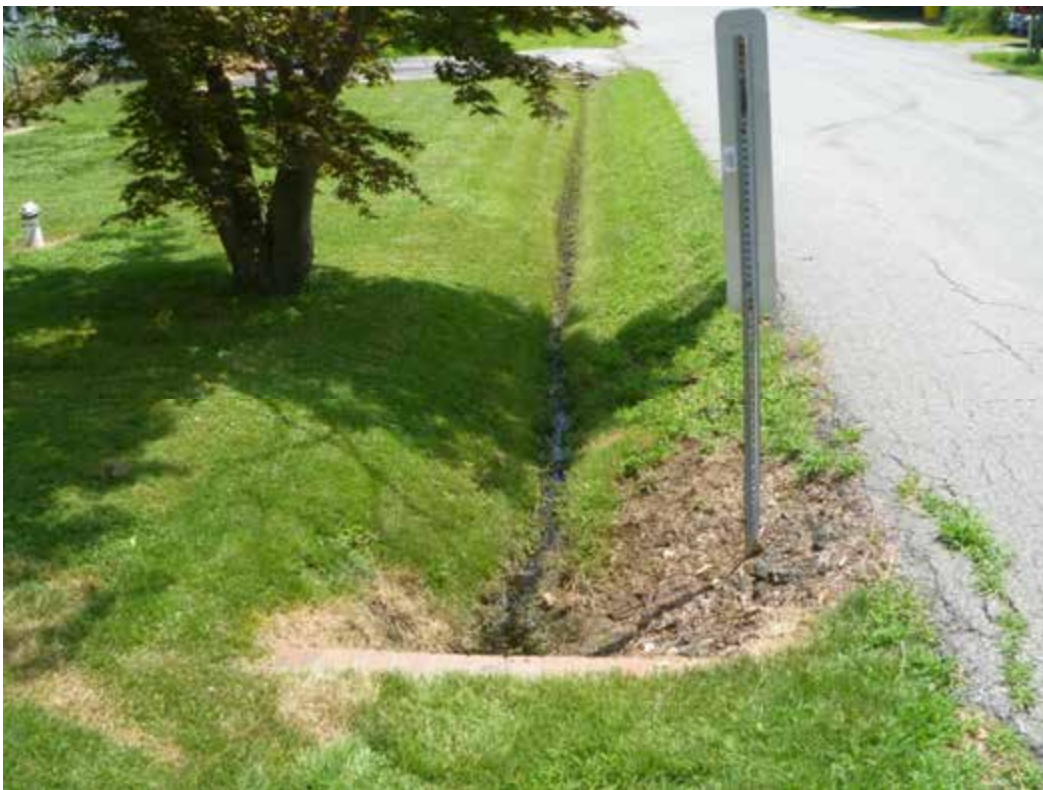
Figure 3. A view of the narrow ditch that drains toward inlet Q34C8I00003; the inlet headwall is seen in the foreground

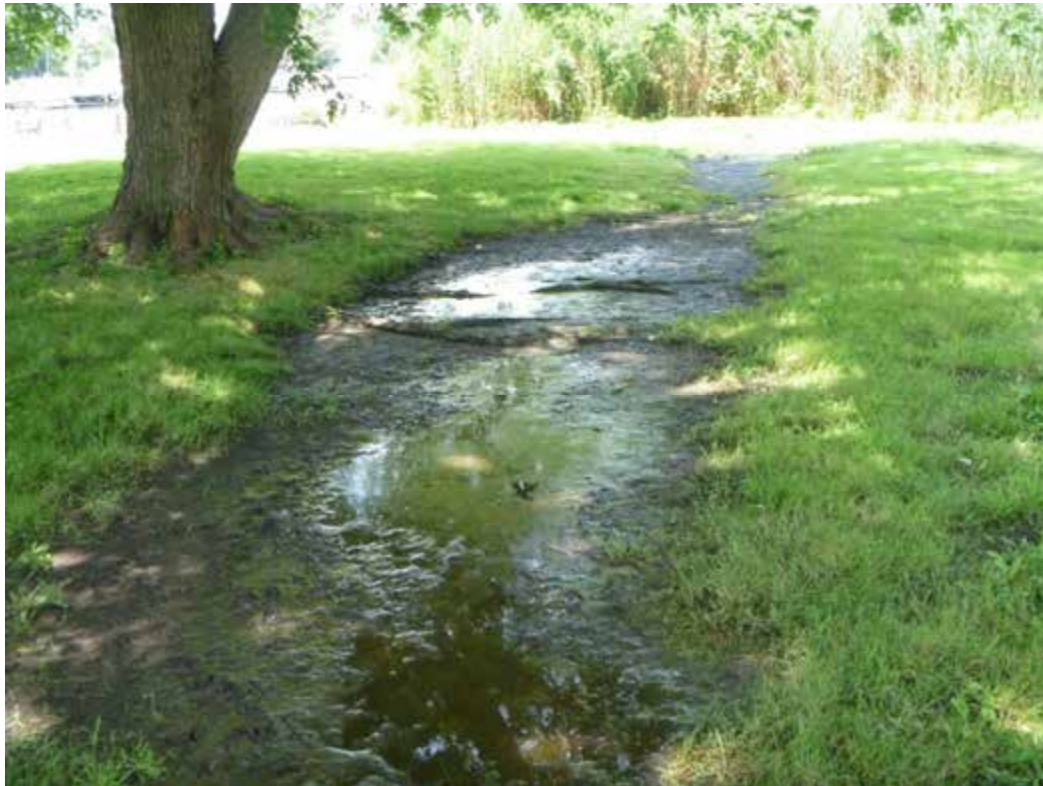
extent broadens when it reaches a larger and flatter floodplain downstream of the south end of the ditch (Figure 4). It is here that the team documented the presence of approximately 45 geese and the tracks of many geese in the mud associated with the discharge path. The team surmised that if the geese frequent this area, goose droppings may be concentrated near the cove of the creek which abuts the western boundary of the open lot. If so, stormwater discharge may transport bulk material and leachate from the droppings into the cove at this location. The accumulated feces may be contributing to the growth in the populations of bacteria in the creek. An area map is provided in Figure 5.

Figure 4. A view of the flat plain that receives and distributes the discharge from the outfall see in Figure 1 and the drainage ditch seen in Figure 2; Rockhold Creek is visible in the background of the photograph
