# ANNE ARUNDEL COUNTY ILLICIT DISCHARGE DETECTION AND ELIMINATION

# 2020 ANNUAL REPORT

## PERMIT NUMBER MD0068306

FINAL: July 2020

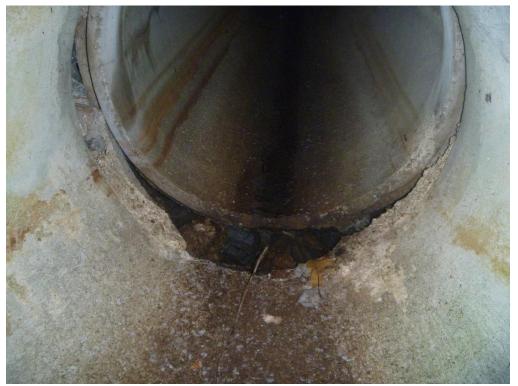
Figure 1. A view of ground subsidence (upper left) approximately 12 feet up-network of outfall O20O010 (lower right)

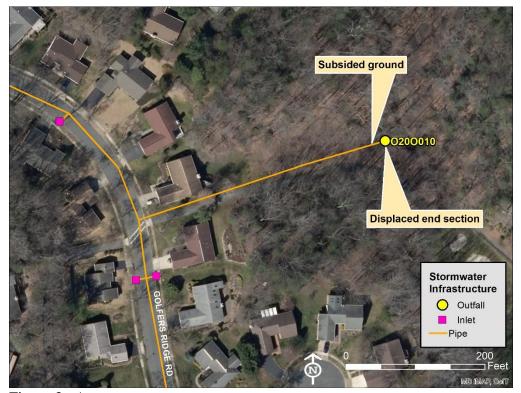
Figure 2. A view of the disconnected flared end section of outfall O20O010

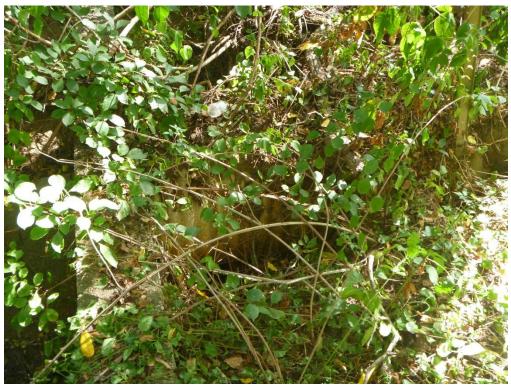
While investigating target outfalls for the County's Illicit Discharge Detection and Elimination (IDDE) program, a Versar team found signs of collapsed infrastructure at outfalls Q210003 and Q210003a. The team investigated the site at 2:50 p.m. on Friday, September 20. At the site, there was evidence of collapsed concrete decking below both outfalls (Figure 1). The team observed the effects of erosion that had undermined the pipe for outfall Q210003 behind the headwall (Figure 2). The team also documented severe erosion downstream of the outfall, which contributes to the evidence of strong forces acting on the infrastructure at the site. An area map, indicating the general location of the collapsed infrastructure, is provided in Figure 3.

Figure 1. A view of collapsed decking below outfalls Q21O003 (right) and Q21O003a (left)

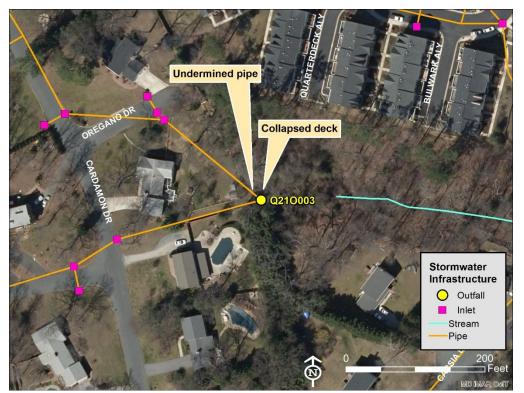
Figure 2. Evidence of erosion undermining the pipe leading to outfall Q21O003 behind the headwall

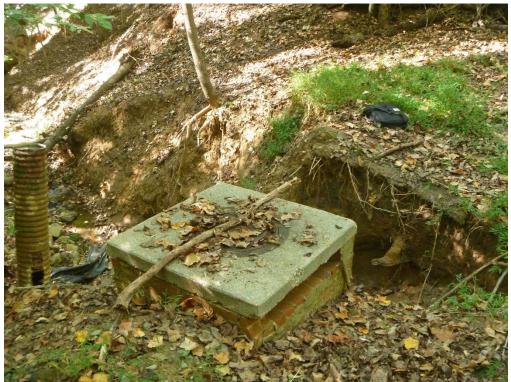
While investigating target outfalls for the County's Illicit Discharge Detection and Elimination (IDDE) program, a Versar team found signs of collapsed infrastructure at outfall N20O020. The team investigated the site at 11:00 p.m. on Thursday, September 26. At the site, there was evidence that the pipe and headwall had completely detached from the adjacent inlet, N20I004 (Figure 1). The team documented that erosion had removed supporting soil from the sides and base of the original configuration (Figure 2). The team investigated the contributing pipe network and found that a pipe entering the network from the northeast (outfall N02O009) was oriented to discharge directly on top of a concrete cap of an inlet, N20I083 (Figure 3). The team surmised that the flows from this disconnected outfall may have contributed to the erosion that had occurred approximately 140 feet down-gradient, in addition to overland flows. An area map, indicating the general location of the collapsed infrastructure and the up-network outfall, is provided in Figure 4.

Figure 1. A view of a completely detached pipe and headwall at outfall N20O020; the adjacent inlet (left) is N20O004

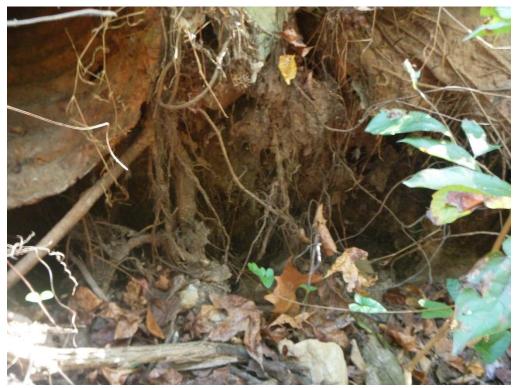
While investigating target outfalls for the County's Illicit Discharge Detection and Elimination (IDDE) program, a Versar team found signs of an undermined pipe at a driveway culvert near outfall O37O002. The team investigated the site at 2:50 p.m. on Friday, October 11. At the site, there was evidence of erosion undermining the pipe that formed the driveway culvert for the residence at 6664 Old Solomons Island Road (Figure 1). The team documented that the ground around the pipe opening appeared to be actively eroding; signs of the extent of the erosion included exposed roots and loss of soil support under the pipe (Figure 2). During the site visit, a resident informed the team that the County had been notified of the issue and the conditions at the site had not yet been resolved. An area map, indicating the general location of the undermined pipe, is provided in Figure 3.

Figure 1. A view of the pipe (center-right foreground) forming a culvert under the driveway (background) at 6664 Old Solomons Island Road; note the eroded bank (lower right)

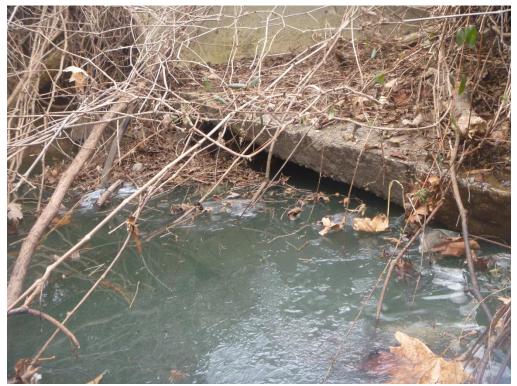
While investigating target outfalls for the County's Illicit Discharge Detection and Elimination (IDDE) program, a Versar team found signs of collapsed infrastructure at outfall J04O004. The team investigated the site at 1:00 p.m. on Thursday, January 23. At the site, the team found that the end section had partially detached from the adjacent pipe section (Figure 1). The team documented evidence of erosion associated with the separation that further undermines the end pipe at the outfall (Figure 2). An area map, indicating the general location of the collapsed infrastructure, is provided in Figure 3.

Figure 1. A view of the partially detached end pipe (lower right) at outfall J04O004, which allows water to flow under the structure and further erode the supporting soil

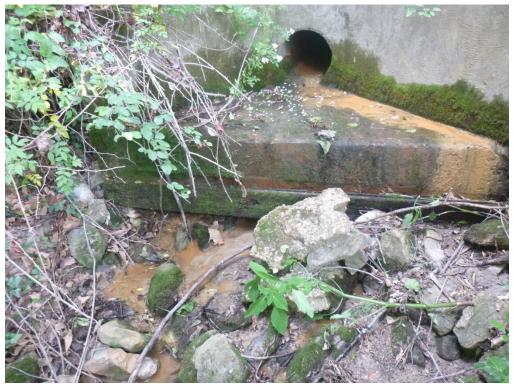
While investigating target outfalls for the County's Illicit Discharge Detection and Elimination (IDDE) program, a Versar team found signs of eroded support for stormwater infrastructure and evidence of a possibly compromised pipe network at outfall L23O001. The team investigated the site at 10:40 a.m. on Tuesday, June 2. At the site, the team found signs of significant erosion behind the endwall and along the connected pipe of the stormwater conveyance system (Figure 1). The team documented water flowing along underneath the endwall and emerging beneath the structure; the team surmised that the water was discharging from the stormwater network, and was thus evidence of a compromise in the pipe system up-network of the outfall (Figure 2). An area map, indicating the general location of the erosion, is provided in Figure 3.

Figure 1. A view of the eroded ground behind the endwall (background) and along the connected pipe (foreground) of outfall L23O001

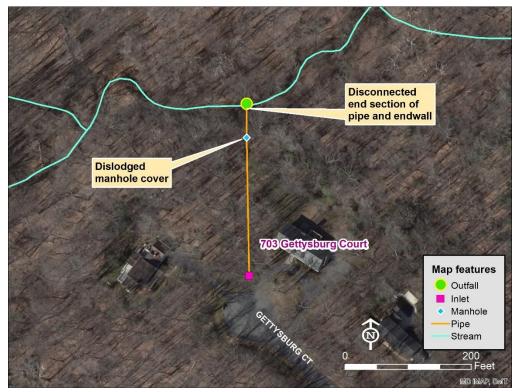
Figure 2. A view of a manhole with a dislodged cover along the pipe network for outfall M23O004

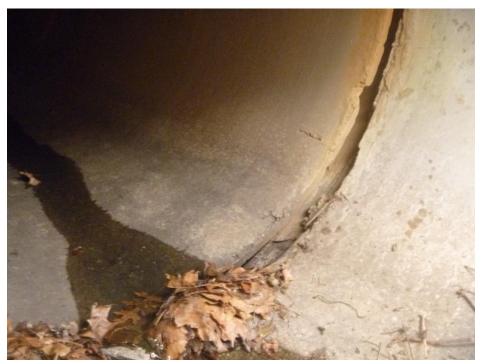
On January 23, 2020, a Versar field team inspected outfall J04O004, which is located behind 1099 Winterson Road, as part of annual outfall screening efforts. At 1:00 p.m., the Versar crew found flowing discharge at the 54-inch reinforced concrete pipe outfall (Figure 1). The crew noted that the effluent was green and had a fragrant odor. The crew obtained a sample of the discharge at the mouth of the outfall, to test for illicit discharge indicators. The results of the tests are provided in Table 1, as Test 1. The result for surfactants (detergents) was above the program threshold, at 3 mg/L; other parameters did not have measurable levels. The team members conducted a brief search of the stormwater network to track the source of the unusual discharge. They backtracked the flow to a car wash behind the 7-11 store at 1595 West Nursery Road (Figure 2) and noted obvious green flowing water at the inlet that received the pooled effluent from the southeast edge of the driveway for Hoyt's West Nursery Road Cinema 14 (Figure 3).

Figure 1. Conditions at outfall J04O004 on January 23

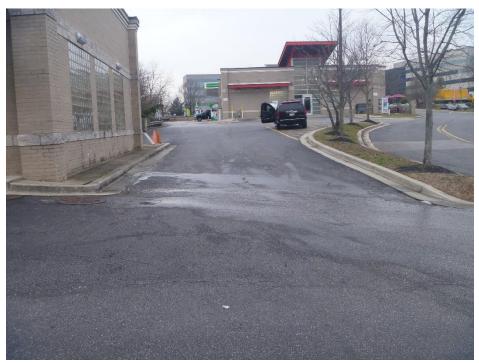
The field team conducted a thorough investigation of the source of the discharge. The discharge accumulated along the south side of the driveway before entering the inlet (see Figure 3). The team backtracked the flow to a curb on the north side of the car wash building (see Figure 2). Discharge water was obviously flowing through seams in the curb (Figure 5). From the fragrant odor and green color of the sample collected from the inlet further downgradient, the team surmised that the discharge leaking from the curb was directly related to car wash operations. The intermittent flow in the discharge also likely correlated with wash water use or pumps in the car wash facility. An area map is provided in Figure 6.

Figure 2. View of the apparent source of the discharge, the curb alongside the car wash (left foreground; the 7-11 store is seen in the background); the photograph was taken on January 23

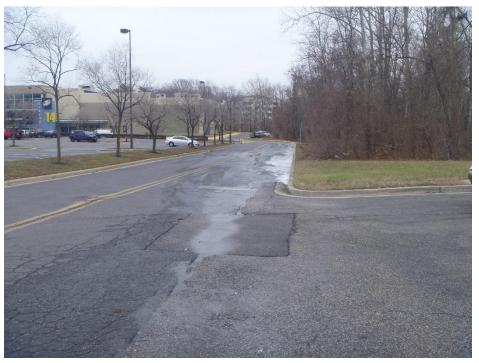
Figure 3. View of the path (foreground to background) of the discharge from the car wash toward the inlet near Hoyt's West Nursery Cinema 14; the photograph was taken on January 23

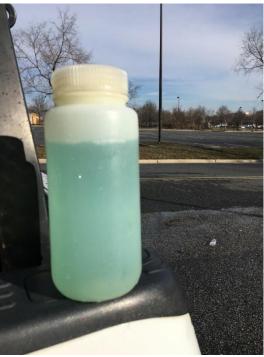
Figure 4. View of the sample collected from the inlet near Hoyt's West Nursery Cinema 14; the photograph was taken on January 24

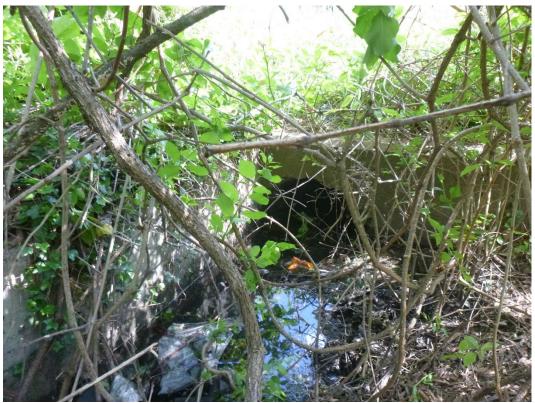
On May 12, 2020, a Versar field team inspected outfall T16O006, which is located behind 1429 Baltimore Annapolis Boulevard, as part of annual outfall screening efforts. At 10:40 a.m., the Versar crew found backed up, but flowing discharge at the 24-inch reinforced concrete pipe outfall (Figure 1). The crew obtained a sample of the discharge at the mouth of the outfall, to test for illicit discharge indicators. The results of the tests are provided in Table 1, as Test 1 (Outfall). The result for detergents was above the program threshold, at 0.5 mg/L; chlorine was also detected at 0.35 mg/L, but was not above the action level. The team tested the water at the next upstream manhole (Figure 2) to obtain a freely flowing sample, whose results were 0.15 mg/L and 0.10 mg/L for chlorine and detergents, respectively.

Figure 1. Conditions at outfall T16O006 on May 12

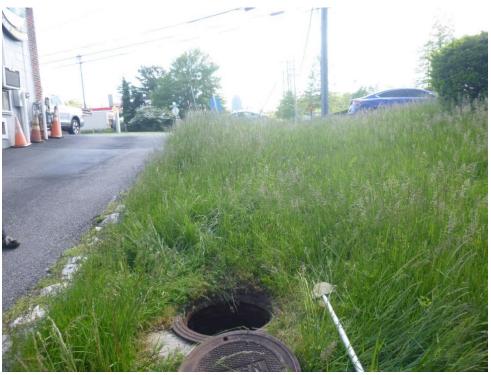
Figure 3. Flowing water observed in inlet on north side of Arnold Road

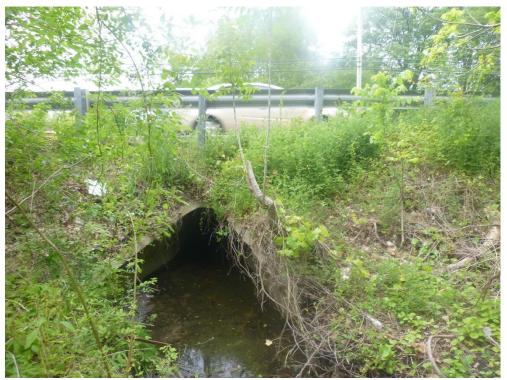
On May 13, 2020, a Versar field team inspected outfall P200003, which is located behind 104 Marquise Lane, as part of annual outfall screening efforts. At 2:30 p.m., the Versar crew found flowing discharge at the 48-inch reinforced concrete pipe outfall (Figure 1). The crew obtained a sample of the discharge at the mouth of the outfall, to test for illicit discharge indicators. The results of the tests are provided in Table 1, as Test 1. The result for chlorine was above the program threshold, at 0.6 mg/L; detergents were also detected at 0.1 mg/L, but was not above the action level.

The team returned to the site at 1:00 a.m. on May 14 and found continued flowing conditions at the outfall. The team obtained a sample of the discharge water at the outfall and tested the sample for program parameters. The results of the tests of the sample are provided in Table 1, as Test 2. The test results indicated that the concentration of chlorine was 0.4, which was equal to the program action level. Detergents were also detected, but at 0.25 mg/L was below the program threshold. Staff reported the potential illicit discharge to the Anne Arundel County pollution hotline on or about May 14.

Figure 1. Conditions at outfall P20O003 on May 14

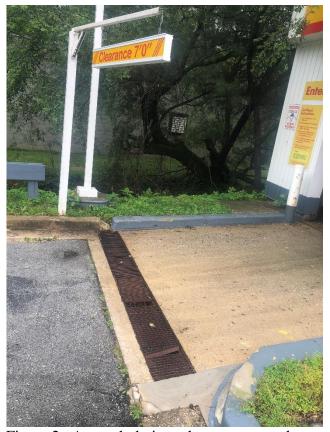
Figure 2. A trench drain at the entrance to the car wash associated with the Shell gas station

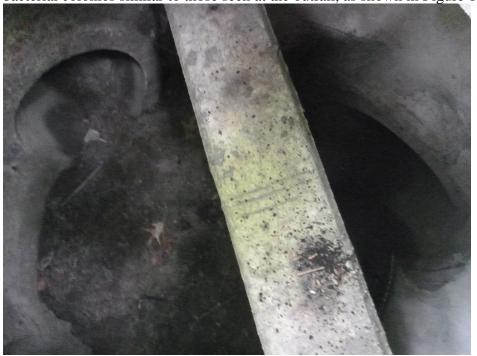
A field team returned to the area on June 2 to continue the investigation of the pipe network and to attempt to clarify where the source of ammonia may be entering the stormwater system. The team tested the discharge found in an inlet and two manholes; other structures found and investigated during the trackdown were dry or could not be opened. The results of the tests are provided in Table 3. The result of the test of the sample from the manhole O22M102, which was a splitter, exceeded the range of the field kit (4.9 mg/L). The team documented that the water in the manhole was stagnant and that it exhibited an odor of sewage (Figure 3). The team deduced, from the pattern of ammonia levels and the available access points, that discharge from a sewer line may be infiltrating the stormwater pipe network and backing up into the system. The team surmised that the most likely location for this incursion would be the sections of pipe between manholes O22M102 and O22M062.

Figure 3. A view of stagnant water in manhole O22M102 on June 2, 2020

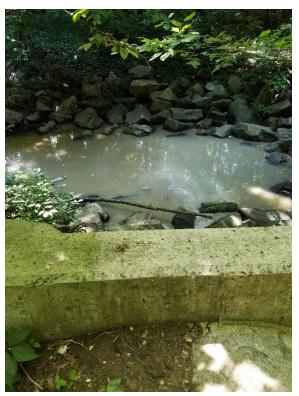
Figure 2. A view of the grey discharge (center right) expanding into the plunge pool; grey foamy globules are evident between the rocks close to the outfall opening

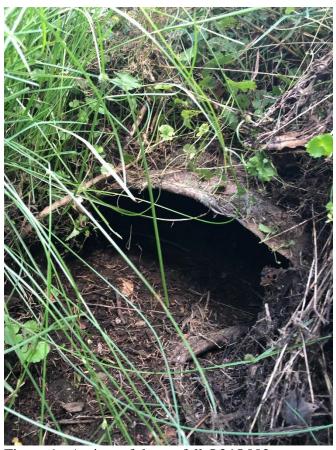
Figure 1. A view of the outfall Q34O002

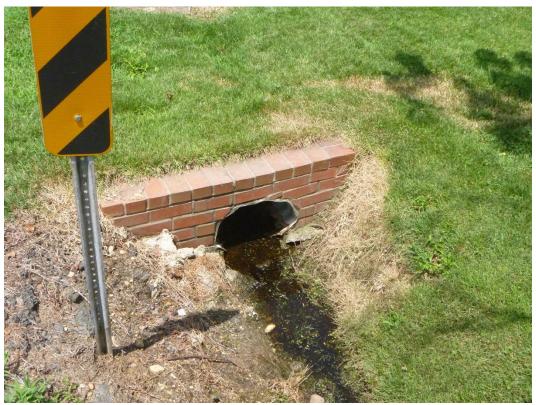
Figure 2. A view of the standing water in the pipe of inlet Q34C8I00003

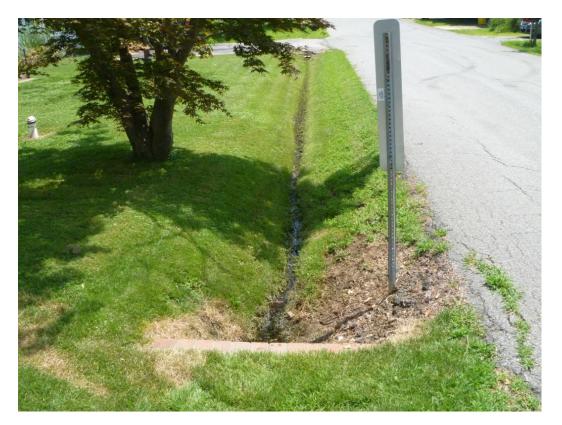
Figure 3. A view of the narrow ditch that drains toward inlet Q34C8I00003; the inlet headwall is seen in the foreground

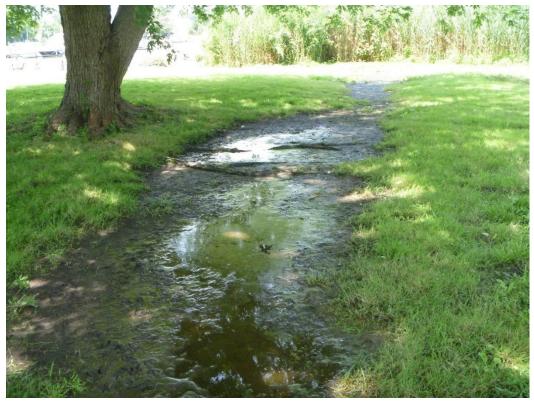
Figure 4. A view of the flat plain that receives and distributes the discharge from the outfall see in Figure 1 and the drainage ditch seen in Figure 2; Rockhold Creek is visible in the background of the photograph

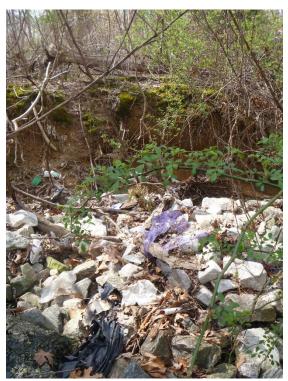
Figure 3. A view of the entrance to the culvert partially blocked by excessive vegetation; note the accumulated debris near the entrance

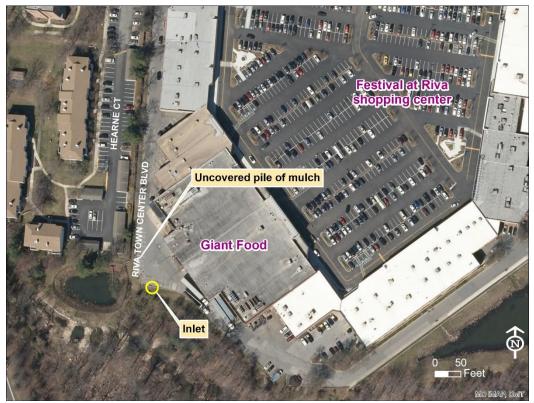
Figure 1. A view of an uncovered pile of mulch stored on the parking lot approximately 15 feet from an inlet (center left)

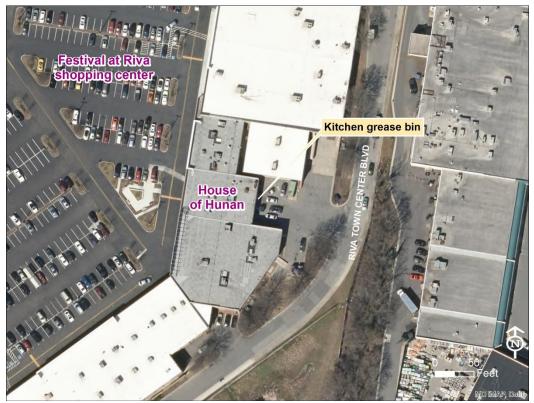
Figure 1. A view of the kitchen grease bin with accumulated grease on and around the bin; note the dark stains on the pavement

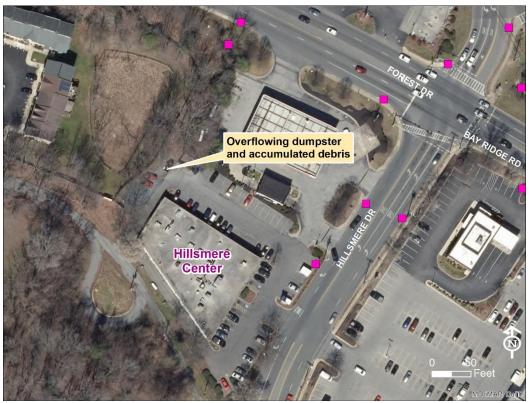
Figure 1. A view of an overflowing dumpster and numerous bags of trash accumulated on the pavement near the dumpster enclosure

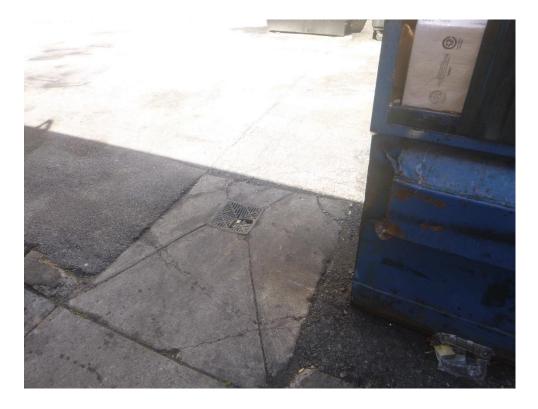
Figure 2. A view of an open dumpster with debris scattered around the base; note the dark stains on and around the base of the bin

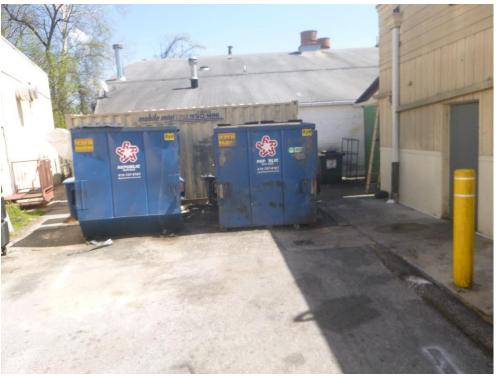
Figure 3. A view of a small, grated drain immediately adjacent to a dumpster bin

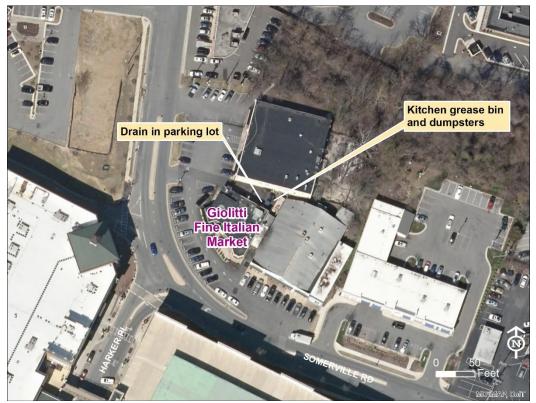
Figure 4. A view of the uncovered storage area for the dumpsters and grease bin; note the grated drain in front of the dumpster shown on the right

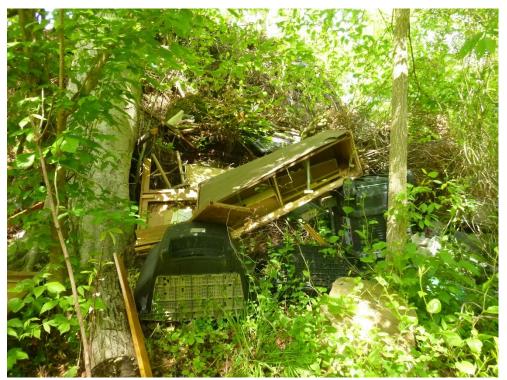
Figure 1. A view of material with likely residential origins dumped into a wooded area to the west of North Zona Street in Parkway Village

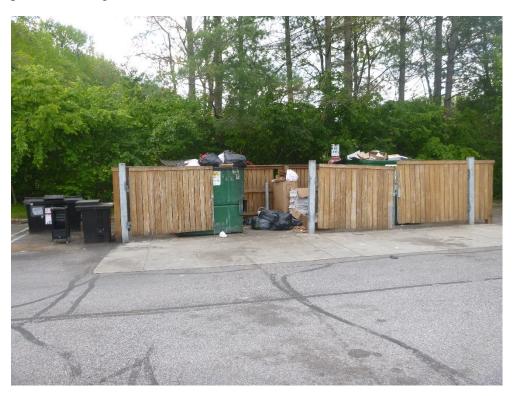
Figure 1. Overall view of the dumpster area located behind the cluster of restaurants at Crofton Station; note the overflowing dumpsters

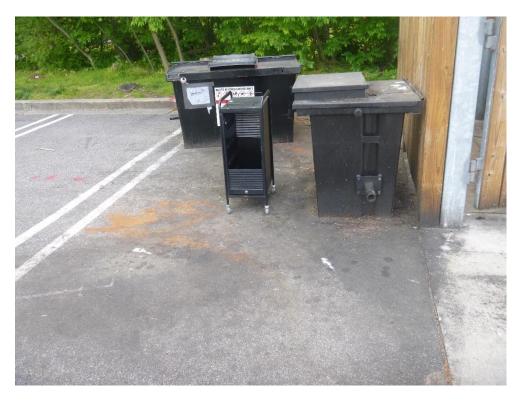
Figure 3. A view of the kitchen grease bins; the dark stains on the pavement suggest grease and oil spills

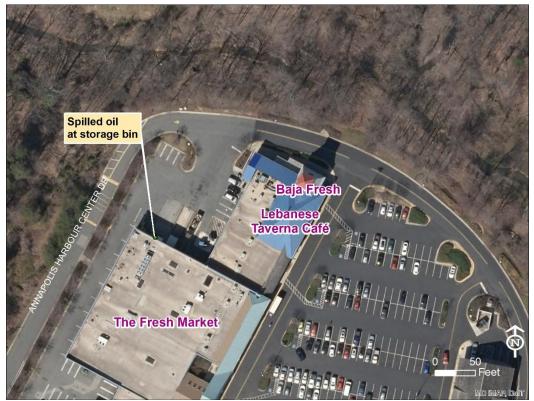
Figure 1. Evidence of cooking oil spills on the pavement near a disposal bin for used kitchen grease near a rear door for the grocery store The Fresh Market

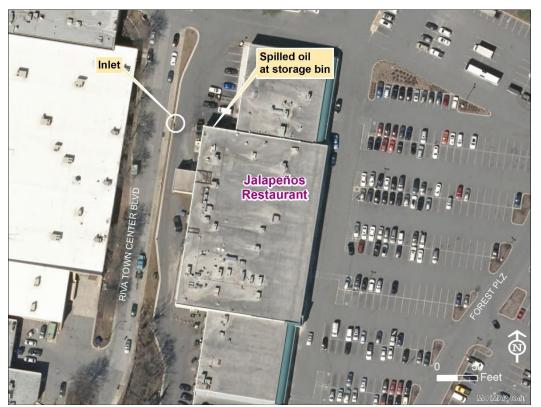
Figure 1. Evidence of cooking oil spills on and near a disposal bin for used kitchen grease in a rear alcove near the Jalapeños Restaurant

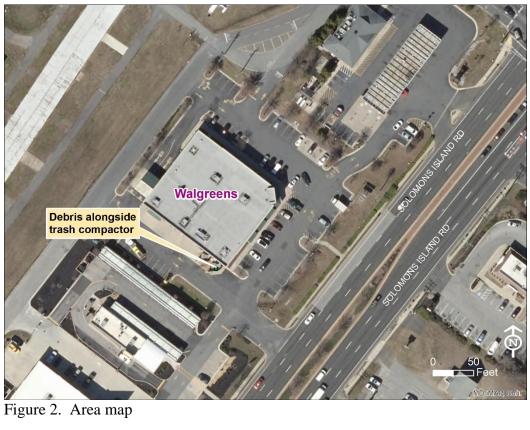
Figure 1. Debris found on the pavement alongside the trash compactor near the Walgreens store
