**BIOLOGICAL AND  
GEOMORPHOLOGICAL CONDITION  
IN THE PICTURE SPRING BRANCH  
SUBWATERSHED, SEVERN RIVER  
WATERSHED, ANNE ARUNDEL COUNTY,  
MARYLAND: 2019 - 2020**

Anne Arundel County, Maryland  
Department of Public Works  
Bureau of Watershed Protection and Restoration  
2662 Riva Road  
Annapolis, MD 21401

Versar, Inc.  
9200 Rumsey Road, Suite 1  
Columbia, MD 21045

FINAL: October 2020

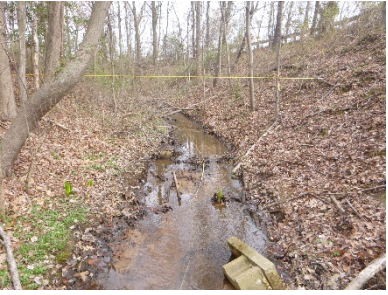
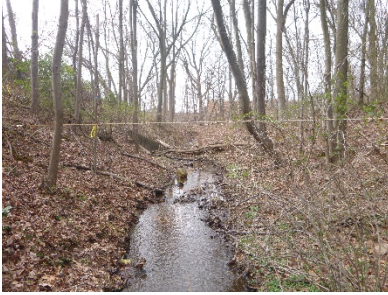
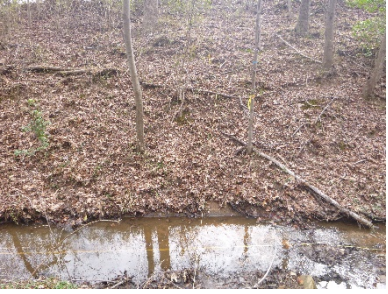
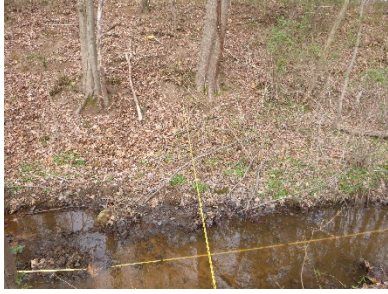
| Upstream View | Downstream View | Bankfull Width ( $W_{bkf}$ ) (feet) | 9.2 |
| | | Adjustments? | Sin ↑ |
| | | <b>STREAM TYPE</b> | <b>F5</b> |

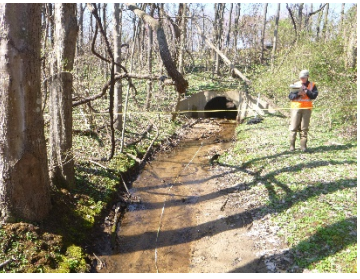
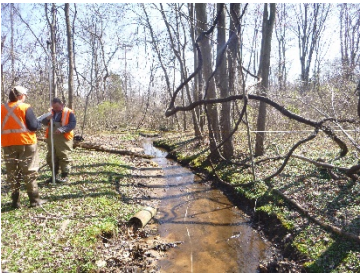
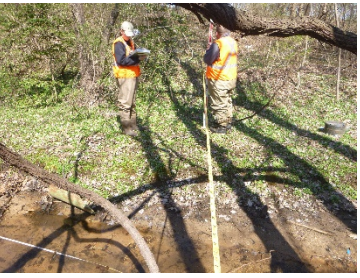
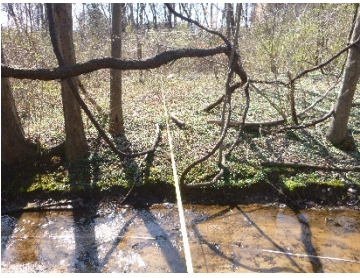
| Upstream View | Downstream View | Bankfull Width ( $W_{bkf}$ ) (feet) | 6.9 |
| | | Adjustments? | Sin ↑ |
| | | <b>STREAM TYPE</b> | <b>F5</b> |
