# Fiscal Year 2021 Annual Report

Illicit Discharge Detection and Elimination

Permit Number: MD0068306

Prepared for  
Anne Arundel County

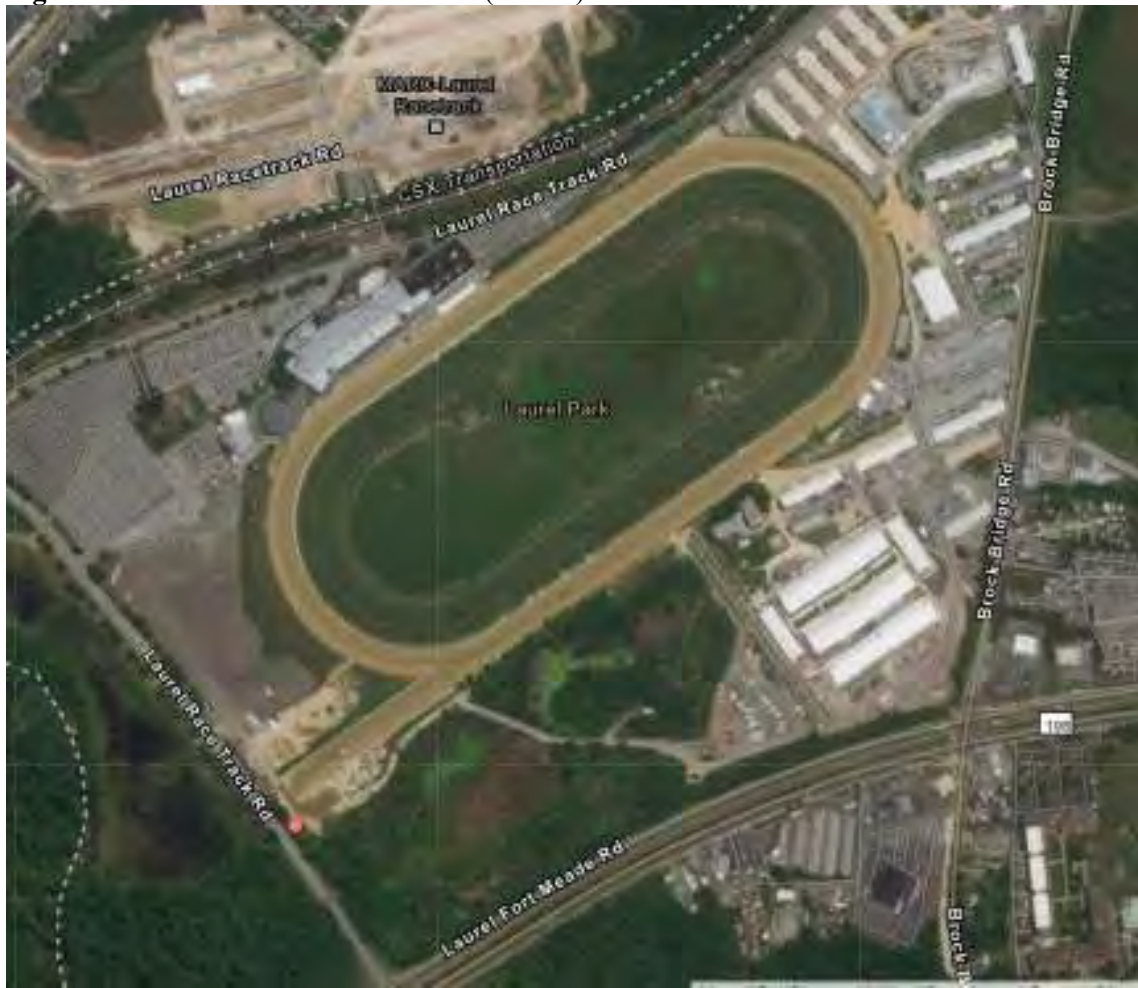
**Figure 2:** Outfall A11O006

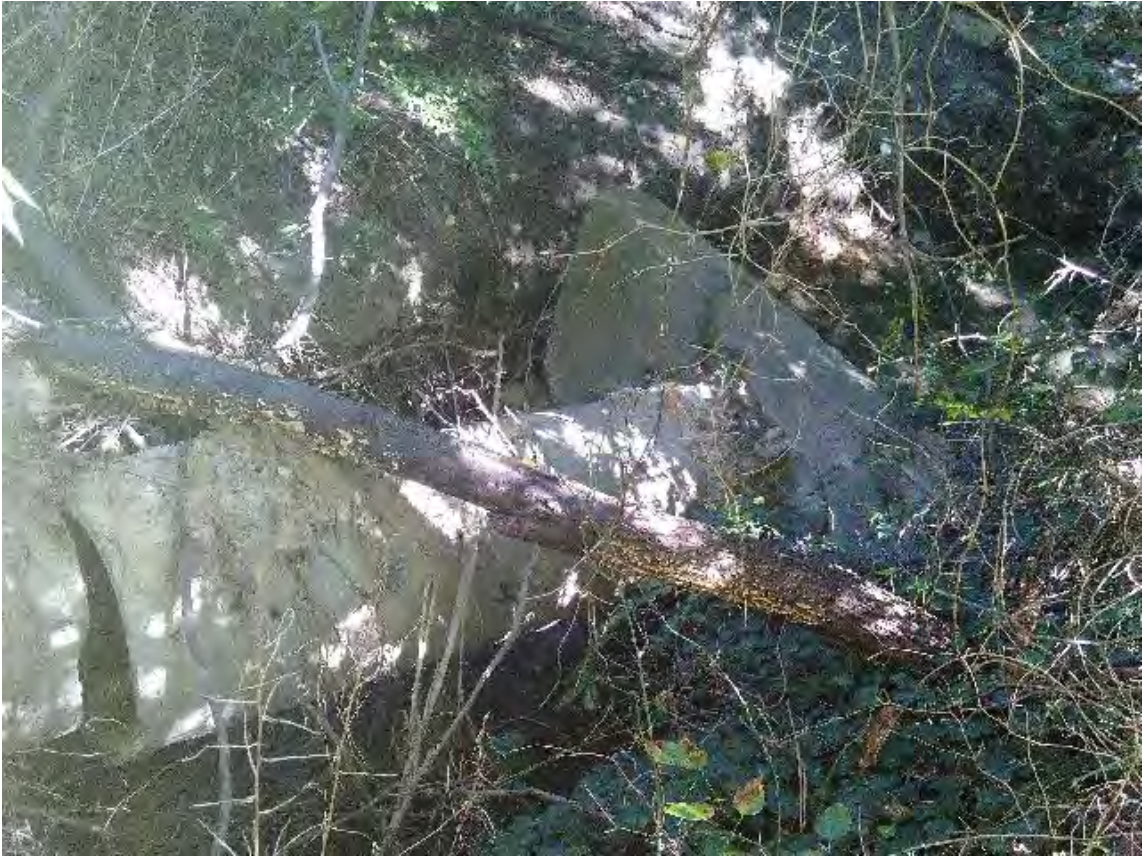
Outfall L09O021 is located in a residential area of Glen Burnie between Kramer Ct and Green Orchard Rd (Figure 1). Severe erosion has occurred surrounding Outfall L09O021 and downstream (Figure 2). The pipe has broken and the end section of the outfall collapsed (Figure3).

**Figure 3:** Broken and collapsed end section of Outfall L090021.

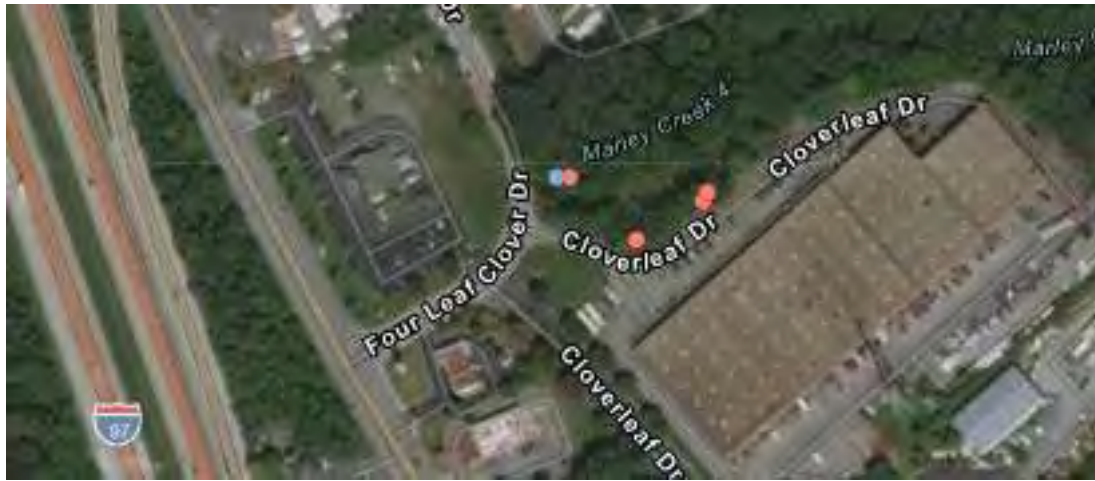
**Figure 2:** Outfall L10O007 pictured in poor condition behind damaged stabilizing structure/trash trap. Outfall L10O010 pictured in foreground.

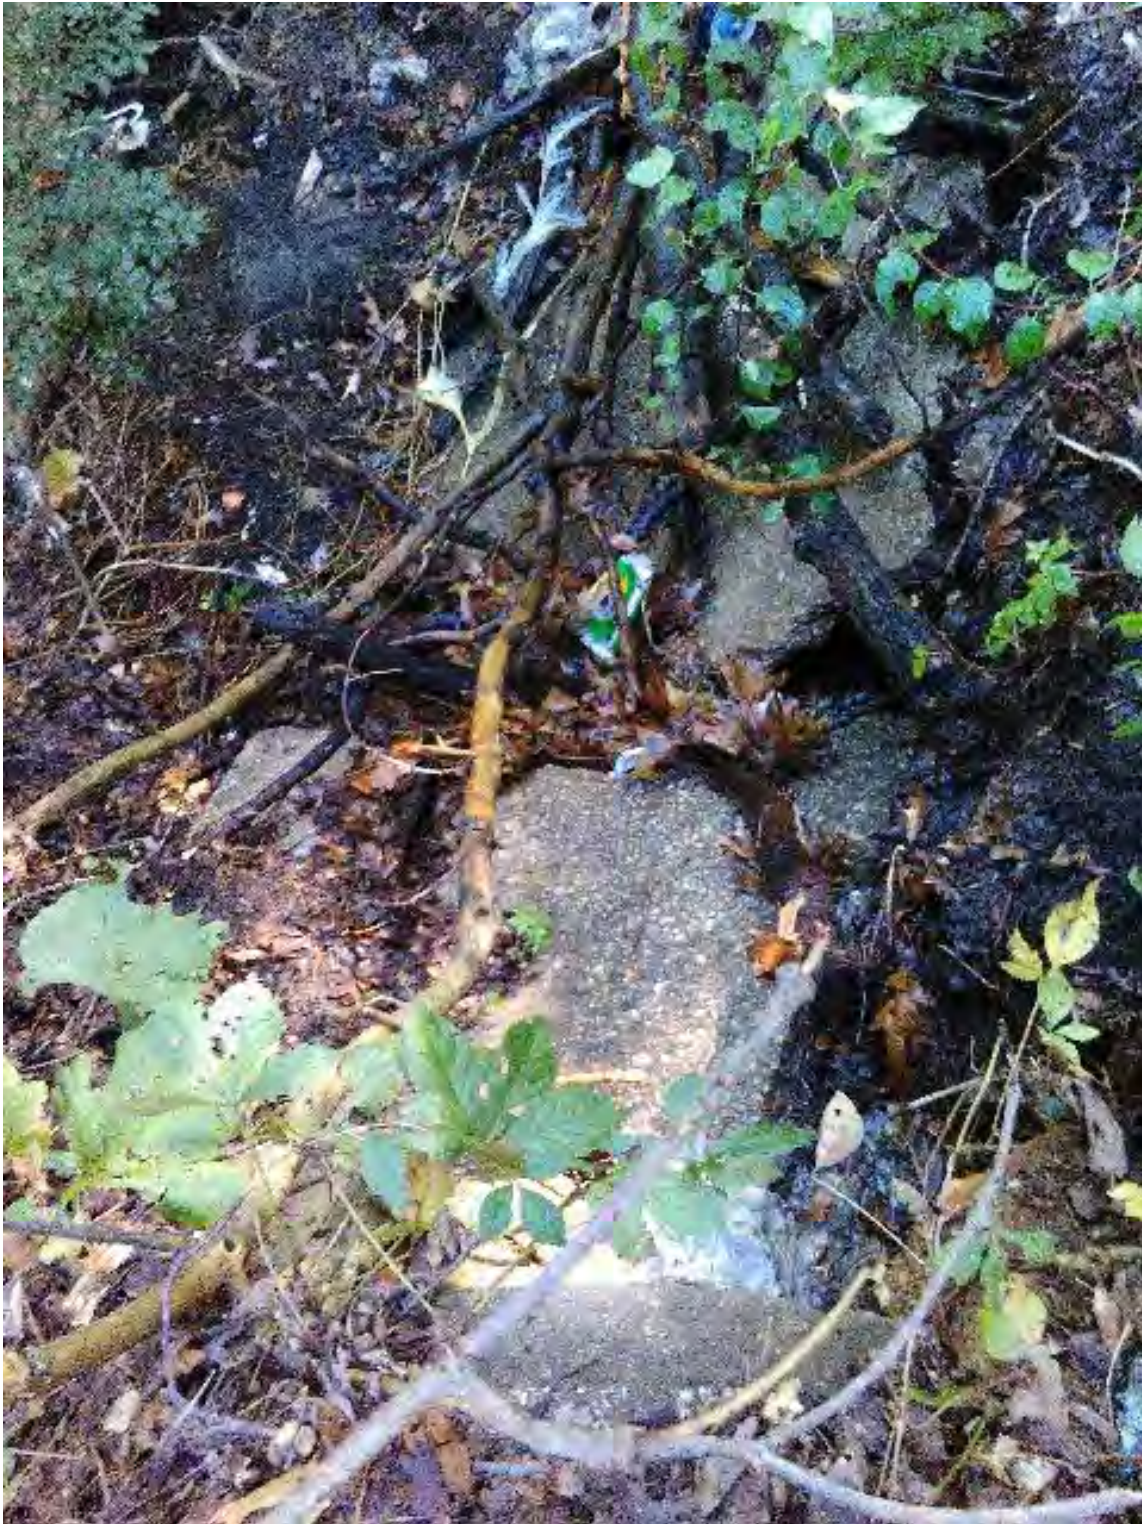
Outfall M09O060 is located within 'The Forest Apartments' complex (Figure 1). The outfall structure is currently stable but its overall condition has been previously degraded (Figure 2). There is evidence of collapsed pipe and severe downstream erosion (3-6 ft) is present (Figure 3).

**Figure 3:** Debris downstream of Outfall M09O060

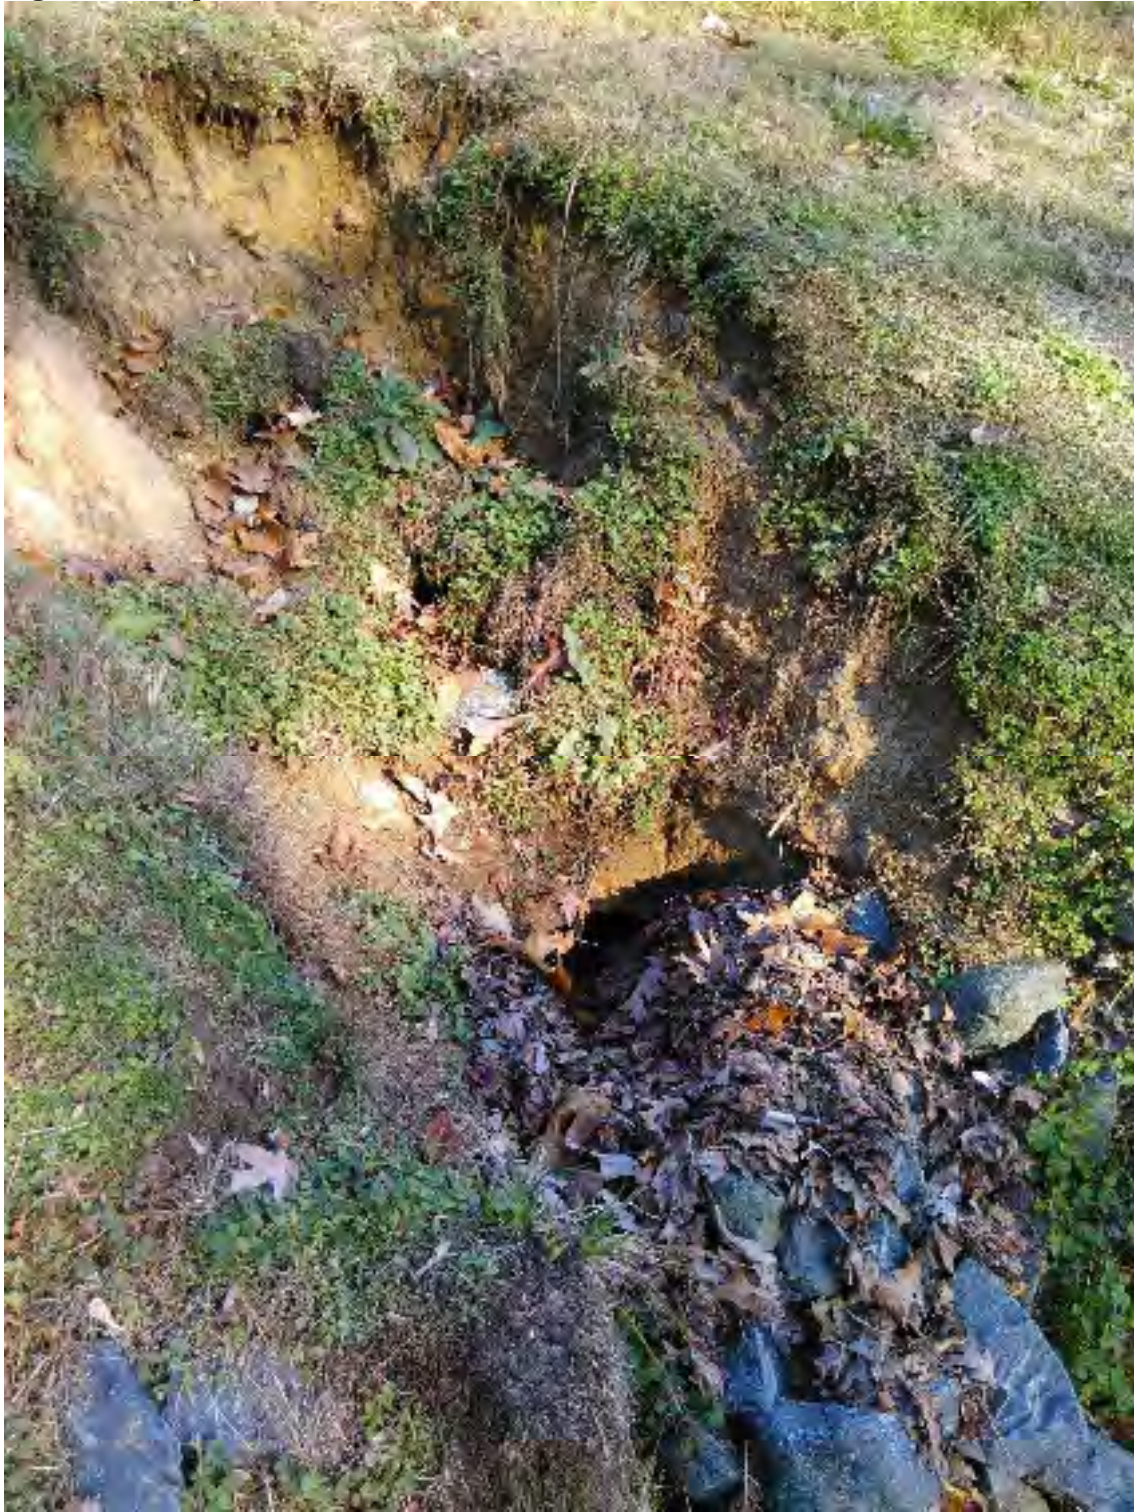
**Figure 2:** Collapsed Outfall (T150001)

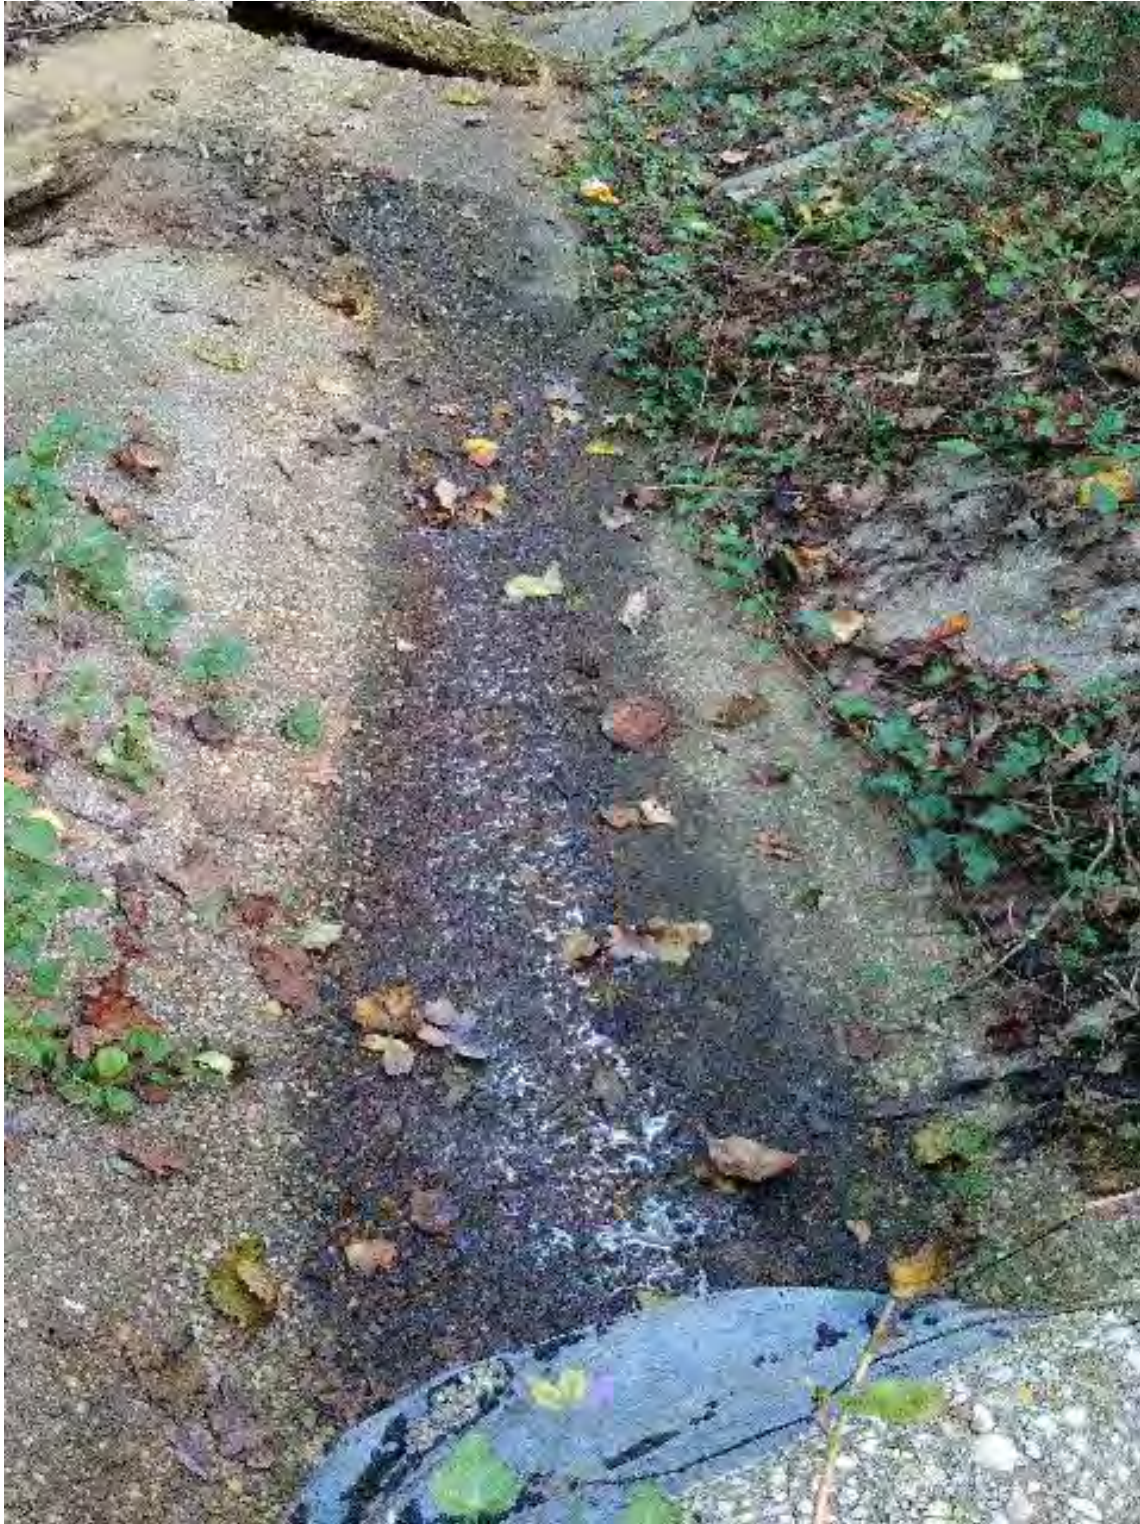
**Figure 3:** Collapsed flow path from Outfall T150059

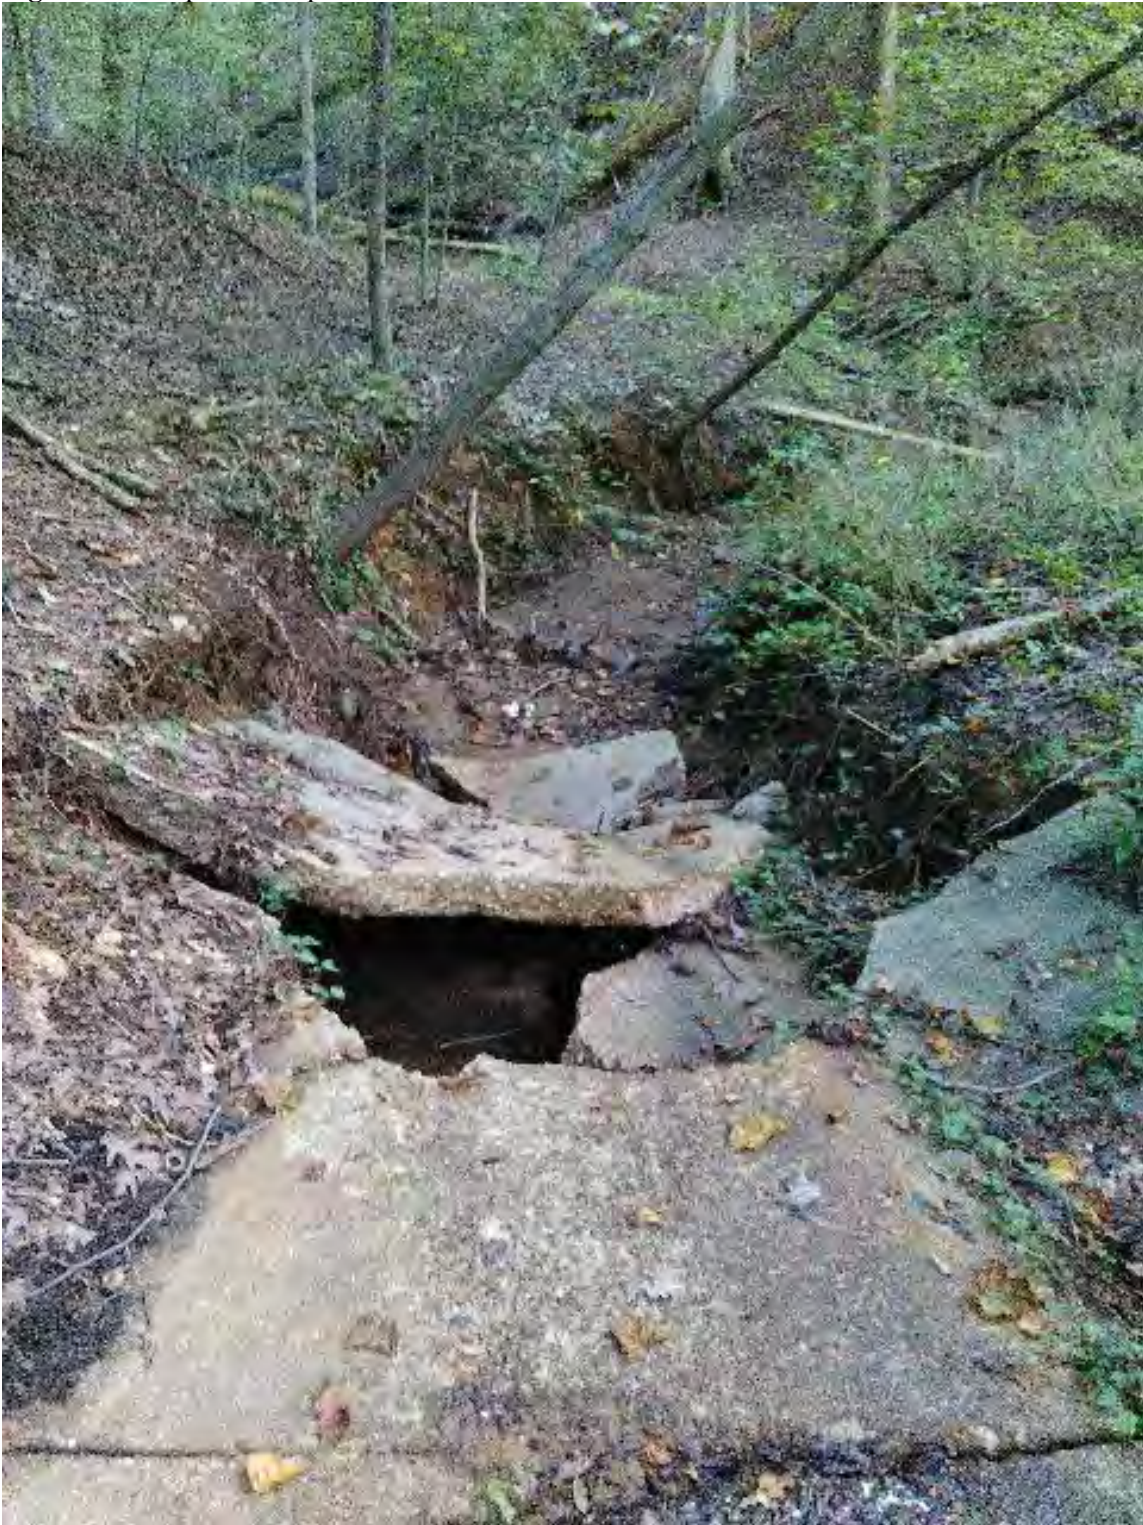
**Figure 4:** Collapsed flow path from Outfall T150059 and downstream erosion

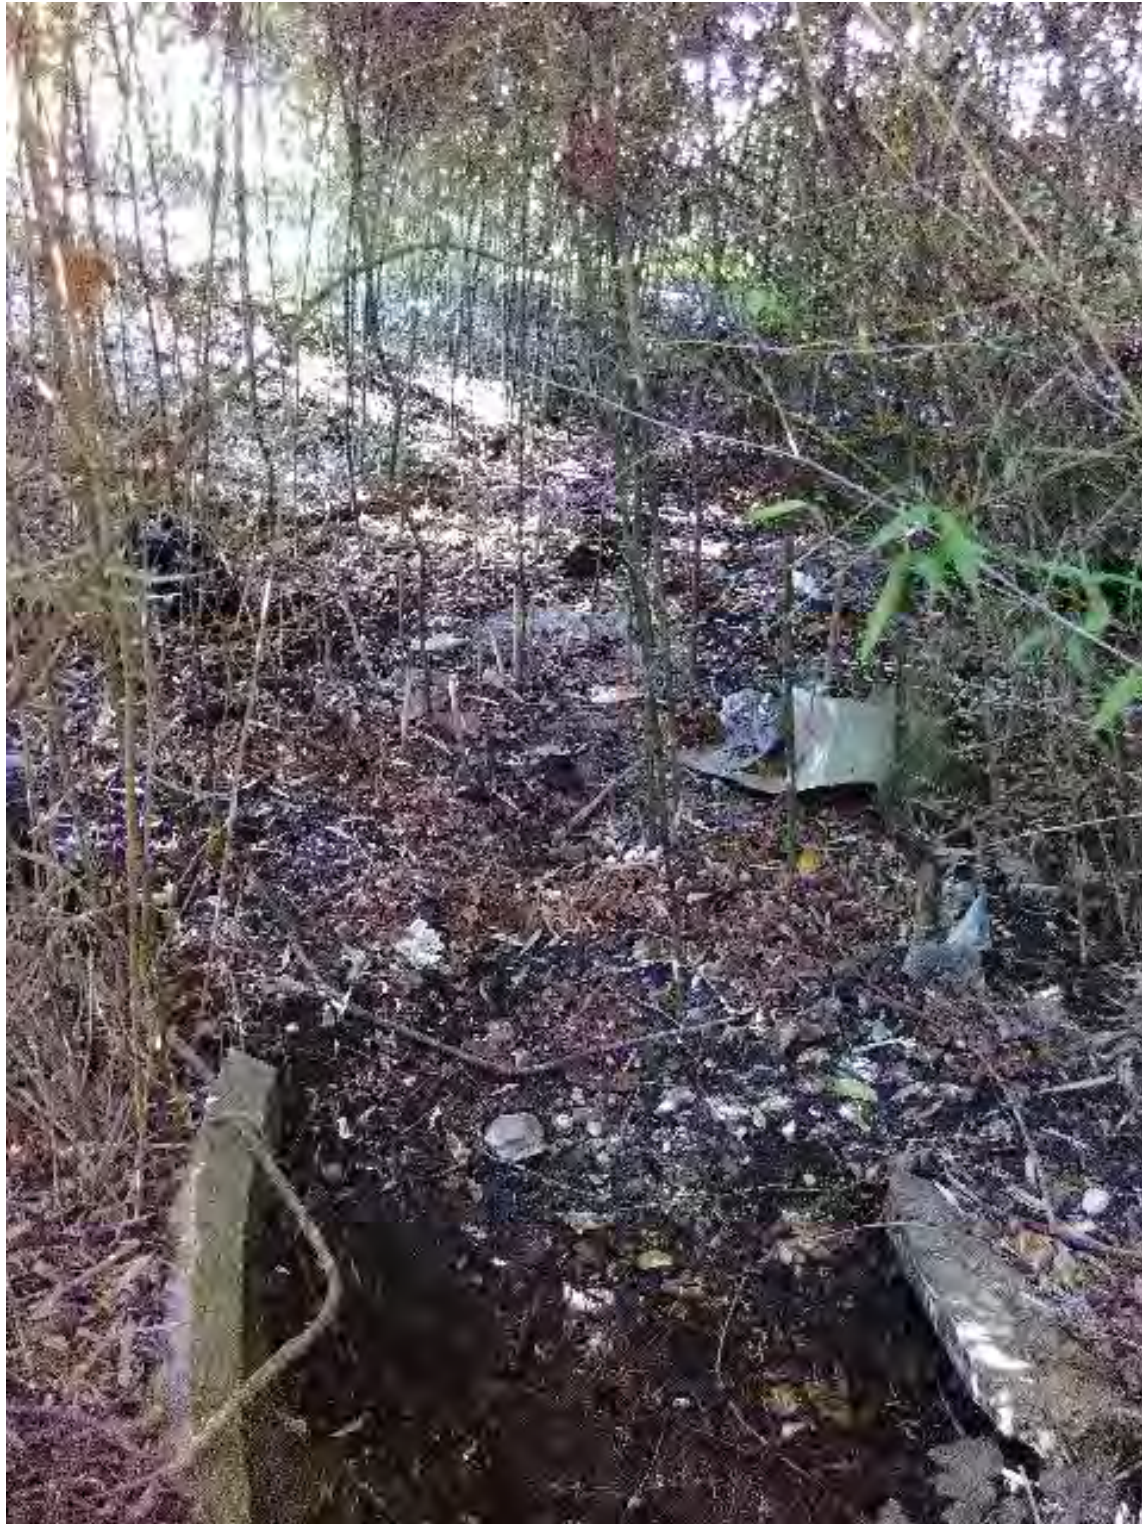
**Figure 3:** Debris downstream of U16O014.

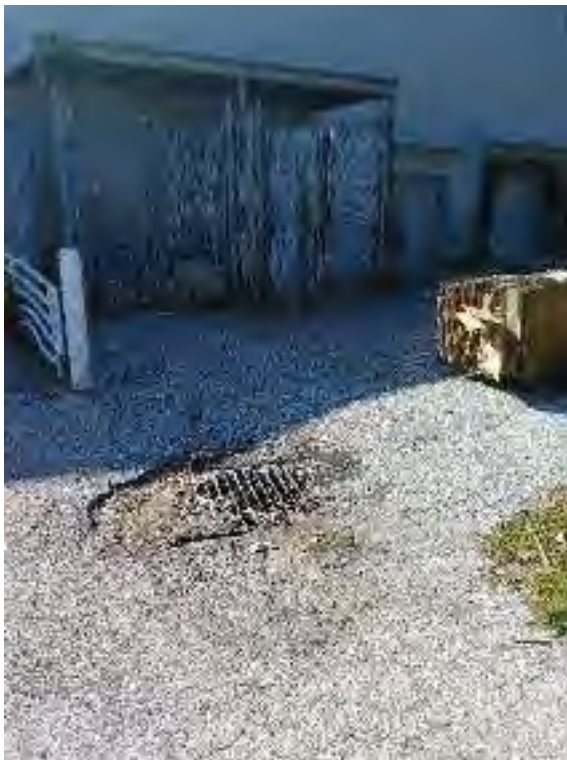
**Figure 3:** Bulk cardboard storage and pallet.

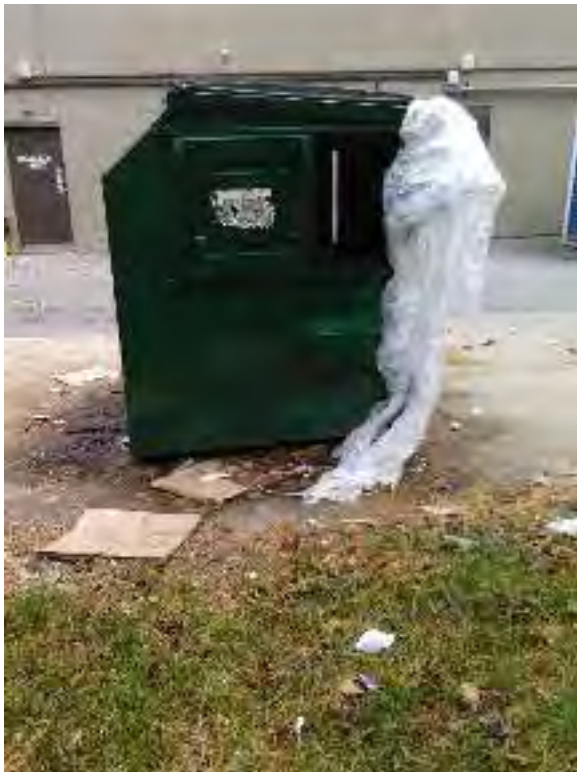
**Figure 2:** Dumpster with trash outside and discoloration near base.

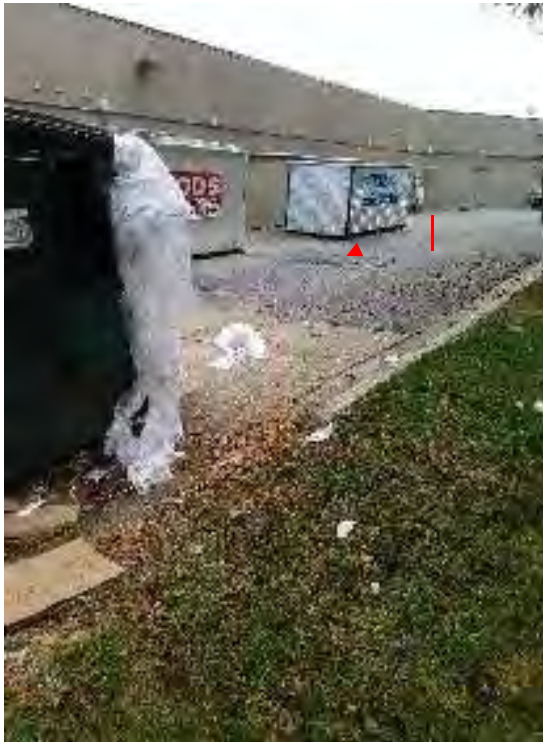
**Figure 3:** Dumpster location relative to inlet indicated by red arrow.

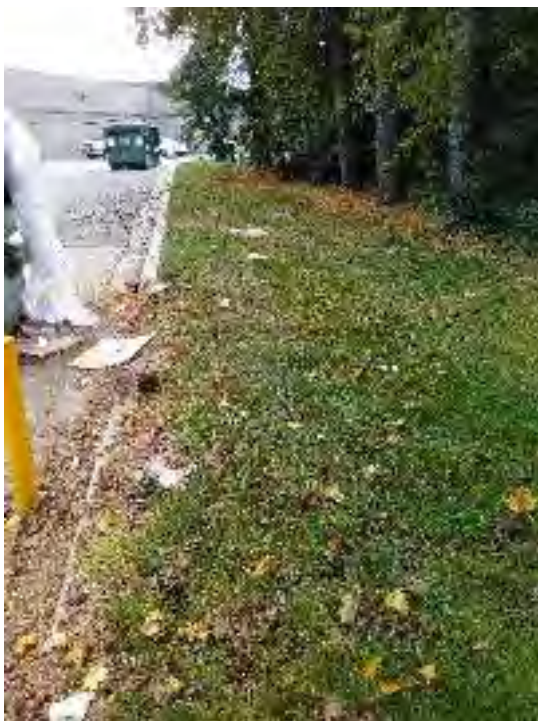
**Figure 4:** Additional trash in grass next to dumpster.

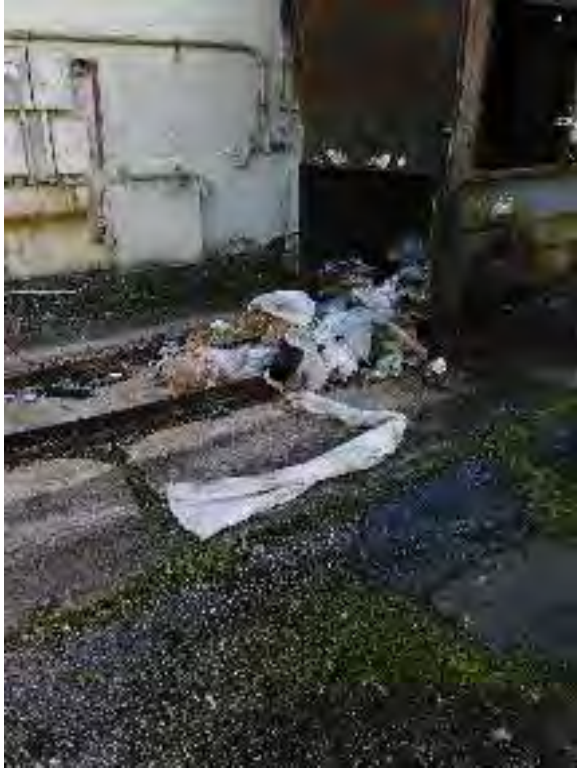
**Figure 2:** Trash compactor chute without dumpster; view 1

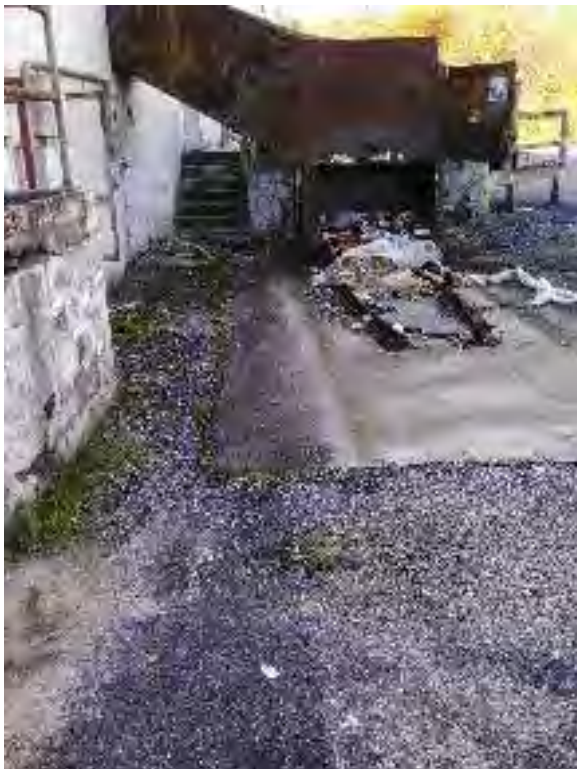
**Figure 3:** Trash compactor chute without dumpster; view 2

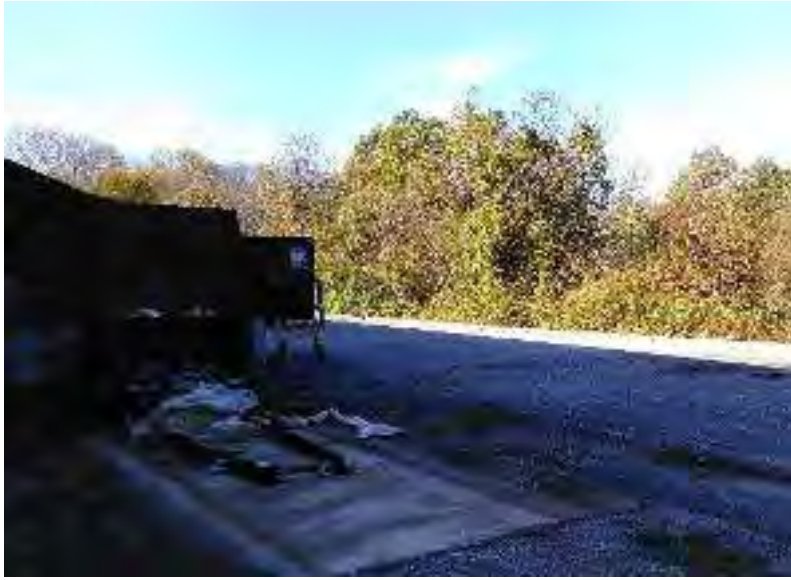
**Figure 4:** Trash compactor chute without dumpster; view 3

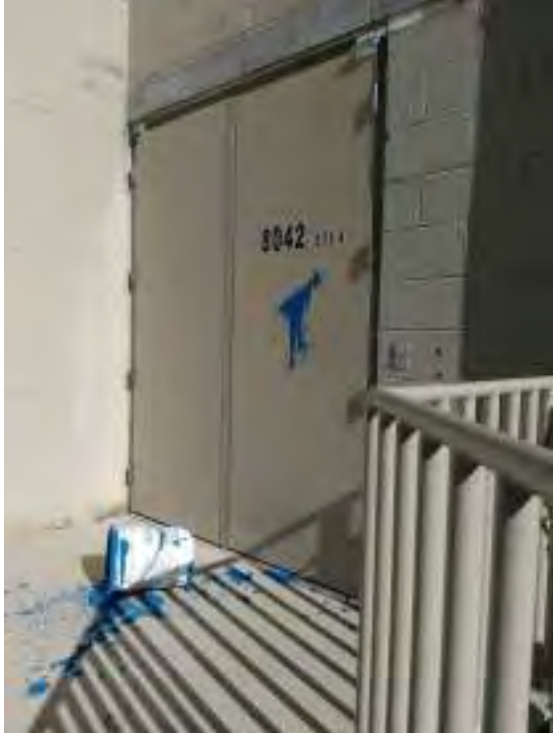
**Figure 2:** Bucket of unknown Dryvit product spilled on the back stoop of vacant retail space.

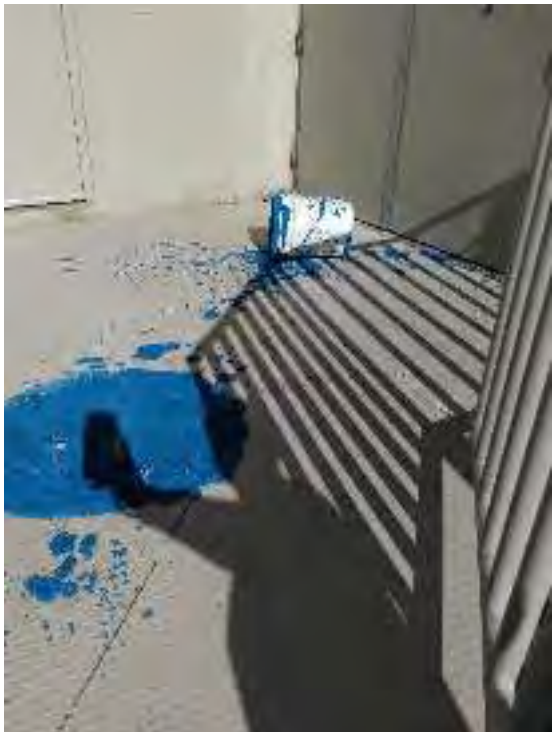
**Figure 3:** Bucket of unknown Dryvit product spilled and hardened on the back stoop of vacant retail space.

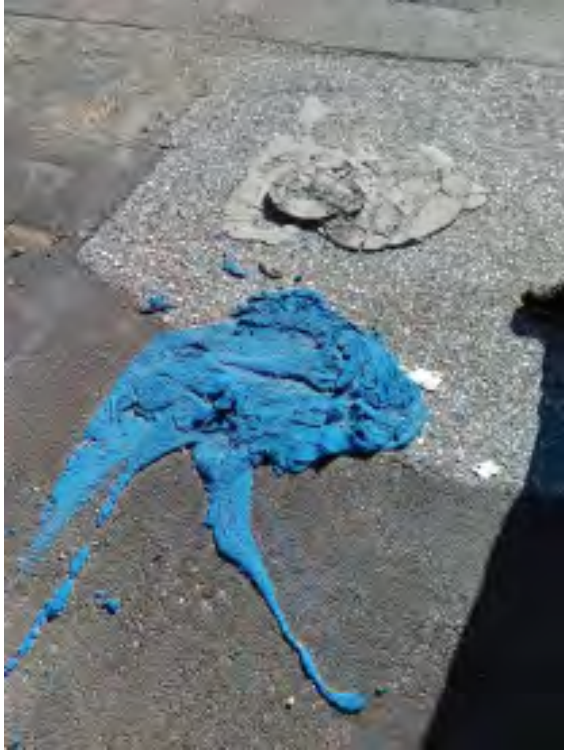
**Figure 4:** Notable patches of hardened Dryvit product on pavement in rear of vacant retail space. Blue and gray patches of spilled product are approximately 2 ft in diameter.

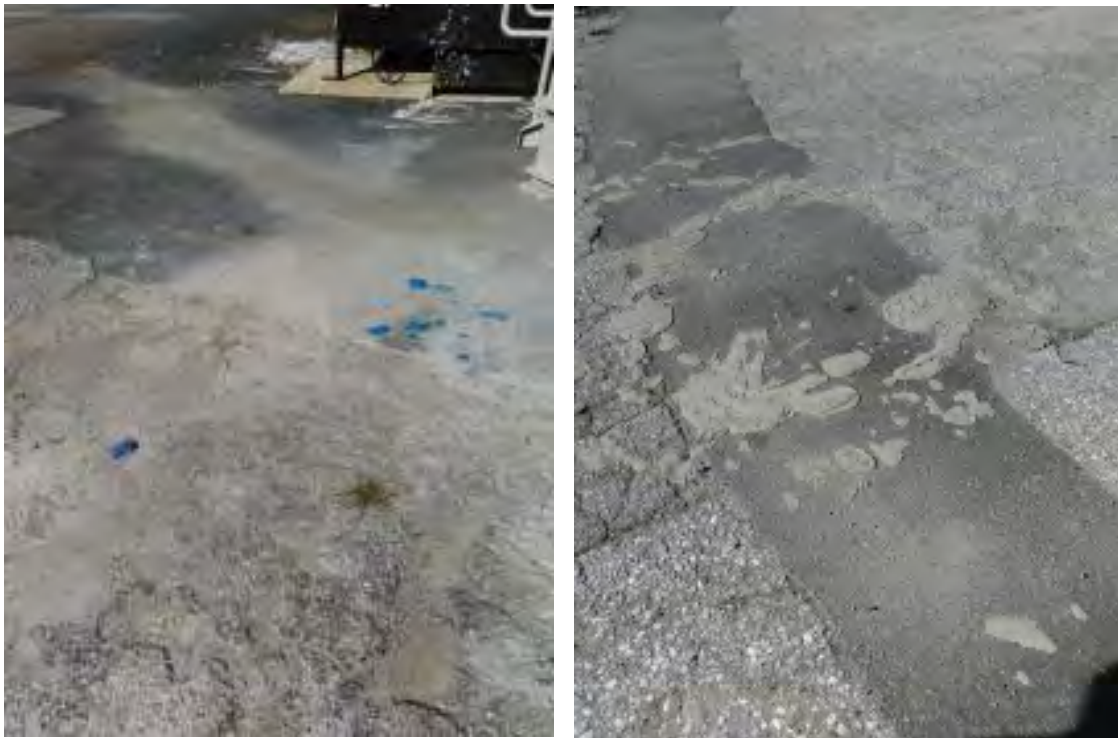
**Figure 5:** Smaller patches of blue (left) and gray (right) hardened Dryvit product scattered on pavement within approximately 30 ft of rear retail space door.

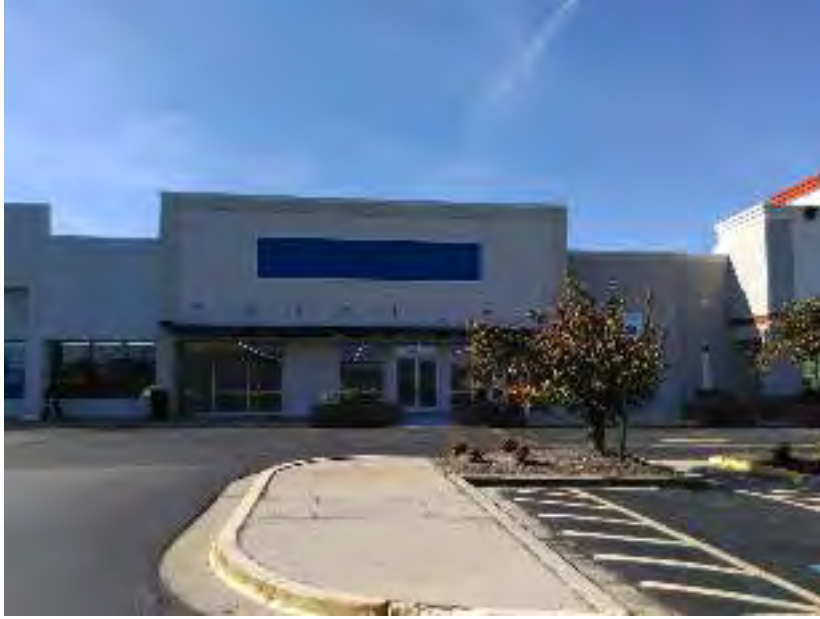
**Figure 6:** Storefront, which appears newly refinished, features same color blue observed spilled behind the retail space.

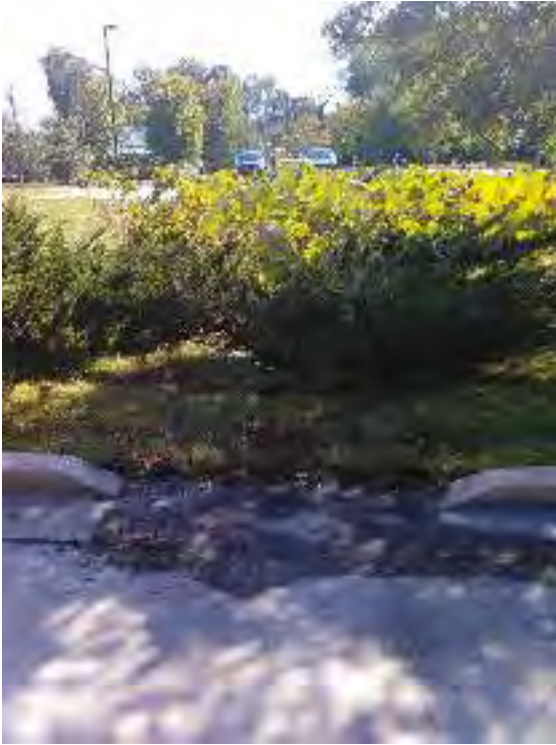
**Figure 2:** curb cut draining rear driveway pad. Drains to western pond.

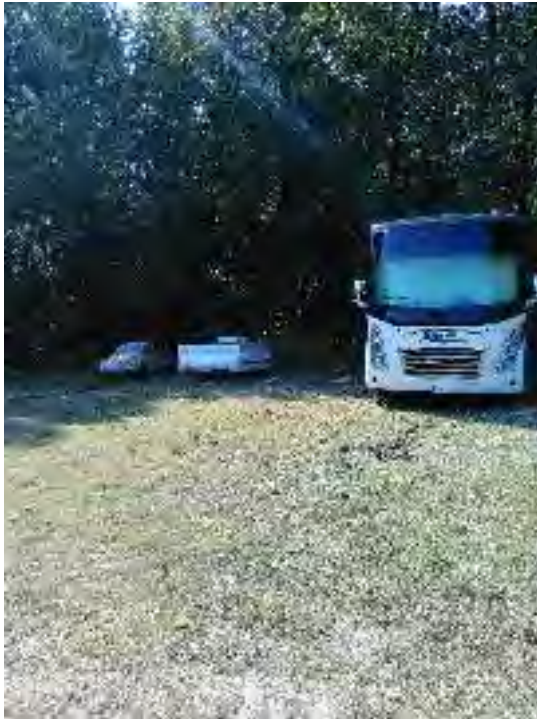
**Figure 4:** Storage of vehicles behind building and parking lot.

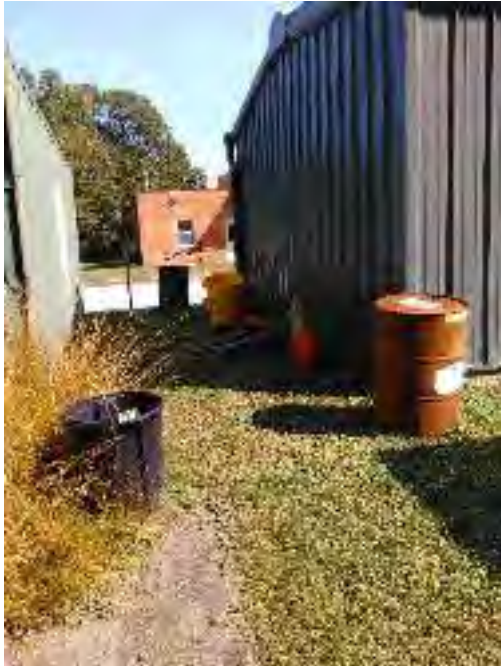
Also on site were 2 improperly stored barrels containing unknown liquid (Figure 6).

**Figure 6:** Improper liquid storage of drums.

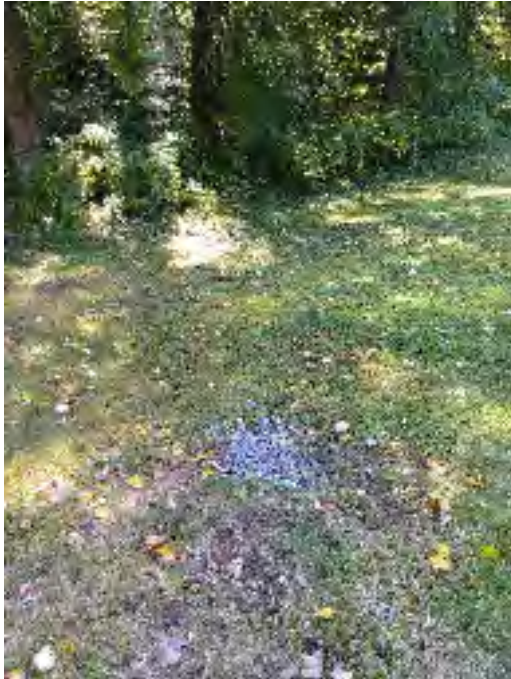
An outfall was also identified onsite that was not in the reference layer, but it is small and no flow was observed (Figure 7 and 8). The team discussed this outfall with an on-site contact and learned that this outfall was installed to fix drainage issues present on the main driveway in front of the building. During rain events, groundwater would rise up through the cracks in the pavement. A perforated pipe (Figure 9) was installed to drain this area that then flows to the discovered outfall.

**Figure 8:** Outfall discharge area.

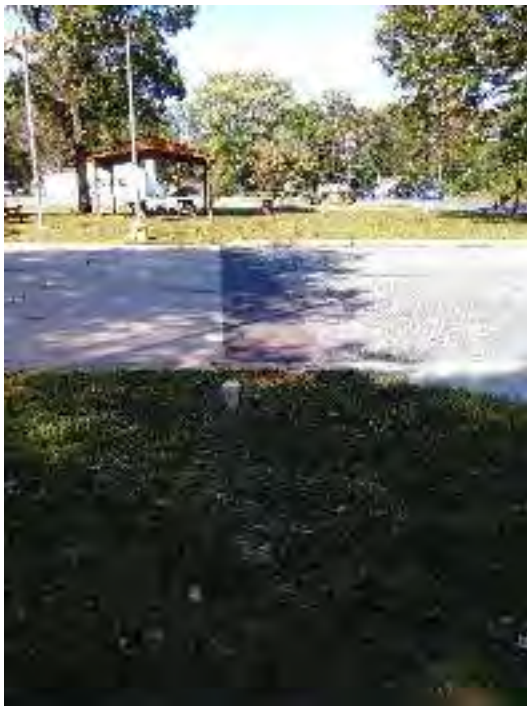
**Figure 9:** Pavement cut under which a pervious pipe is draining the groundwater.

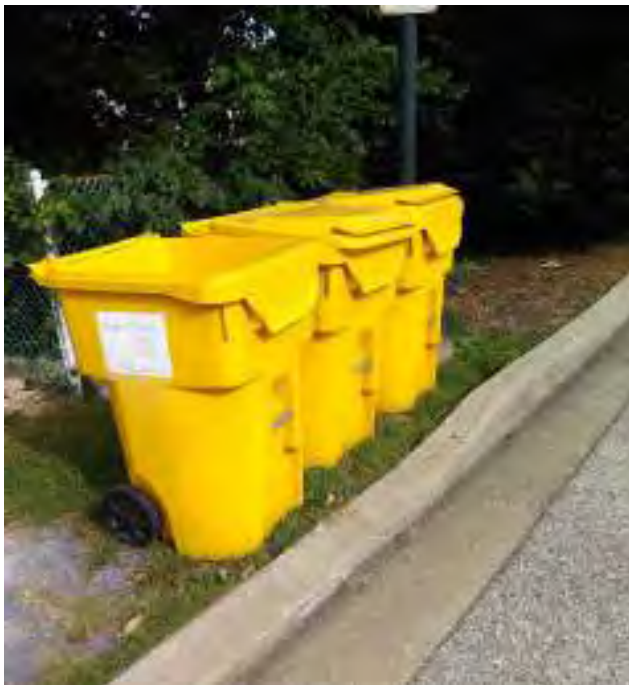
Dumpsters and recycling bins are present behind the station. At the time of the site visit, there was no evidence of the dumpsters or bins leaking and/or waste being improperly disposed of outside the designated containers (Figure 2, Figure 3).

**Figure 3:** Recycling area behind Brooklyn Fire Co. 31

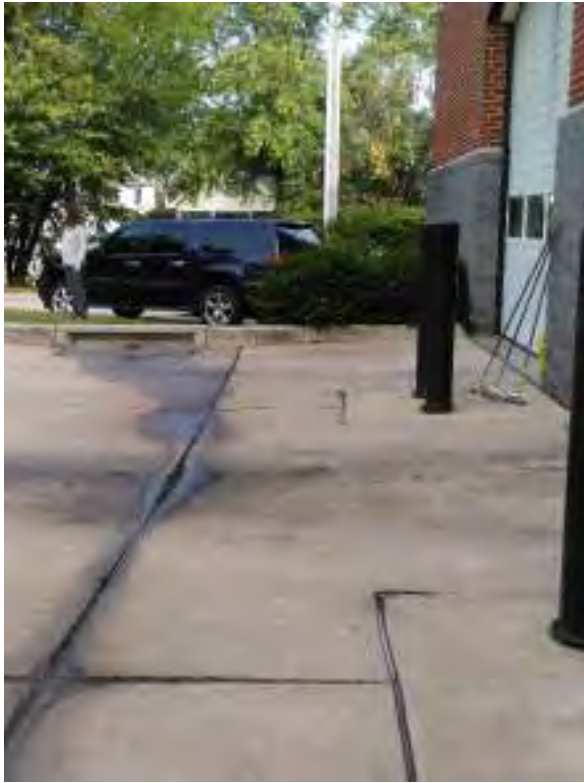
There are 3 stormdrain inlets on the property. Vehicle washing occurs behind the station, adjacent to one of these stormdrain inlets (Figure 4). Some trash and debris was present in the western most inlet however did not warrant maintenance at the time of the site visit. The southernmost inlet present also drains the adjacent commercial lot immediately southeast of the Brooklyn Fire Co 31 parcel.

**Figure 4:** Vehicle Washing Area located immediately behind the Brooklyn Fire Co. 31 Station.

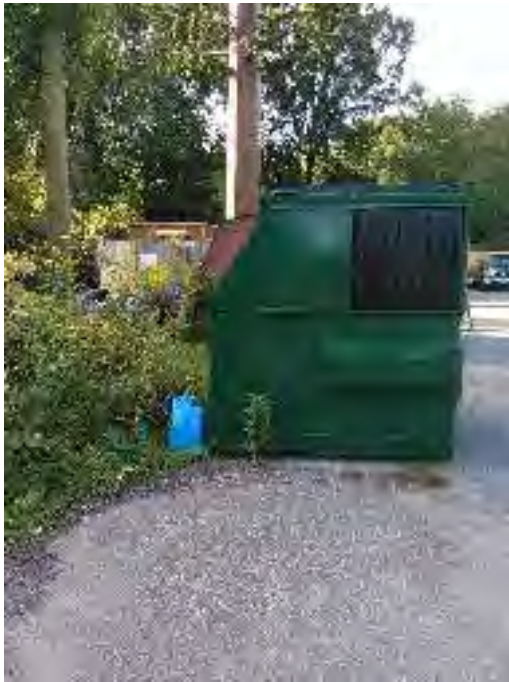
In the southeast corner of the parking lot, the team noted a dumpster with two blue fuel cans (Figure 1 – blue circle) behind it. Inspection of the cans revealed they were partially full. The fuel cans pose a relatively minimal risk of leaking, but should be moved to a covered location for longer term storage.

**Figure 2:** Fuel cans located behind the dumpster

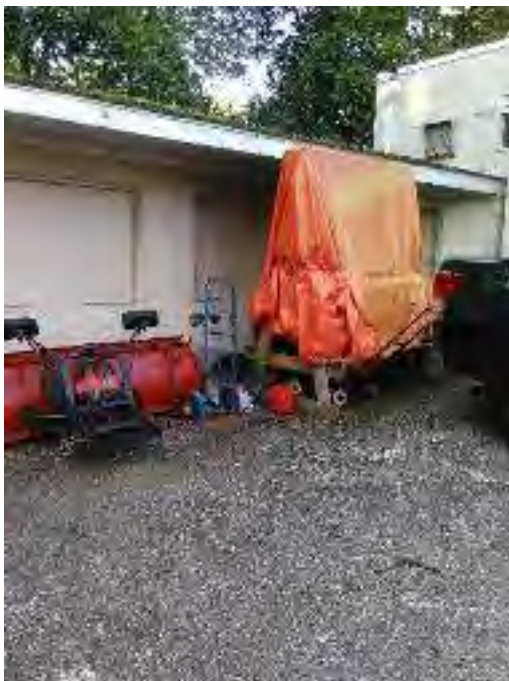
The field team also noted the bulk storage (Figure 1 – yellow circle) of deicing salt was knocked over and only partially protected by an overhanging roof. Additional deicing salt was observed on the ground behind a snow plow. It was unclear how easily storm water would come into contact with the spilled salt, but the team would recommend cleaning up any loose salt and covering the salt storage container with a lid.

**Figure 3:** Knocked over bulk storage of deicing salt

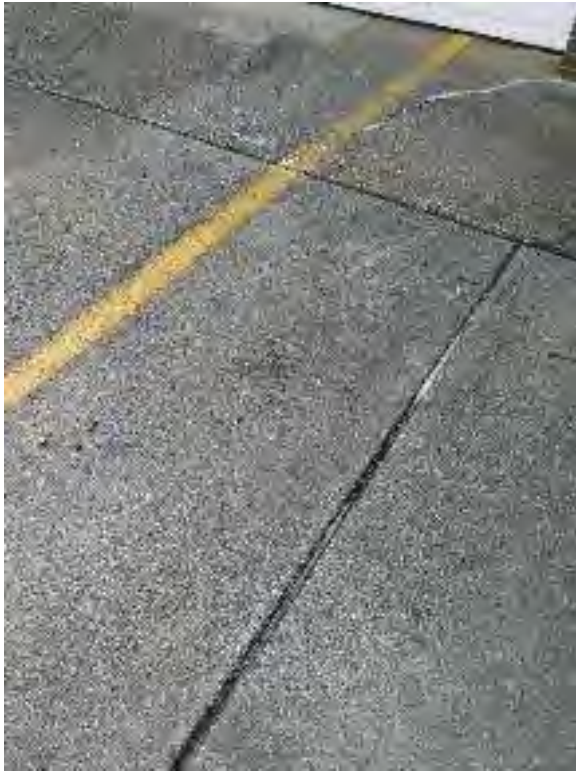
Washing of vehicles likely occurs in the front of the facility, and the field team observed some residuals suds in the front the facility, but washing location was not confirmed with firefighting staff. Washing water (if washing does occur in the front) would sheet flow onto the street for curbside storage.

**Figure 4:** Residual suds in front of the site, likely washing location.

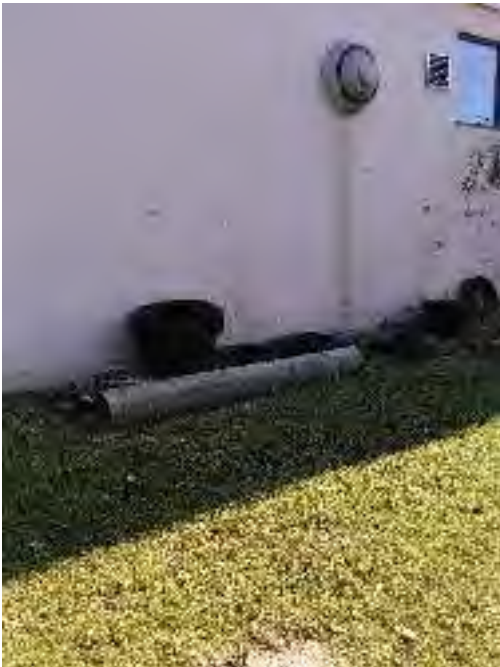
Figure 9: Improper bulk solid storage along north edge of property.

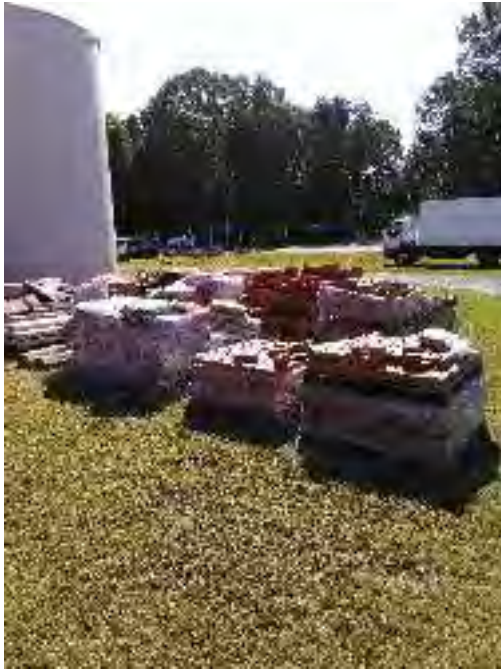
Figure 10: Improper bulk solid storage on southwest corner of warehouse building.
