# Fiscal Year 2021 Annual Report

Illicit Discharge Detection and Elimination

Permit Number: MD0068306

Prepared for  
Anne Arundel County

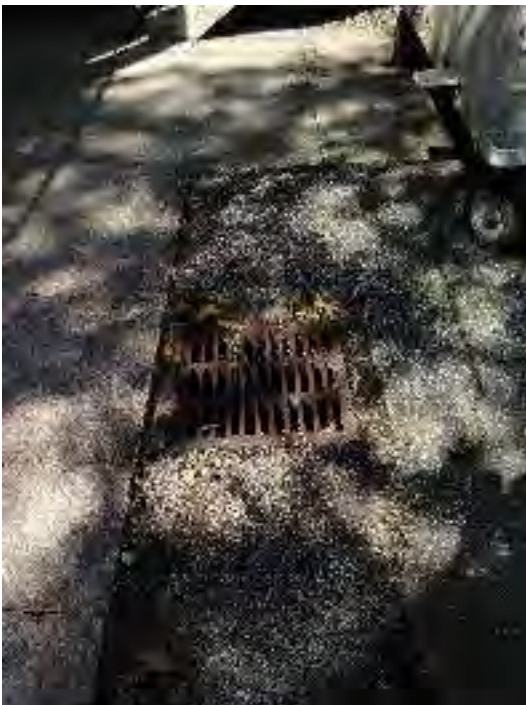
The team observed high water elevation and potentially clogged pipes in two catch basins on the site. No pipes were visible above the elevation of water. See Figure 3 and Figure 4.

Figure 5: High water elevation in catch basin at east end of property

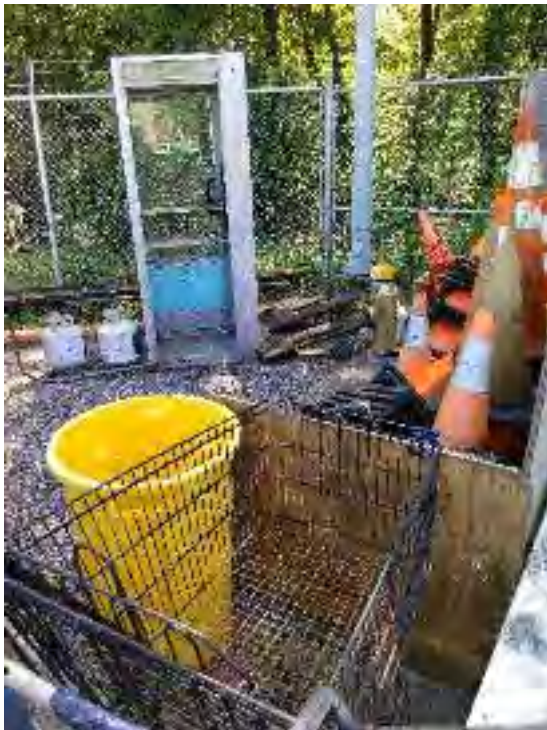
Multiple locations were noted in which solid materials and liquids (including gas tanks) were being stored without secondary containment (see Figure 7, Figure 8, and Figure 9).

Figure 9: Gas can storage, other materials storage requiring secondary containment

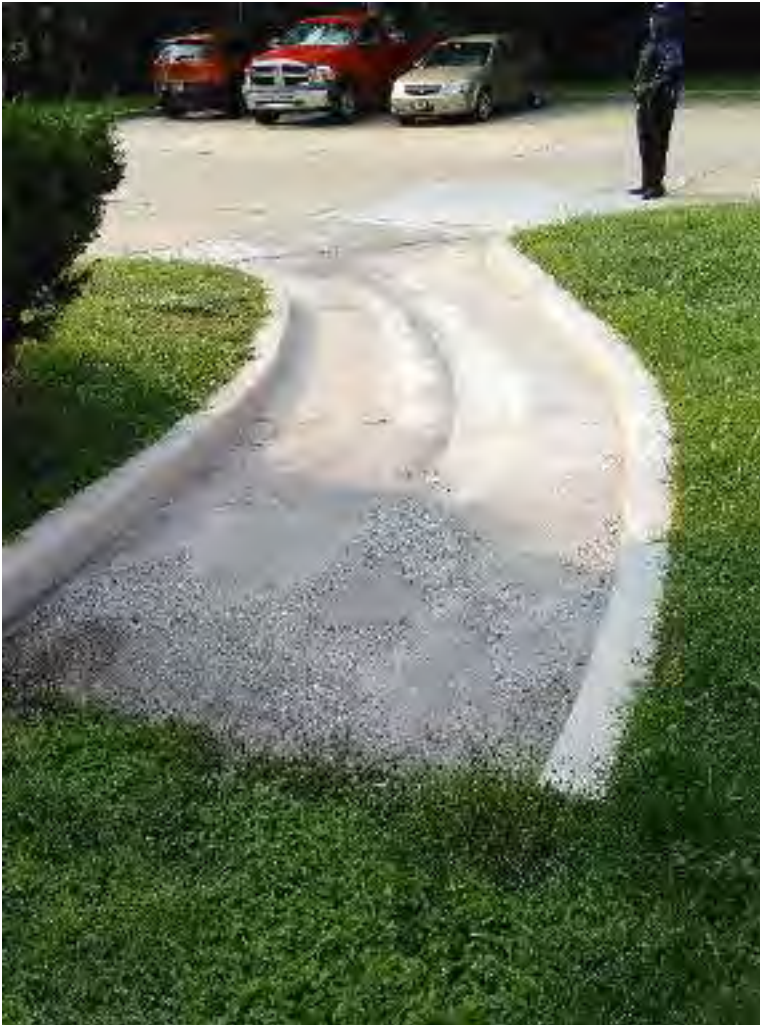
Figure 2: Washwater residue on parking lot outlet to pervious lawn.

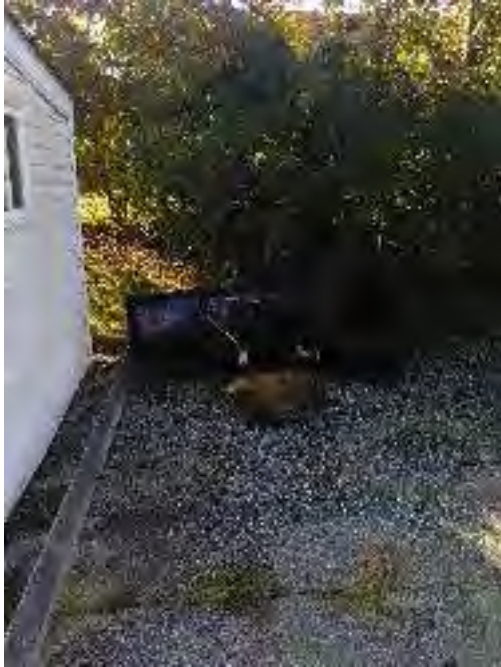
Figure 4: Improper bulk solid storage of tire and plow.

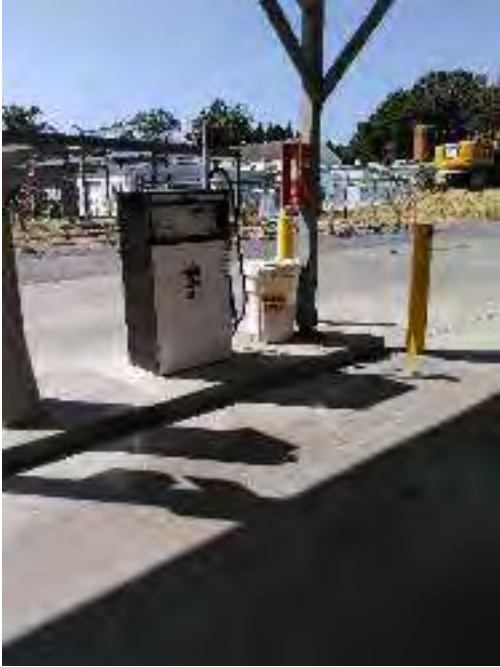
The fueling station was inspected and found to be in good condition, with an emergency spill kit present and no signs of any spills on the surrounding pavement. The water tower also appeared in good condition with the spillway well maintained and stable. The field team, observed some uncovered soil related to construction activities though the soil was behind a silt fence and had construction equipment parked on top. The field team also observed a recycling area which was free and clear, but it also not likely in use presently.

Figure 2: Fueling station with emergency spill kit

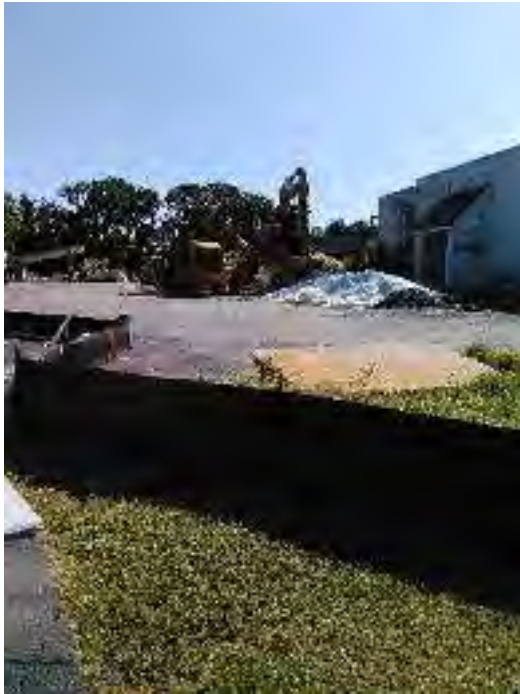
Figure 4: Uncovered soil behind silt fence.

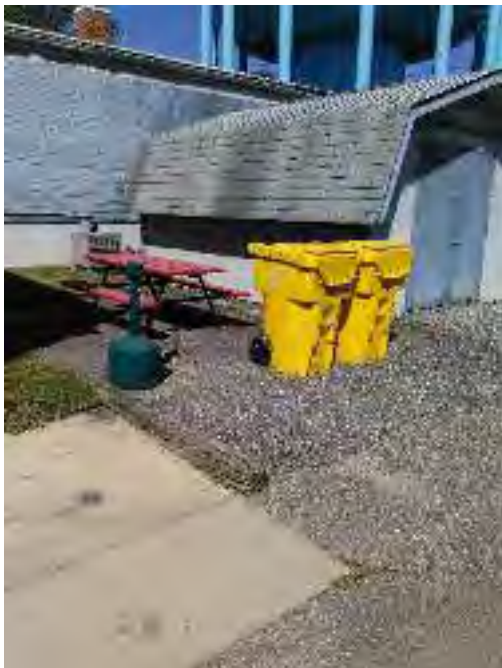
Figure 5: Recycling area to the east of the existing fire station

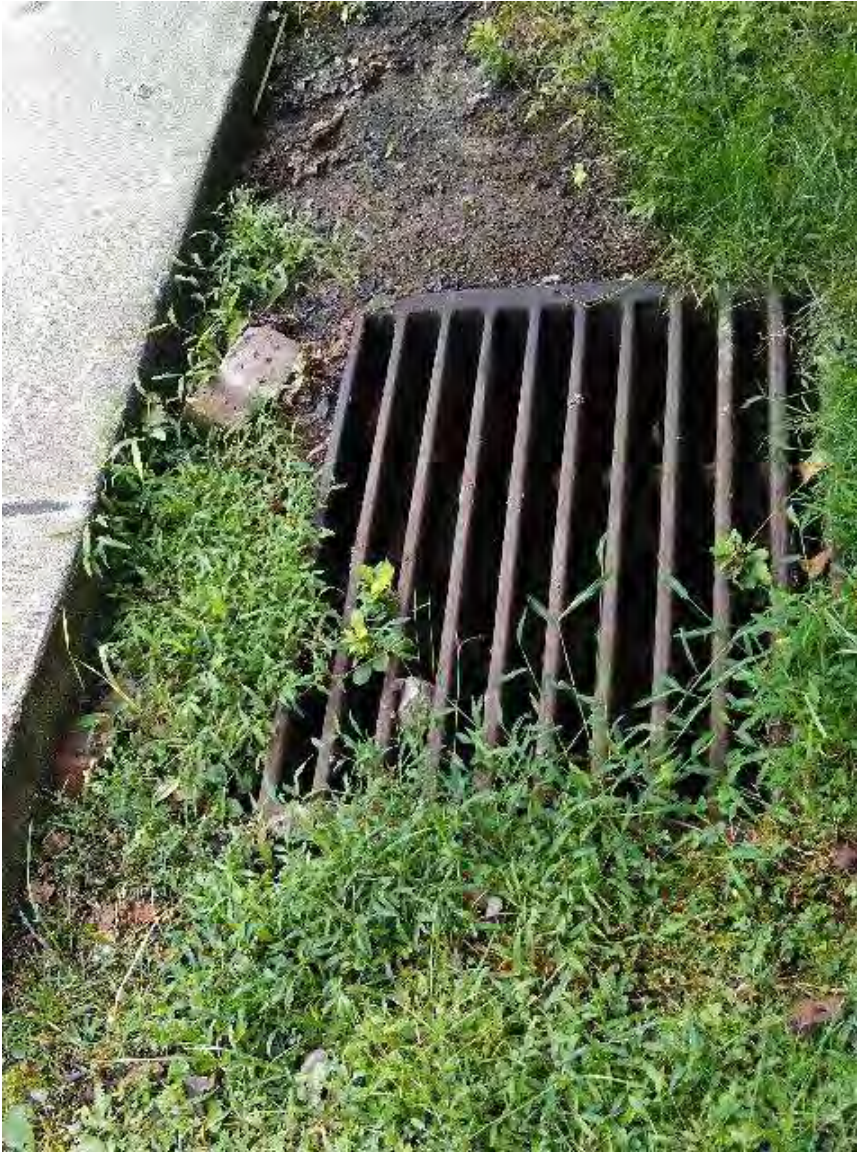
The site does not have any obviously functional storm drain inlets. The main garage pad and parking lot on the north and west of the building drain north towards Max Blobs Park Road and then along Max Blobs Park Road west and away from the site. The rear of the property is uncurbed and recently paved. This area flows further southwest into the forested area between the parking lot and the radio tower. This is the location of the only inlet found on the site, but it doesn't look to capture any flow from the parking lot, the discharge location is unknown, and the inlet looks partially clogged.

Figure 2: Stormdrain inlet near rear of parking lot.

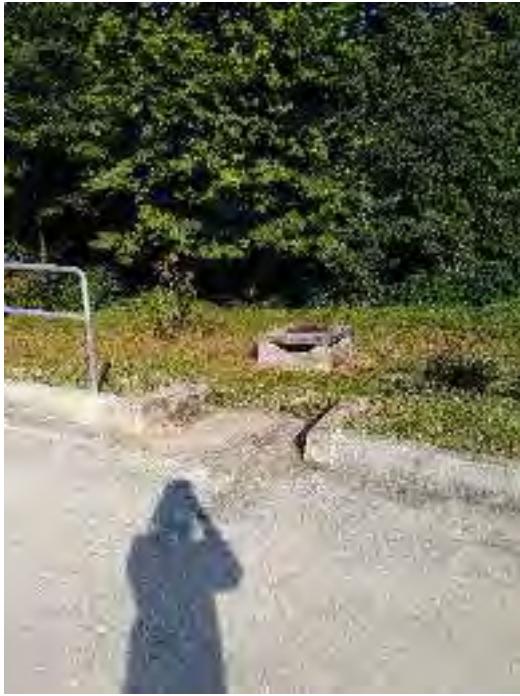
Figure 3: Curb cut inlet from front drive way into dry pond.

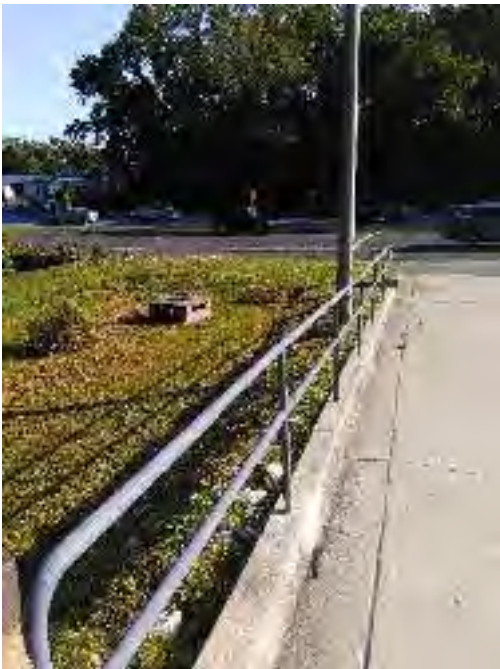
Figure 4: Dry pond riser structure and curb flow path to dry pond

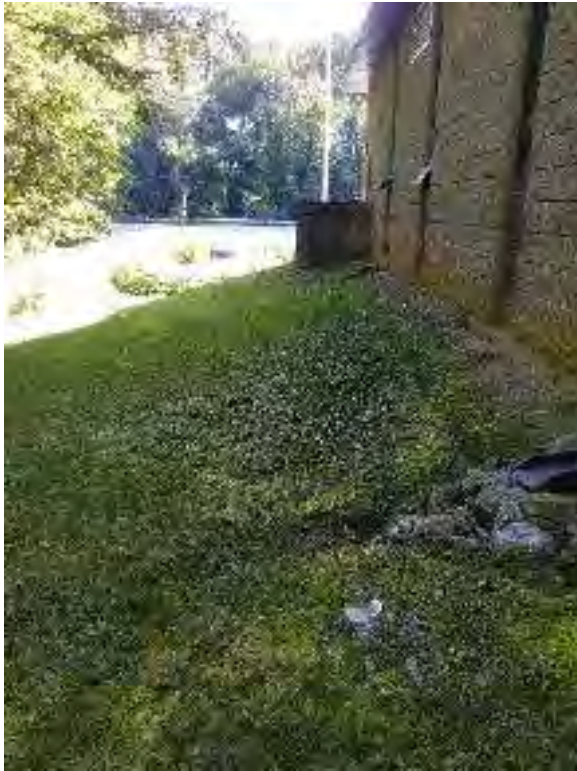
Figure 5: Roof downspouts which route flow to dry pond via inlet at the base of the splash block

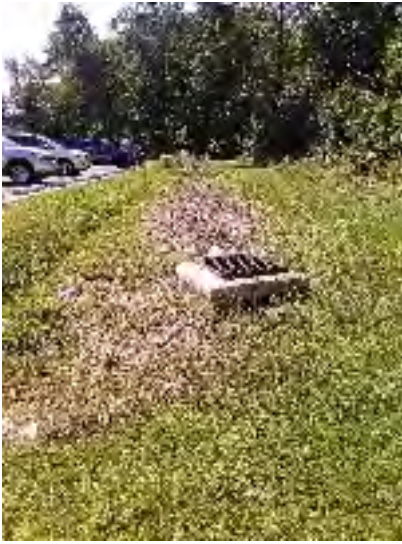
Figure 3: Western stormwater pond adjacent parking area

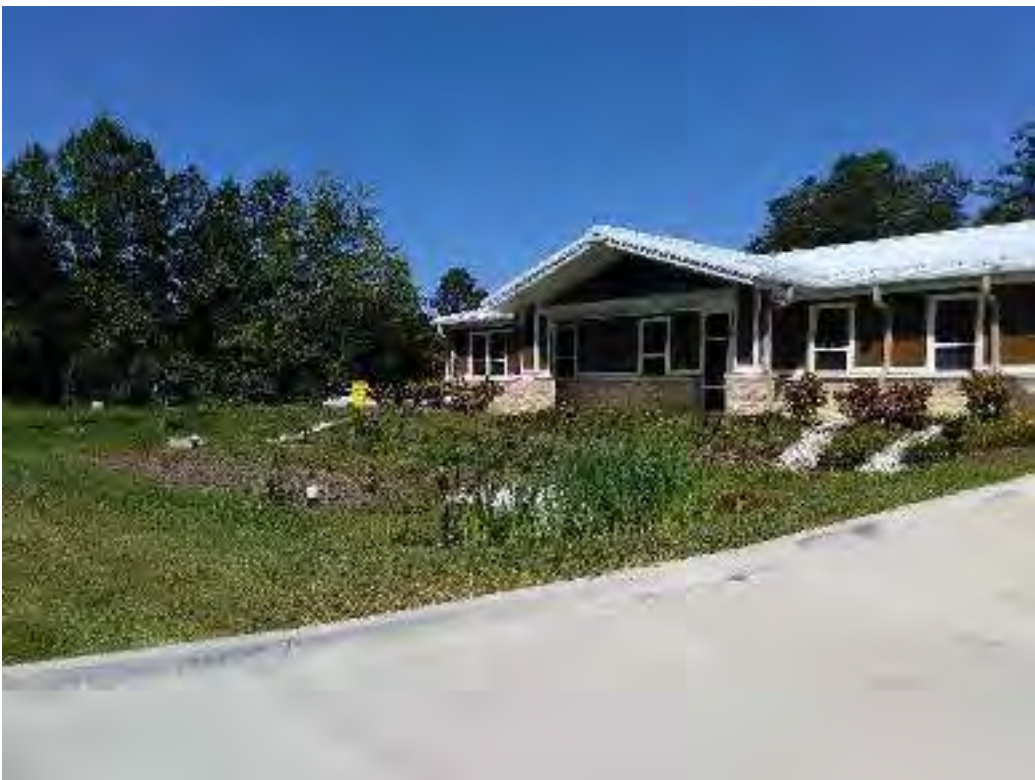
The stormwater pond in front of the building receives a portion of the rooftop's runoff while downspouts on the east side of the building sheet flow to the forested edge of the property (Figure 5).

Figure 5: Stormwater pond receiving rooftop runoff

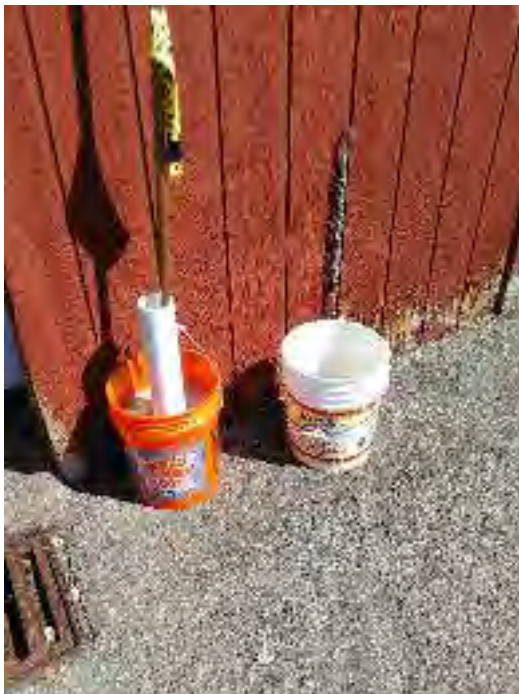
Any onsite washing activities would occur in front of the building (Figure 9). A trench drain in front of the garage doors appears to be in good condition.

Figure 9: Evidence of washing activities in front of building; runoff captured by adjacent trench drain.

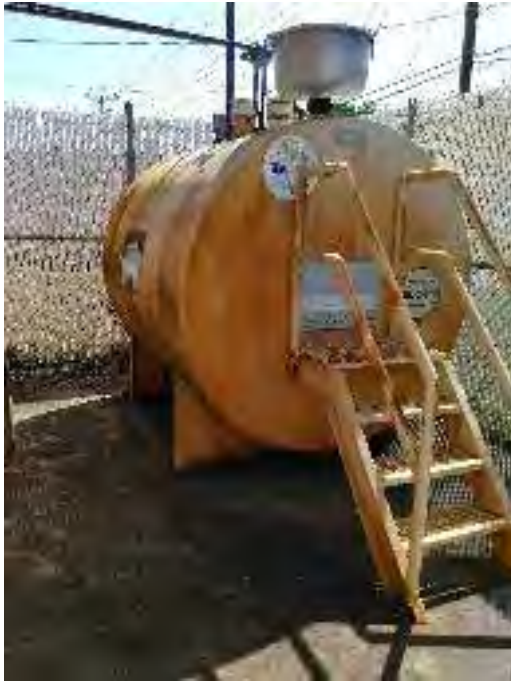
Figure 10: Fuel tank in front of old Lake Shore Fire Co 20 facility

A gated, but unlocked, fuel tank is present onsite in front of the Fire House (Figure 10). The fuel tank appears in satisfactory condition with no signs of leakage. Filled to approximately the 2.5ft mark however, the tank could be emptied or relocated if no longer in use at this facility.

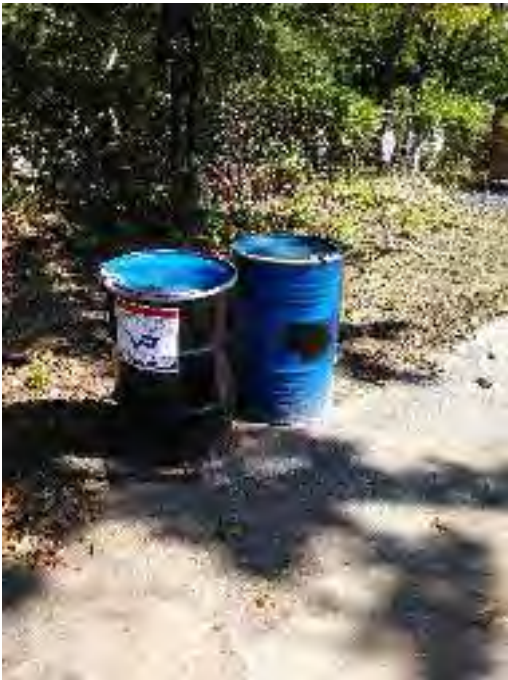
Figure 11: Barrels of grease behind old Lake Shore Fire Co 20 facility

Drums of grease are located behind the facility (Figure 11). They are in good condition but could be relocated out of the elements for added protection against exposure.

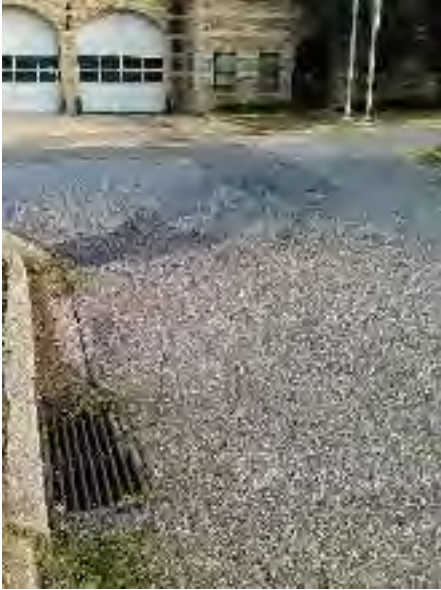
The front entry of the main garage on the east side of the main building is sloped towards Laurel Fort Mead Road. This appears to be a wash location, and there is potential wash water residue in the area of the storm drain inlet (See Figure 2).

Figure 2: Possible wash water drainage into the stormdrain inlet.

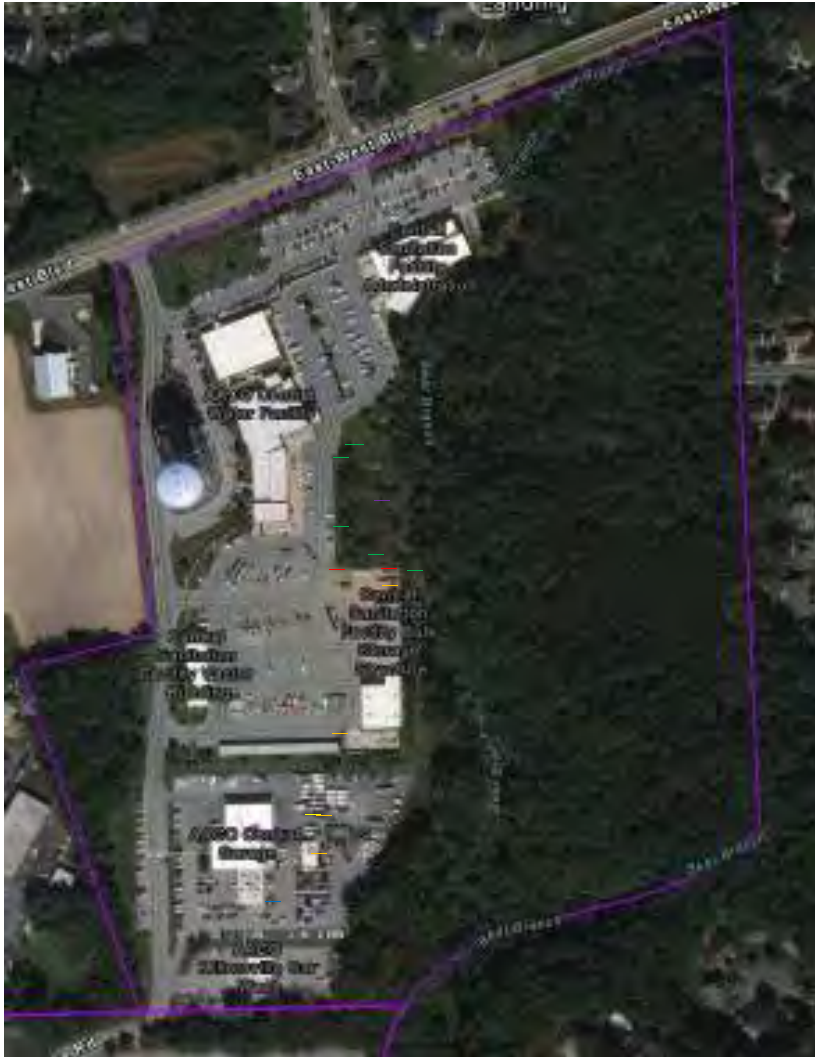
Figure 1: Aerial map of the Millersville Garage property  
 Purple Outline = Parcel boundary  
 Orange Point: Improper bulk solid storage  
 Green Point: Inaccessible outfalls within detention facility  
 Red Point: sedimented outfalls  
 Blue Point: Washdown activity  
 Yellow Point: Improper liquid storage  
 Purple point: Detention Facility

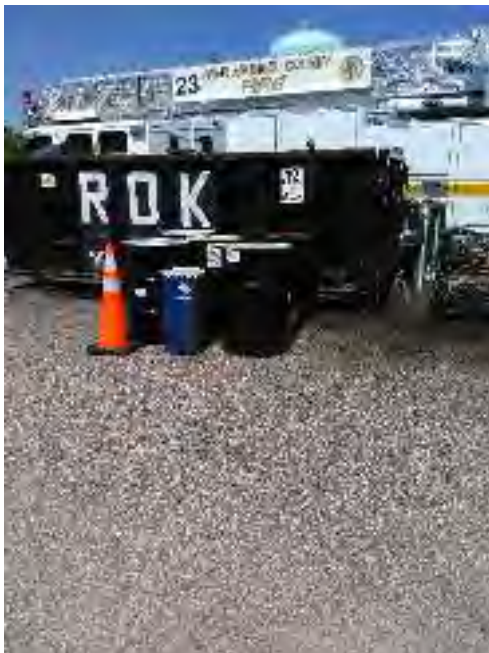
In the fenced area within the Millersville garage there was washdown activity (Figure 2) as well as improper bulk solid storage of parts and tires (Figures 3 and 4) and improper liquid storage (Figure 5).

Figure 5: Improper liquid storage.

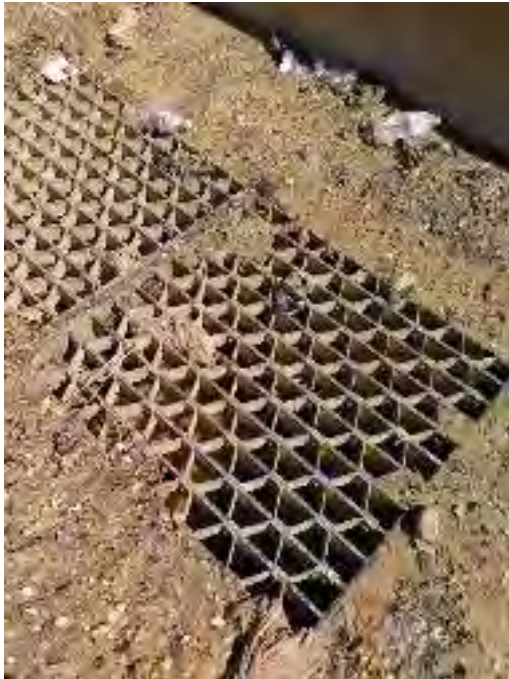
Within the Central Sanitation fenced area, the concerns are mainly centered near the bulk solid storage structure located in the rear of the parking lot. This location is also near the detention facility that manages the runoff for the parking areas. Bulk solids were stored under the canopy as recommended (Figure 6), but also outside the canopy (Figure 7). These solids were being washed off the pavement and into nearby storm drains that fed the detention facility (Figures 8 and 9).

Figure 8: clogged outlet near bulk solid storage.

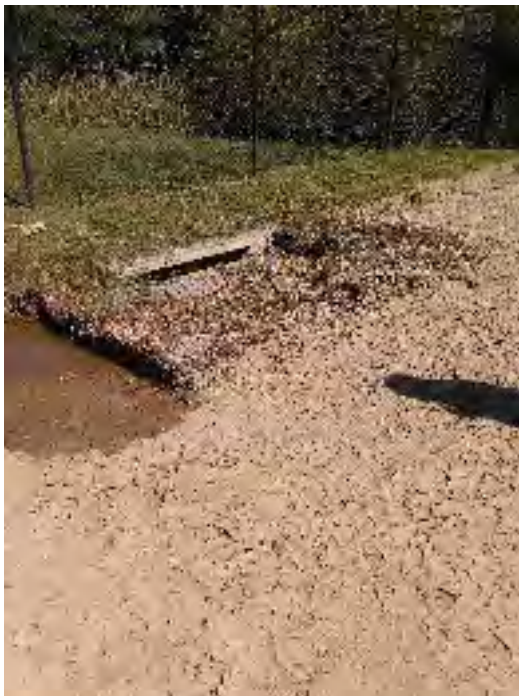
Figure 9: clogged outlet near bulk solid storage.

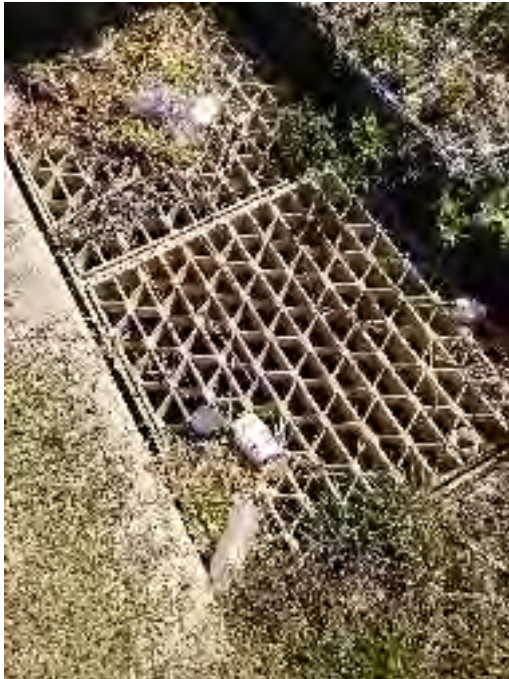
Figure 10: Trash present in outfall on west edge of detention facility.

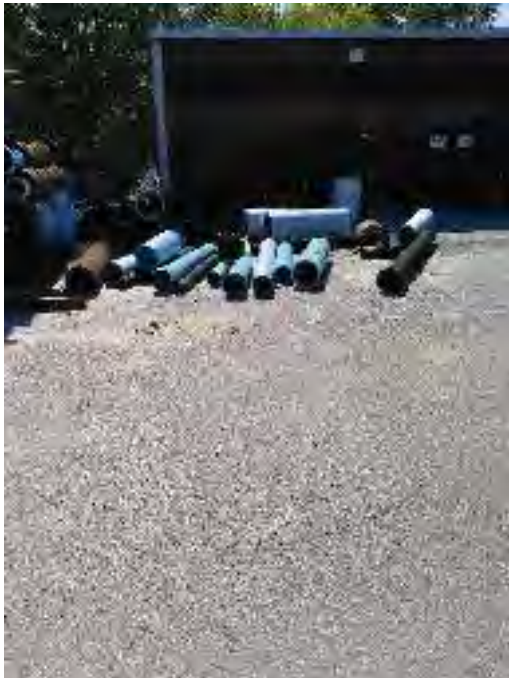
Figure 11: Additional improper bulk solid storage.

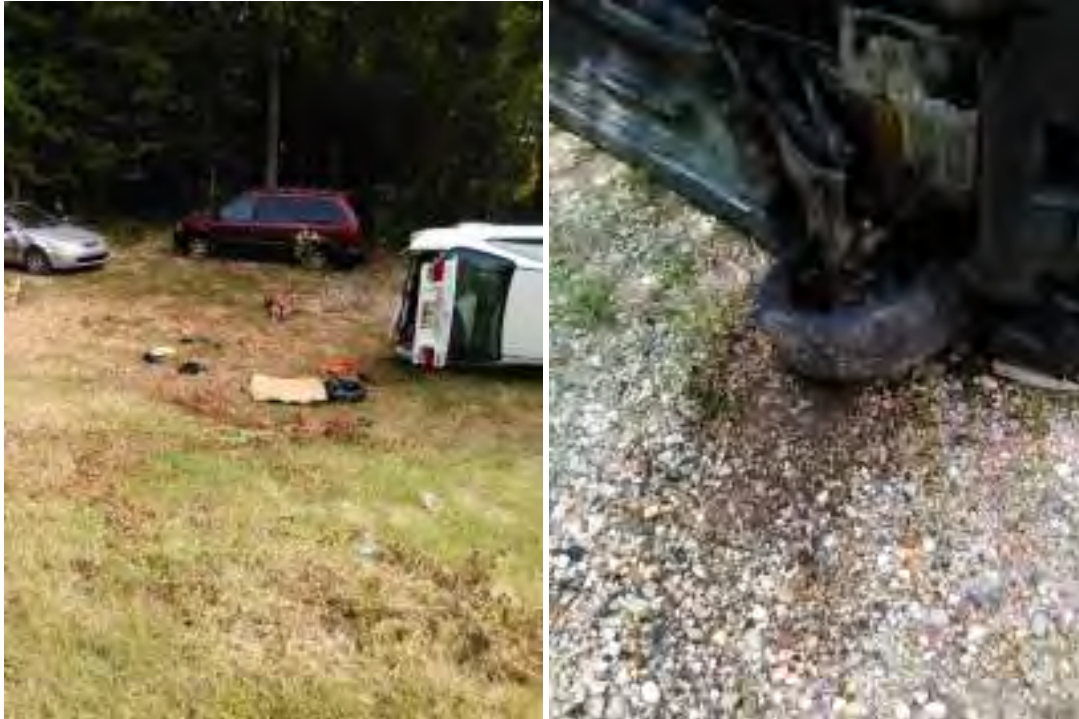
The clearing, northeastern adjacent to the rear drive, appears to possibly be used for on-site training. Several abandoned, burned, vehicles are present (Figure 4). Discoloration was present on the ground in this area but there were no signs that any vehicles were actively leaking fluid at the time of the visit.

Figure 4: Abandoned vehicles located at assumed, onsite training area.

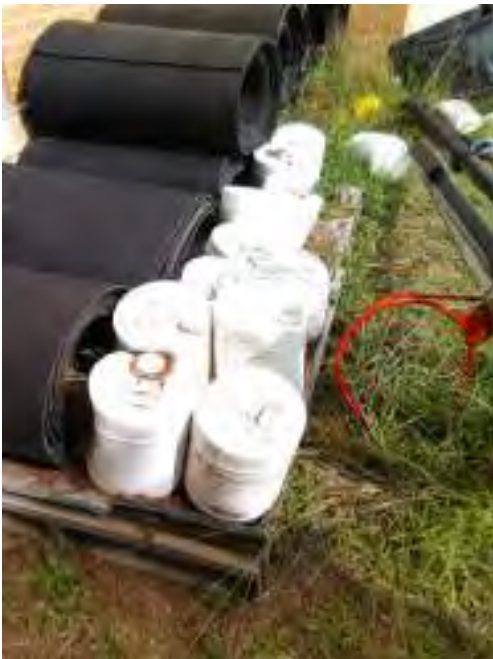
At the southernmost corner of the fire station, at the rear of the building, LimnoTech observed 12 containers of liquid fire fighting foam (i.e., Aeroform Fluoroprotein foam) stored outdoors (Figure 5). Containers did not appear to be leaking or damaged at the time of the visit but storage may be improved by moving these materials indoors and/or by utilizing secondary containment.

Figure 5: Outdoor storage of fire-fighting foam

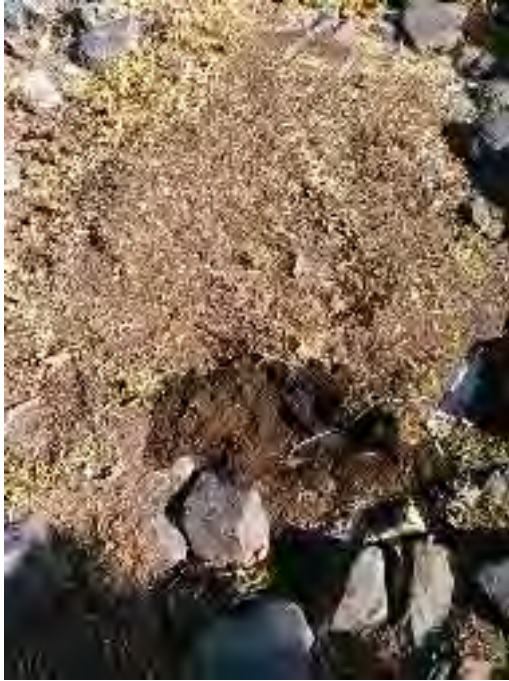
During the site visit the field team found a single blocked inlet (Figure 1 – red circle) in a conveyance channel near the entrance to the front parking lot. The inlet was mulched over completely blocking flow. Additionally the field team observed a work crew temporarily storing mulch and trimmings on the permeable pavement. The work crew did blow off the pavement after completing work and there was no notable sign of clogging observed, but it's possible that finer sediment remained which could decrease the effectiveness of permeable pavement. The County should consider if there is a need to revise landscaping practices to avoid landscaping on permeable pavement if possible.

Figure 2: Blocked inlet which is mulched over.

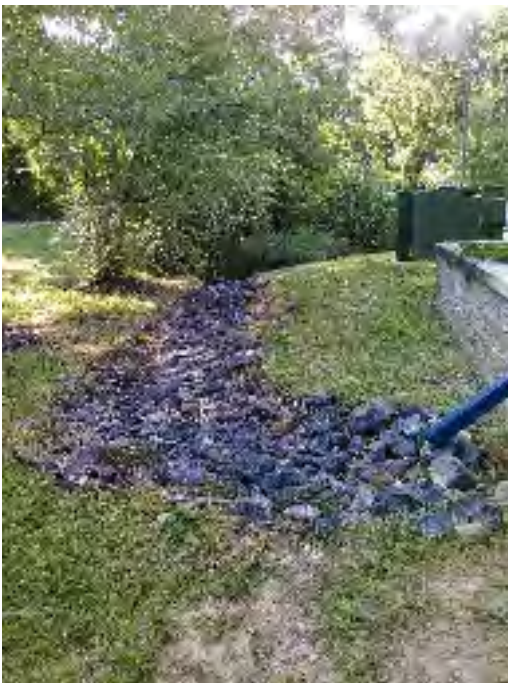
Figure 5: Downspout into stone lined conveyance channel leading to rain garden

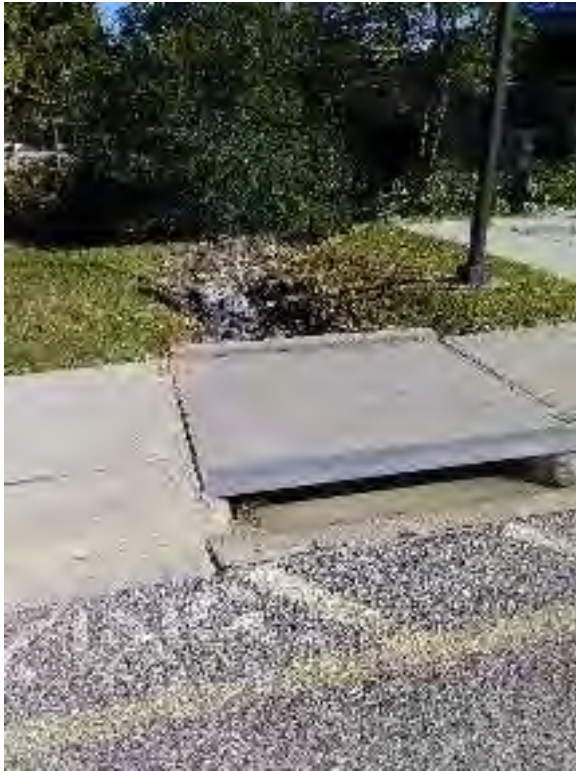
Figure 6: Parking lot inlet routing flow to micro bioretention.

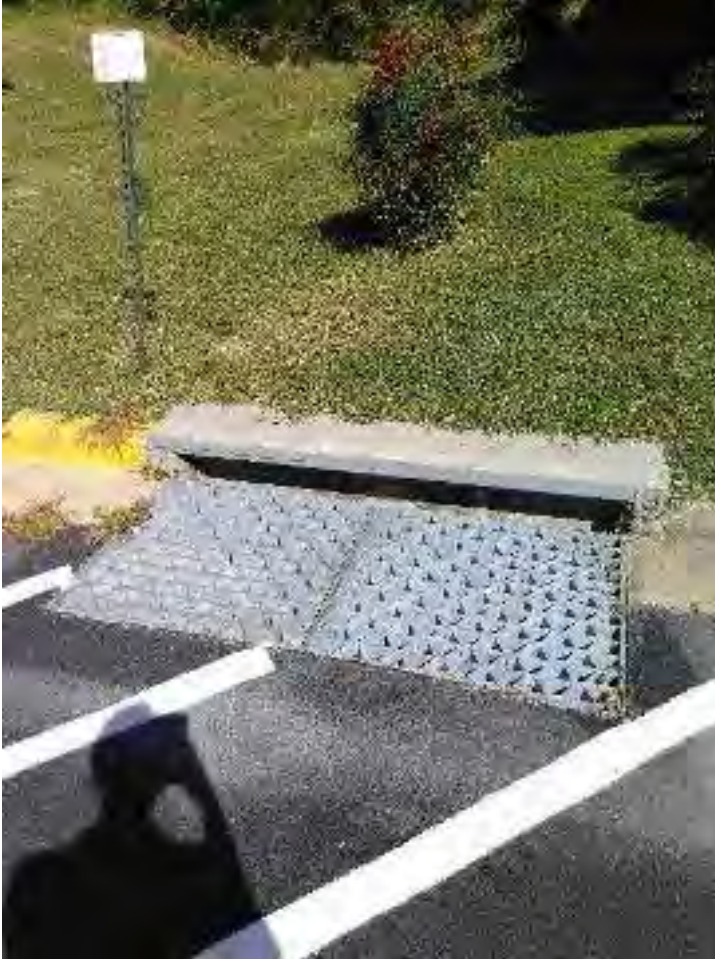
There are no concerns on this site, all inlets are in good condition, and the dumpster area does not contain any debris. There were also no improper solid storage locations as everything looks to be stored in sheds near the southeast corner of the site.

Figure 3: Typical Police Headquarters inlet.

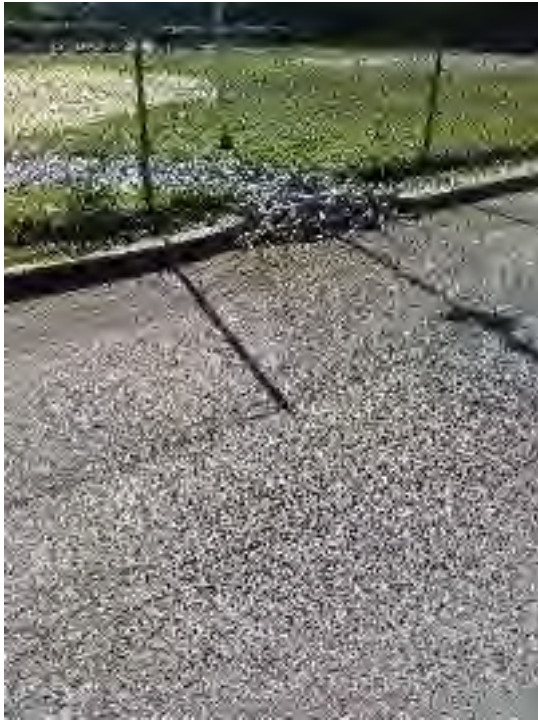
Figure 2: Curb cut to BMP1 with evidence of ponding.

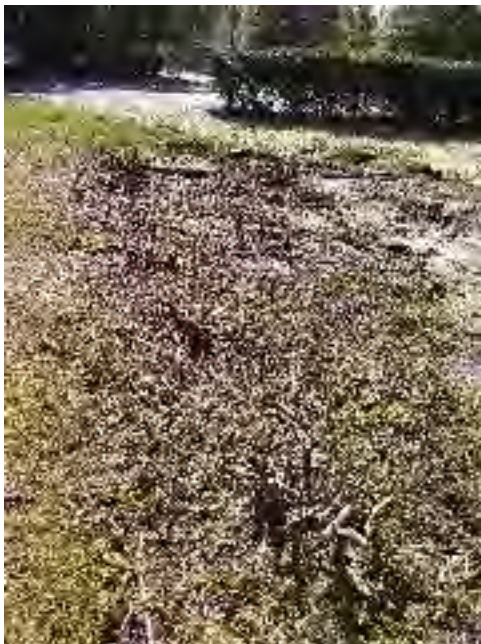
Figure 3: BMP1 showing lack of vegetation/maintenance.

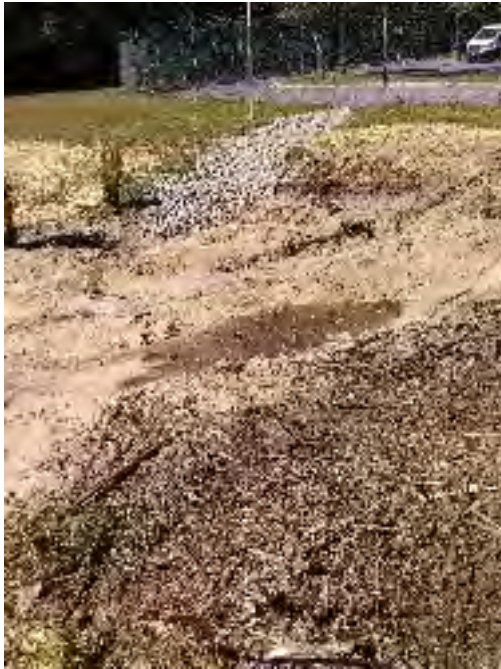
Figure 4: erosion and lack of vegetation in BMP1.

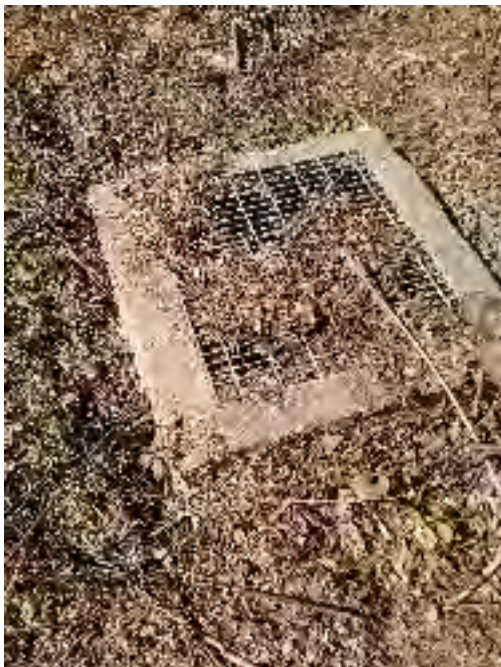
Figure 5: overflow structure for BMP1 is somewhat clogged and should be cleaned.

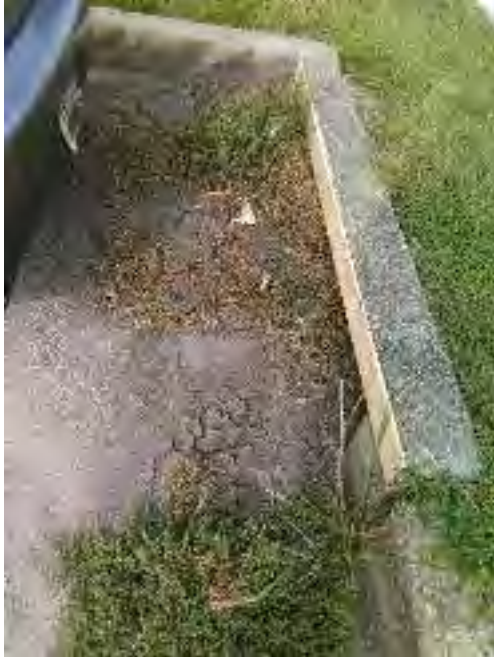
Figure 2: Partially blocked inlet at the Northern District Police Station

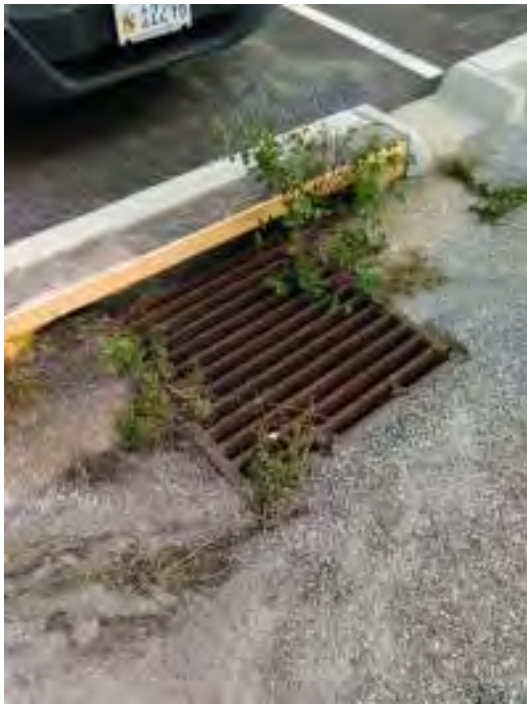
In the rear of the facility one inlet was noted with minor vegetation but not restricting flow or warranting a follow-up (Figure 3). The wash station is located behind the facility as is adjacent storm inlet (Figure 1, yellow circle) (Figure 4). Recycling area was clear, but it was noted that one can was cracked. Fueling station in rear of facility was well kept. A spill response kit was present.

Figure 3: Partially vegetated inlet

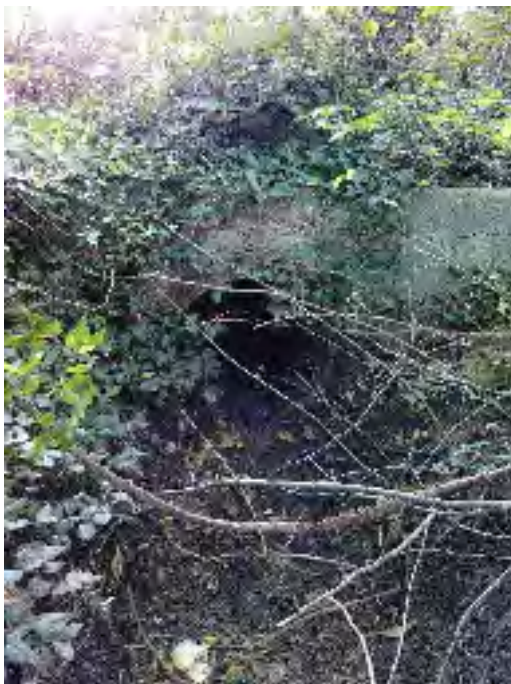
One (1) stormwater outfall is located on the property (Figure 5). The outfall is 24 inches in diameter and made of reinforced concrete. At the time of our visit this outfall was not flowing. Sediment deposits were present.

Figure 5: Stormwater outfall at the Northern District Police Station (Brooklyn, MD)

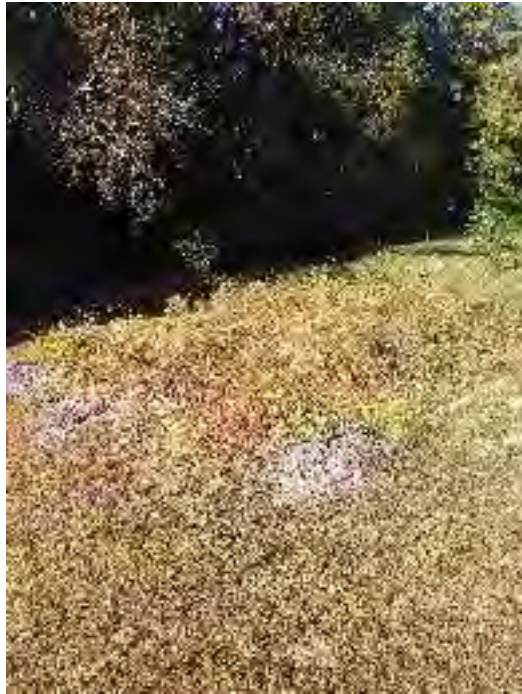
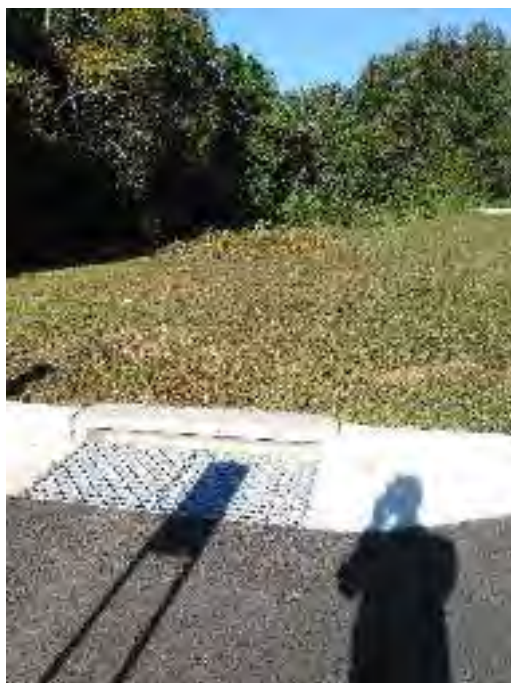
Towards the west corner of the site behind the old training building is an unidentified stormwater structure. This structure appears to accept flow from a nearby storm drain inlet and grassed swale and is potentially an infiltration practice, but the team was not able to determine its precise function. It includes a gravel subbase and is planted with vegetation (See Figures 4 and 5).

Figure 4: Unidentified stormwater structure.

Figure 5: Unidentified stormwater structure and storm drain inlet.

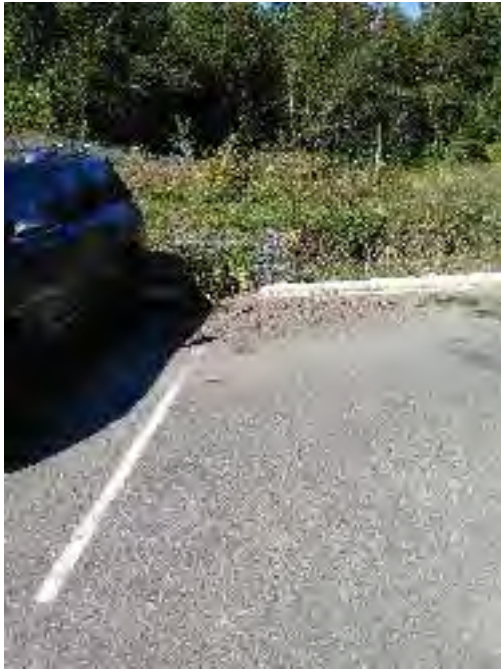
Figure 6: Ponding area just upstream of BMP ponds.

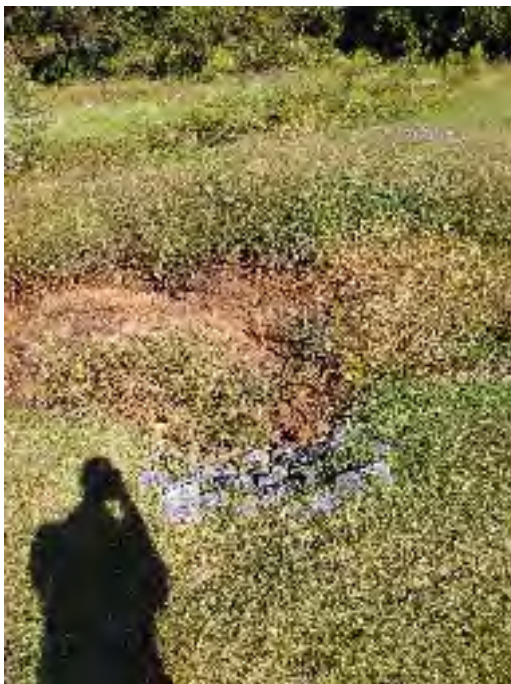
This site includes many BMPs, most of which are functioning as designed, however there are two BMPs that are not functioning correctly. These are marked with a red circle in Figure 1. The first is an outlet channel that directs parking lot runoff to the southern BMP pond (Figure 6). This outlet contains debris and sediment consistent with ponding caused by the BMP backing up into the parking lot. The second is an outfall that directs flow towards the northeastern pond. This outfall is 24" and directs flow into the BMP which then looks to clog (See Figures 7 and 8). The team talked with someone at the site and found out that the situation is being resolved through the proper channels.

Figure 7: BMP clogging just downstream of outlet.

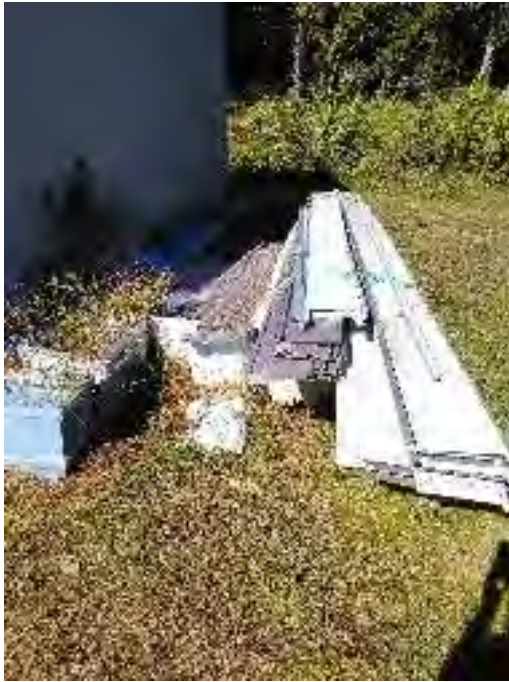
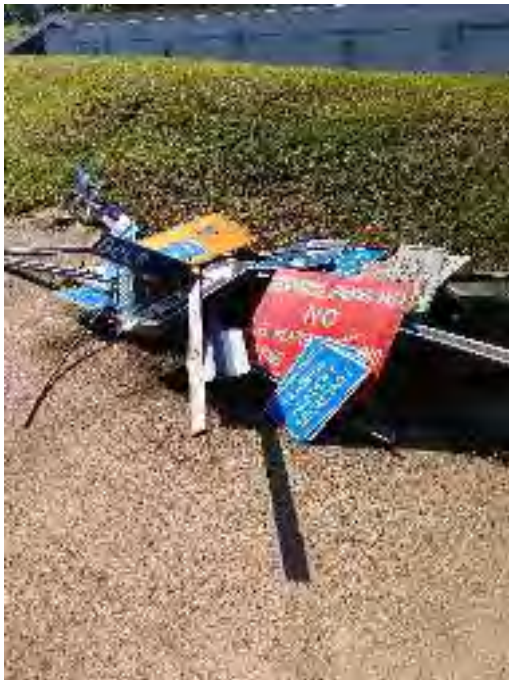
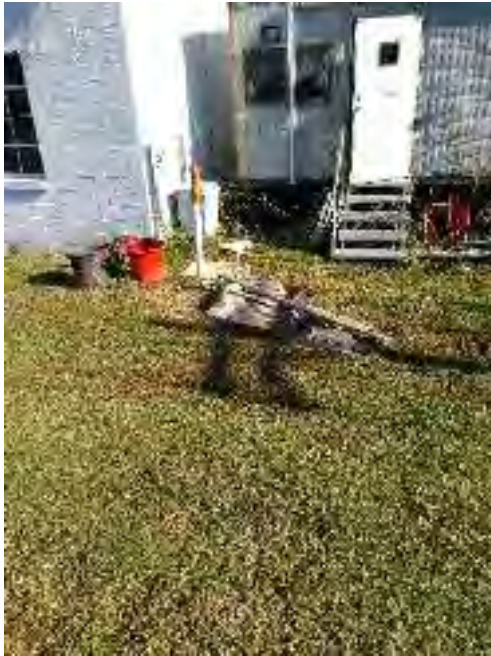
The site also has various bulk storage locations that need to be discarded or moved into secondary containment. These locations are marked with white points and are shown in Figures 10, 11, and 12.

Figure 10: Bulk solid storage (building materials)

Figure 11: Bulk solid storage (signs and posts)

Figure 12: Bulk solid storage (wood and construction debris)

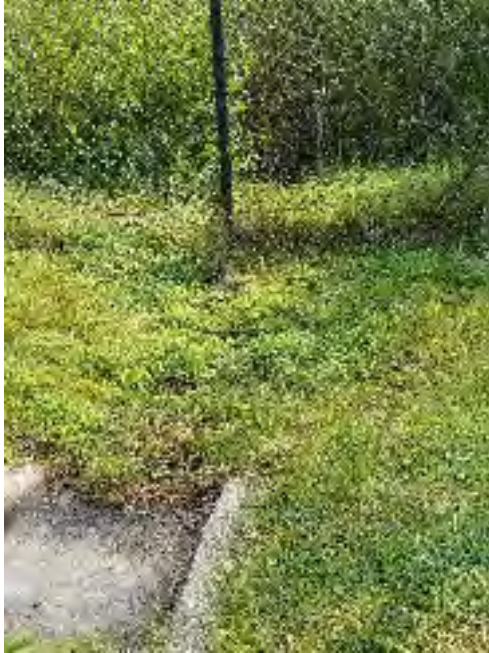
Figure 2: outlet channel to detention pond.

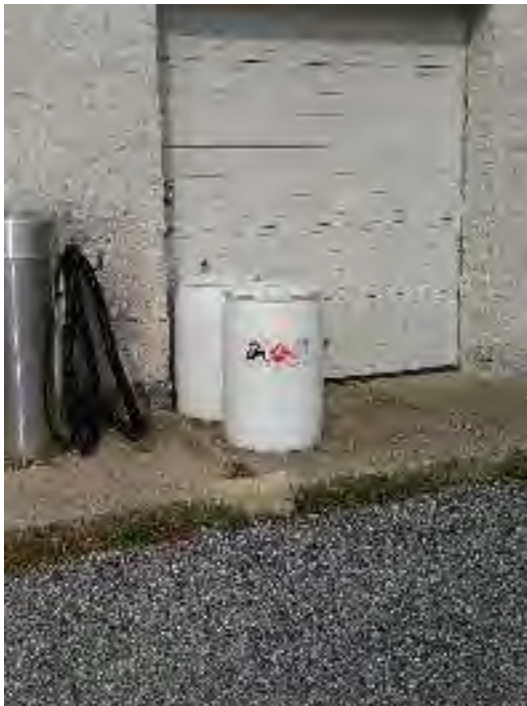
Figure 3: Illicit liquid storage of window washing fluid.

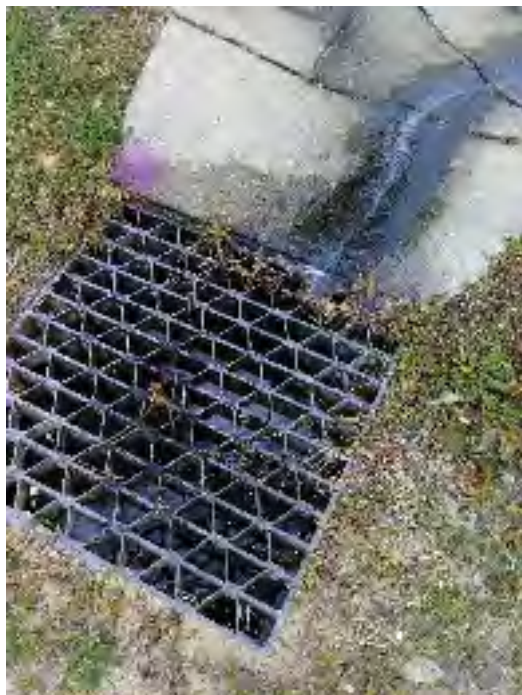
Figure 3: Stormdrain inlet accepting wash water runoff during first test.

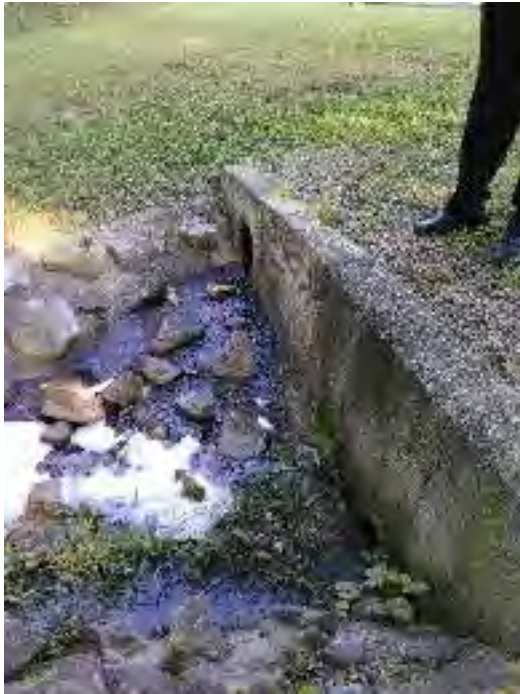
Figure 4: Outfall during first test and washing activity.

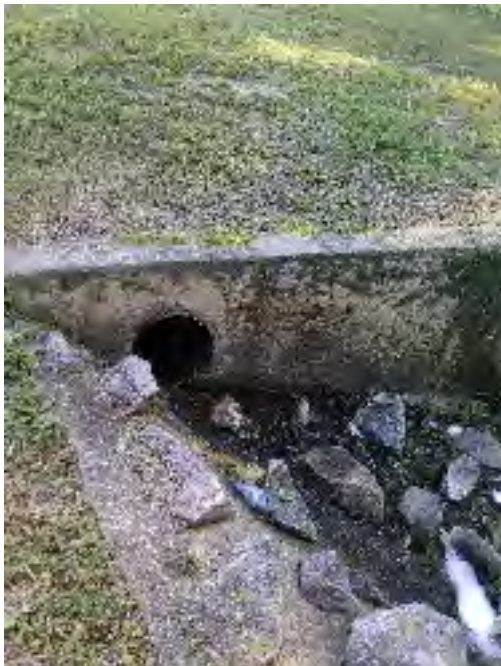
Figure 5: Outfall during first test and washing activity.

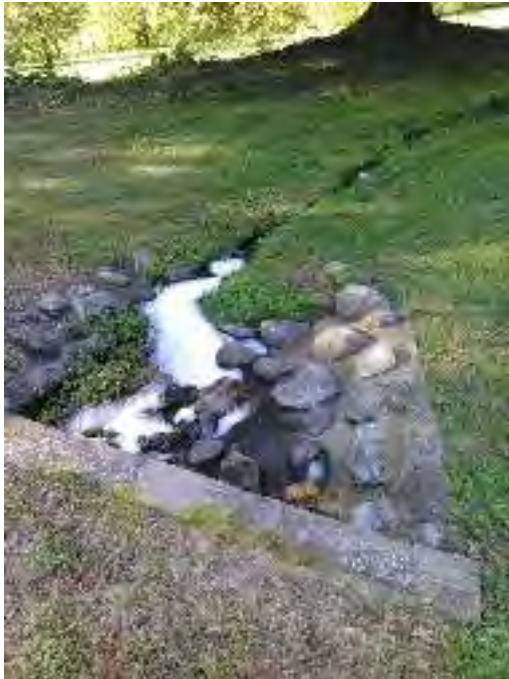
Figure 6: Outfall discharge area during first test and washing activity.

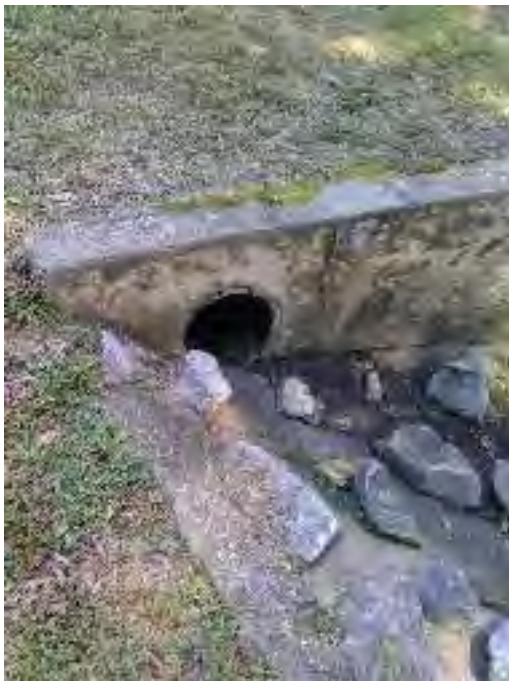
Figure 7: Outfall during second test, after washing activity and not actively flowing.
