# Fiscal Year 2021 Annual Report

Illicit Discharge Detection and Elimination

Permit Number: MD0068306

Prepared for  
Anne Arundel County

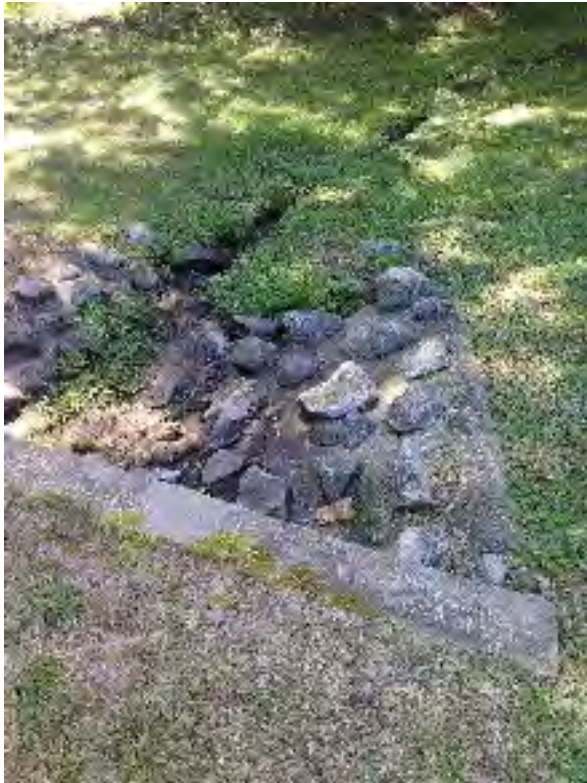
Figure 8: Outfall discharge area during second test, after washing activity and not actively flowing.

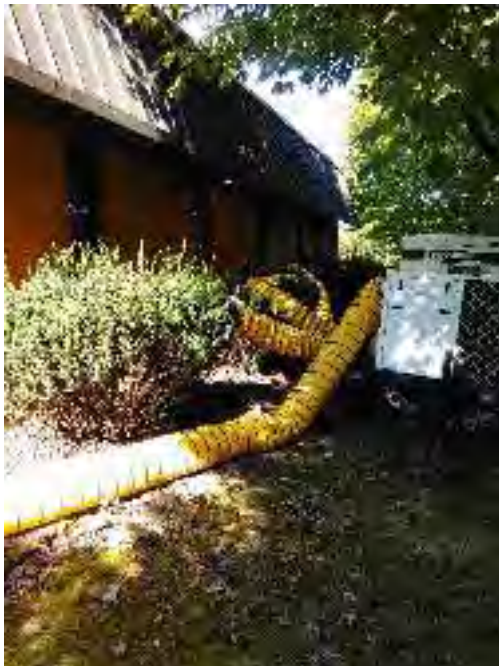
There were no immediate concerns identified on the site. On the rear pad there is evidence of potential wash water, but this could not be confirmed (Figure 2). This site also had what looks to be an air conditioning generator near the building (Figure 3).

Figure 3: Potential air conditioning generator.

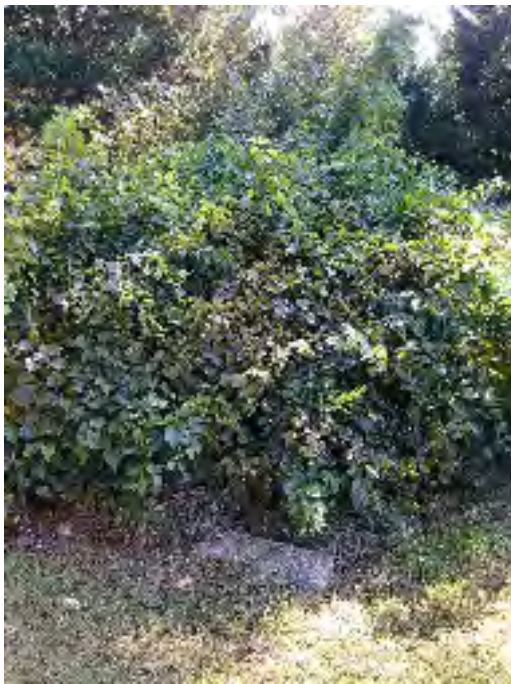
One outfall was identified on the site but was not flowing and a drainage area could not be determined (Figures 4 and 5).

Figure 5: vegetated area draining outfall.

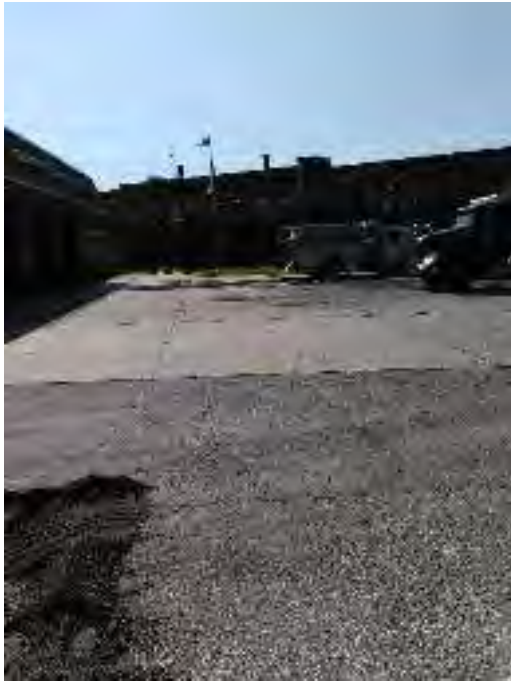
Figure 2: Front driveway pad undergoing construction.

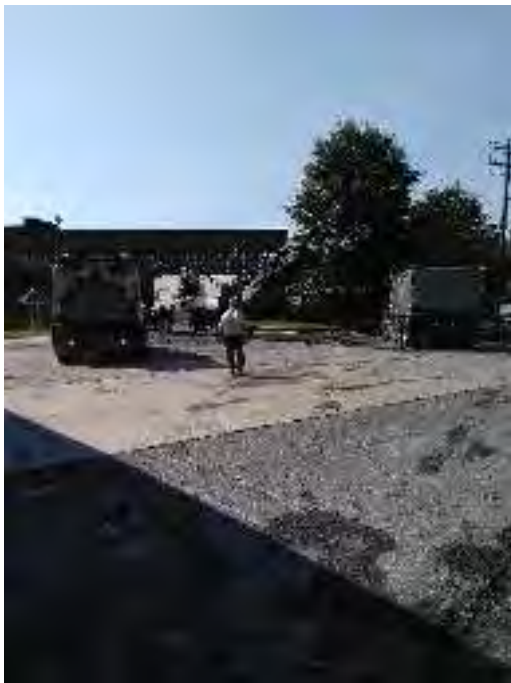
Figure 3: Front driveway pad undergoing construction.

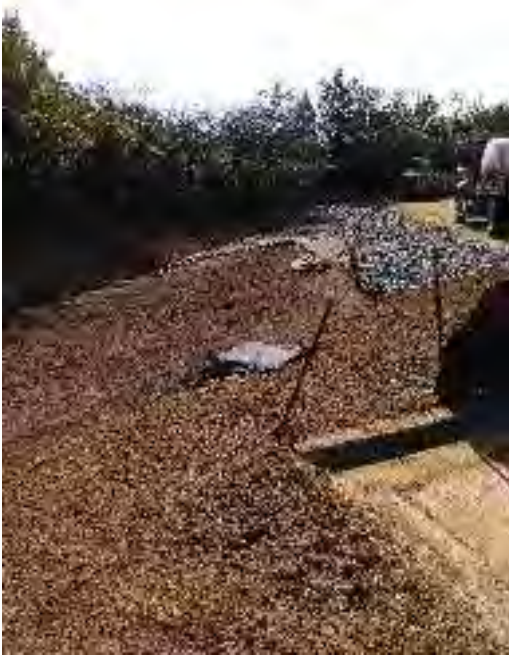
Figure 4: Fresh earthwork done in rear of property.

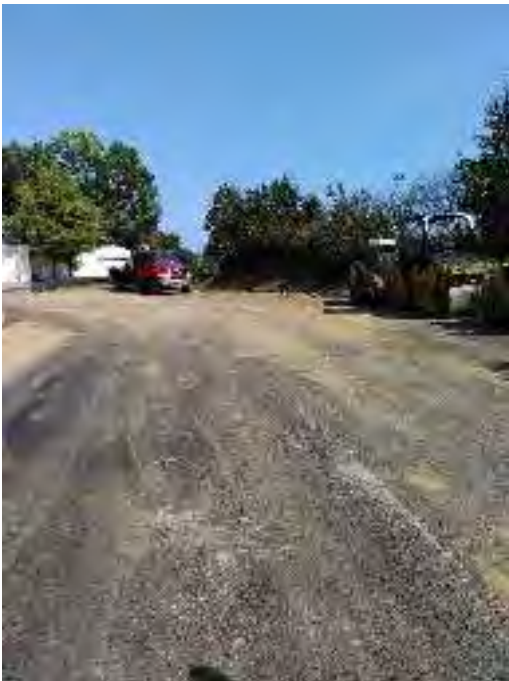
Figure 5: fresh pavement in rear of property.
