**GEOMORPHOLOGICAL CONDITION  
IN THE PICTURE SPRING BRANCH  
SUBWATERSHED, SEVERN RIVER  
WATERSHED, ANNE ARUNDEL COUNTY,  
MARYLAND: FY2021**

FINAL: June 2021

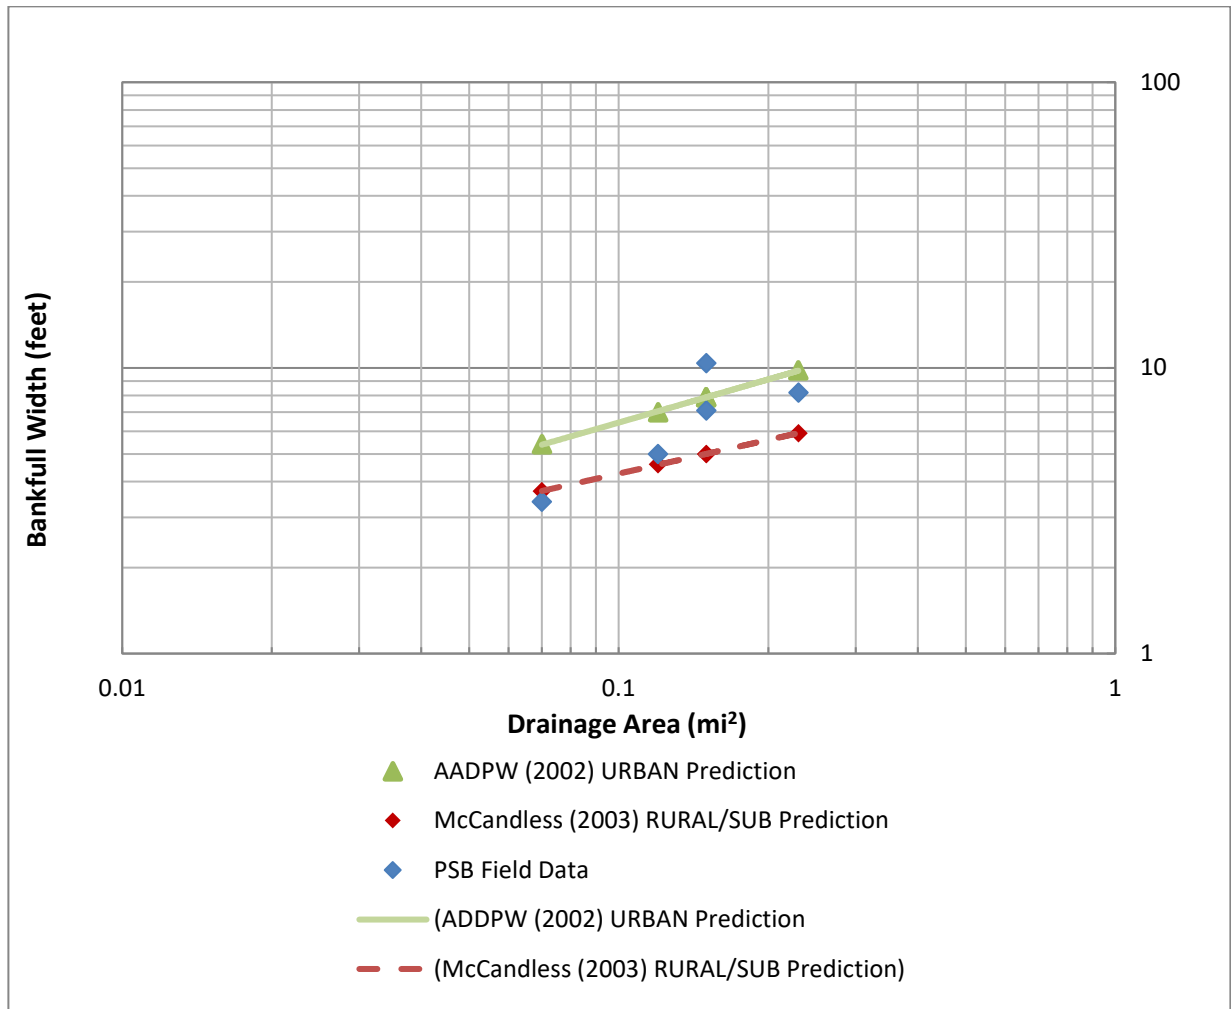
Figure 3-1. Comparison of the bankfull width drainage area relationship between Picture Spring Branch (PSB) Fall 2020 field data and regional relationship curve data

The geomorphic assessment field data were compared to both the Maryland Coastal Plain (MCP) regional relationships of bankfull channel geometry (McCandless 2003) and relationships for gauged urban Coastal Plain streams developed specifically for Anne Arundel County (AADPW 2002) to determine how bankfull characteristics observed in the field compared to those predicted by the MCP and urban relationships. Comparisons of bankfull width, bankfull cross-sectional area, and mean bankfull depth are shown in Figures 3-1, 3-2, and 3-3, respectively. In Fall 2020, bankfull width values fell between the MCP and urban curve values at three sites, with two points wider than predicted by either curve. Field data for mean bankfull depth mainly fell between the MCP curve and urban curve predictions, with one site more shallow than predicted by either curve. All bankfull cross-sectional area field data values fell between the MCP curve and urban curve predictions. Overall, most of the field data fell somewhere between the MCP and urban relationships. However, the regional curves were developed using streams with drainage areas ranging from 0.3 to 89.7 square miles, with the majority of data collected in watersheds greater than one square-mile with low (zero to three percent) imperviousness. Thus, it is possible that stream channels with smaller drainage areas and more imperviousness, such as those studied in this assessment (ranging from 0.07 to 0.23 square miles), exhibit greater variability in channel dimensions when compared to the MCP relationships. Additionally, the Rosgen method is best used on streams that are free to adjust their lateral boundaries under the current discharge regime experienced by the system (Rosgen 1996), conditions which do not necessarily exist in the study area. For example, cross-sections 2, 3, and 5 are underlain by concrete trapezoidal channels, possibly making the accurate determination of the bankfull indicators in the field at these locations problematic. Regardless, given the high imperviousness of the study drainage area (35%) and the modified nature of the channel, it is not surprising that the field data deviated in some cases from the MCP curve and were more closely matched to urban curve predictions for bankfull width.

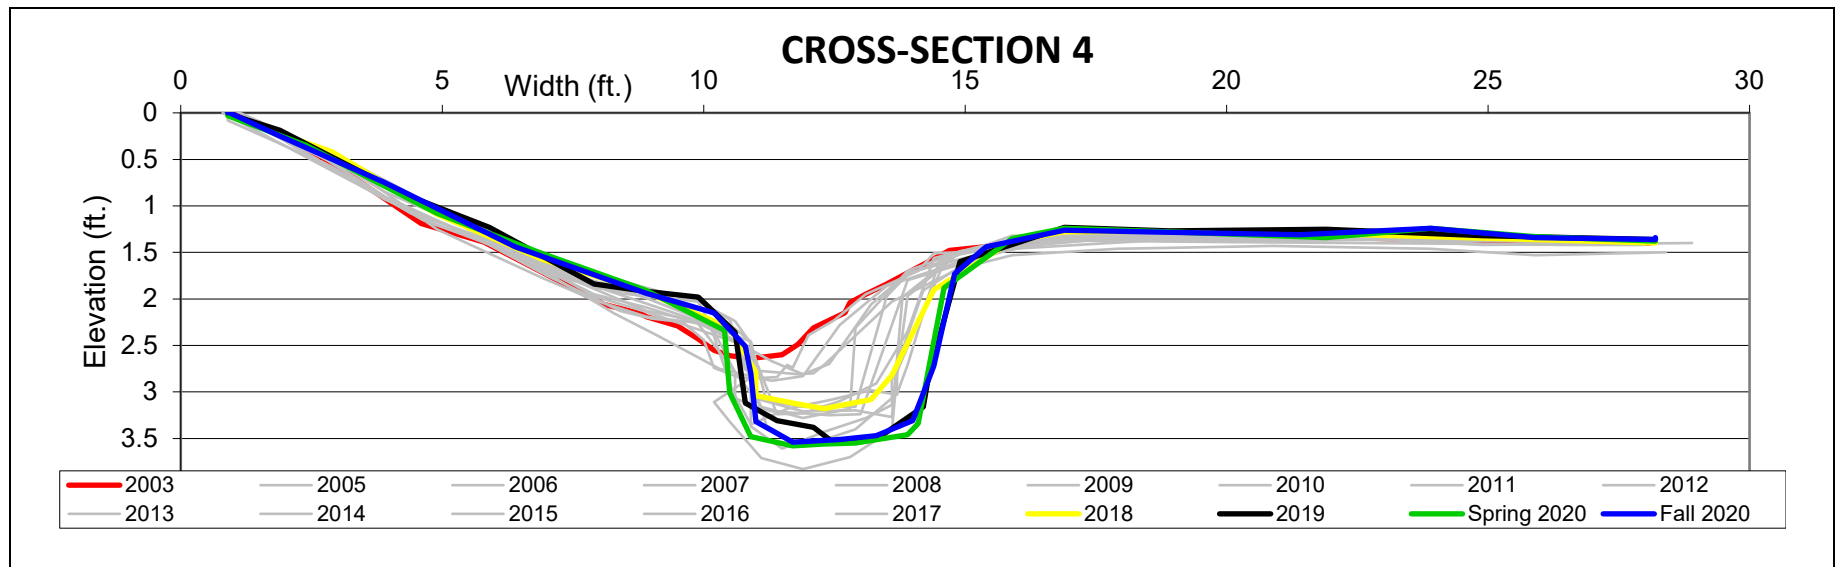
Bankfull Width ( $W_{bkf}$ ) (feet)	7.1
Mean Depth ( $d_{bkf}$ ) (feet)	0.5
Bankfull Cross-sectional Area ( $A_{bkf}$ ) (feet <sup>2</sup> )	3.5
Width/Depth Ratio ( $W_{bkf}/d_{bkf}$ )	14.4
Width of Flood-prone Area ( $W_{fpa}$ ) (feet)	13.2
Entrenchment Ratio (ER) = $W_{fpa}/W_{bkf}$	1.5
Channel Materials $D_{50}$ (millimeters)	0.091
Water Surface Slope (S)	0.0054
Sinuosity (K) = stream length/valley length	<1.2
Adjustments?	Sin ↑, ER ↓
<b>STREAM TYPE</b>	<b>F5</b>
