**ANNE ARUNDEL COUNTY
ILLICIT DISCHARGE DETECTION
AND ELIMINATION
2015 ANNUAL REPORT**

PERMIT NUMBER MD0068306

January 12, 2016

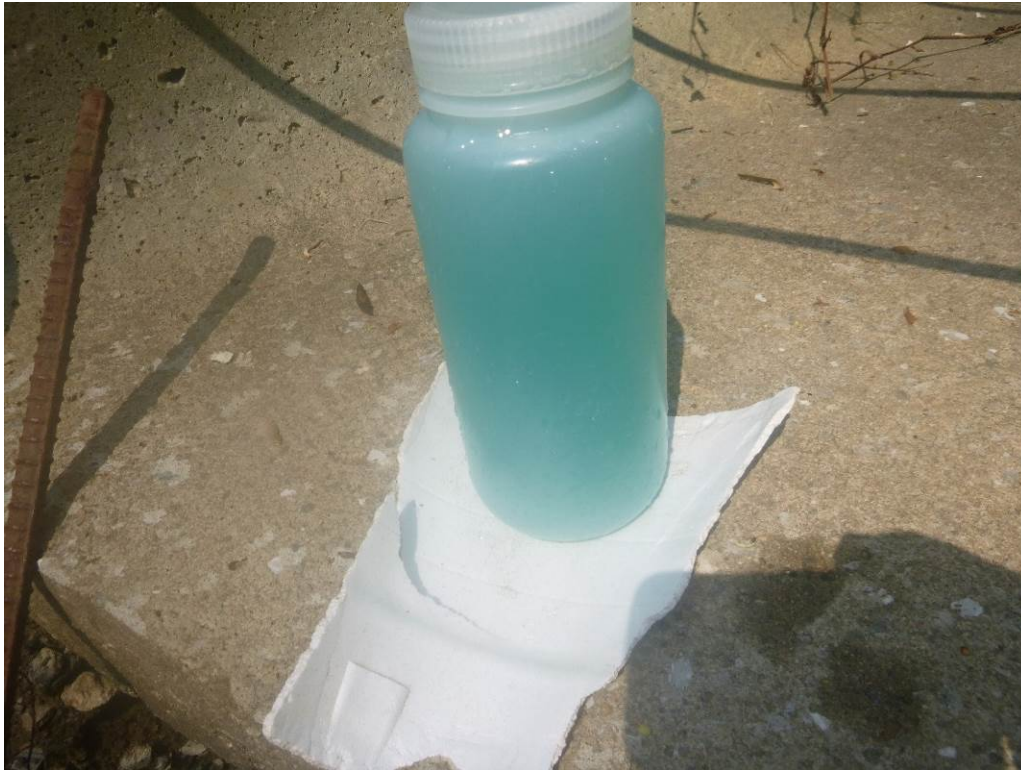
Figure 3. Outfall water sample showing color

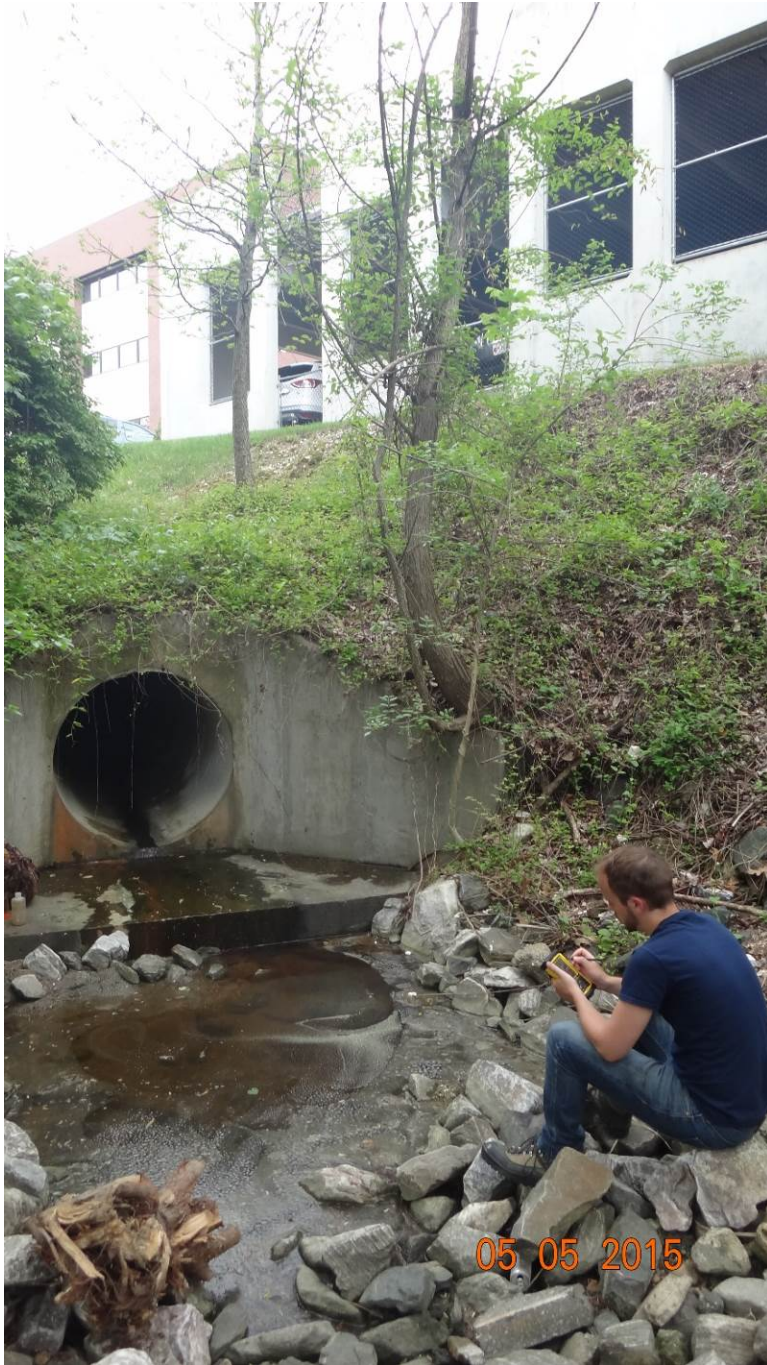
Versar inspected the above outfalls on May 5, 2015 at 3:11 p.m. The screening results for I04E4O006 (Figure 1) included an above-action level result for detergents (0.5 mg/l; Table 1). The inspectors also screened outfall I04F3O014 (Figure 2), which was a part of the drainage to outfall I04E4O006. Outfall I04F3O014 failed the screening test for detergents (1 mg/l; Table 2) and the team suspected that the discharge from this outfall was a possible source of the detergent concentration at outfall I04E4O006.

Figure 1. Outfall I04E4O006

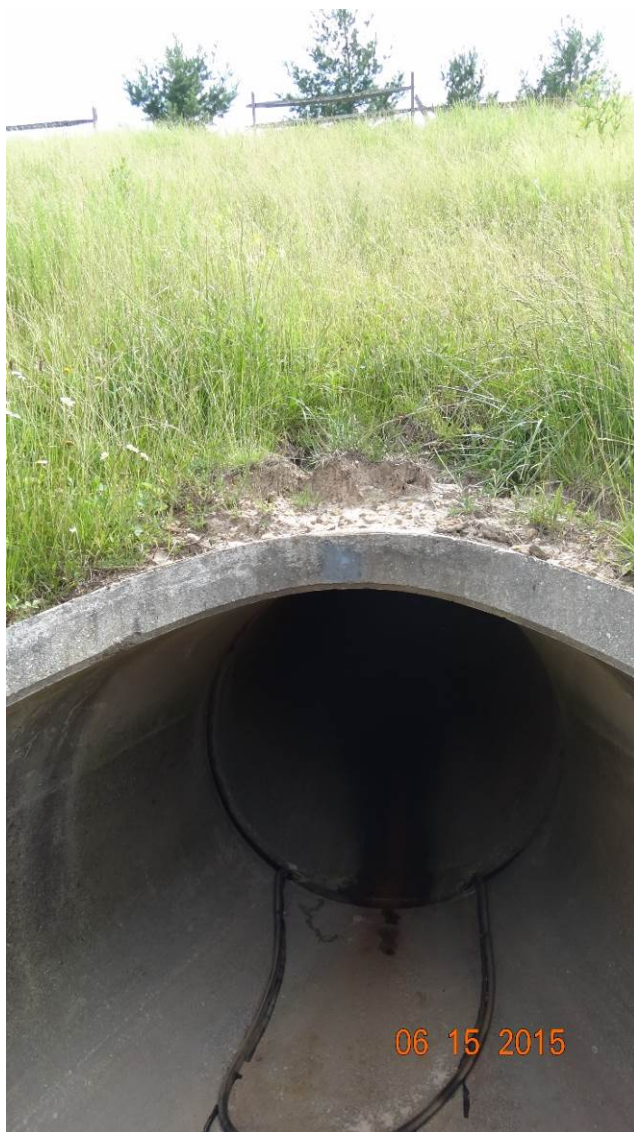
On the basis of identifying two potential illicit discharges in the same storm sewer catchment, onsite field staff performed a trackdown during the second visit even though the indicator pollutants at outfall G06G3O001 were within the acceptable range. Field staff implemented trackdown procedures on June 15 and June 16 to identify the source. Staff tracked the flow to a junction manhole upslope of the SWM. The western branch (originating from Dorsey Road) could not be sampled from the manhole due to extreme depth; staff tested flow at an upstream manhole instead and found a detergent concentration of 0.1 mg/l. Along the southern branch, the flow from the parking lot of 7001 Dorsey tested at 0.5 mg/l for detergents. Farther up-network, at the only flowing and sampleable conduit, the detergent concentration was 0.3 mg/l. Staff noted that within a gated area behind 7001, absorbent berms had been placed around a yard inlet (Figure 2). All other conduits contributing to the outfall were dry or had very low and unsampleable flow. Staff communicated their findings to the pollution hotline on June 16, 2015. An area map is provided in Figure 3.

Figure 1. Outfall G06G3O004, June 15, 2015

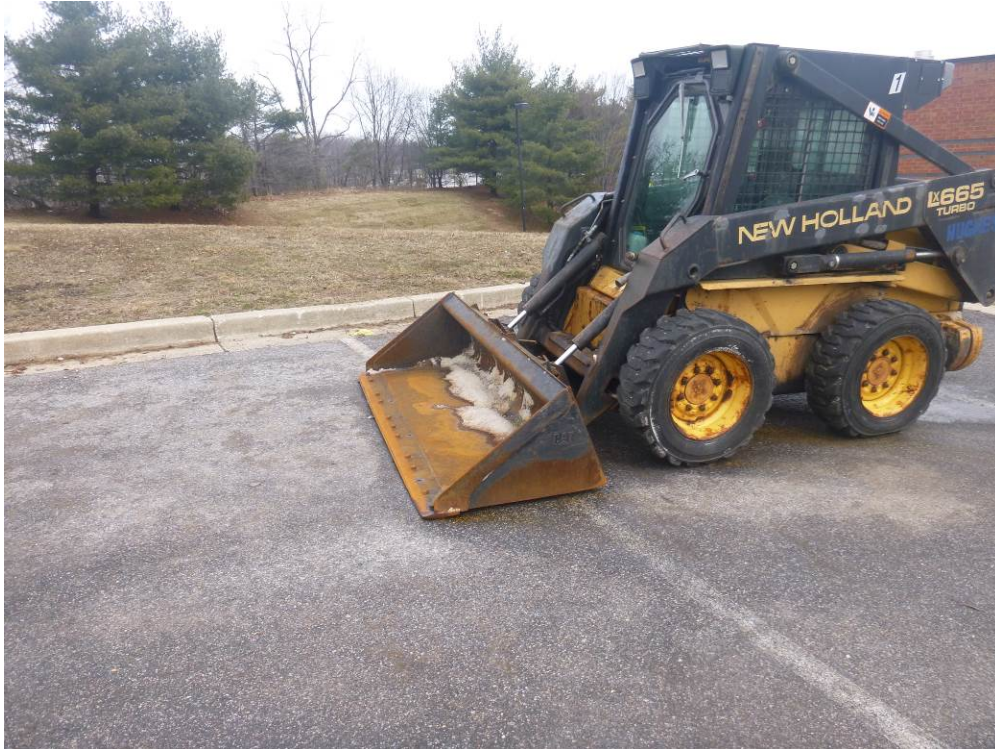
Figure 2. Skid steer loader found with de-icing salt in the bucket

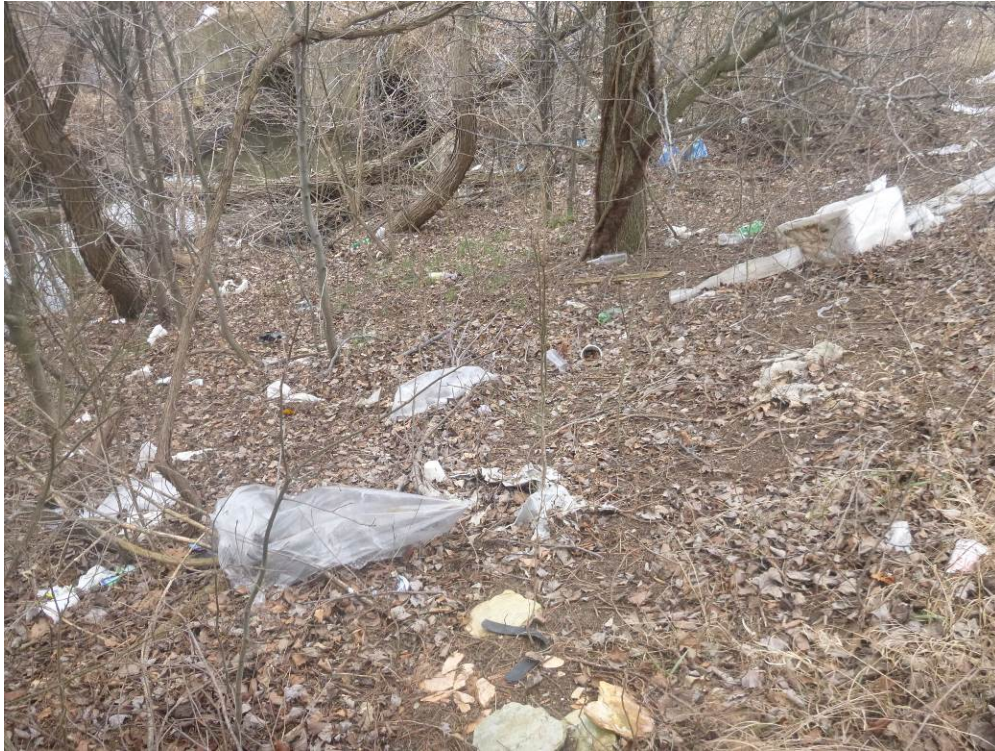
Figure 2. Larger items documented among the debris
