**ILLICIT DISCHARGE DETECTION
AND ELIMINATION
2014 ANNUAL REPORT**

PERMIT NUMBER MD0068306

Versar, Inc.
9200 Rumsey Road
Columbia, MD 21045

October 2014

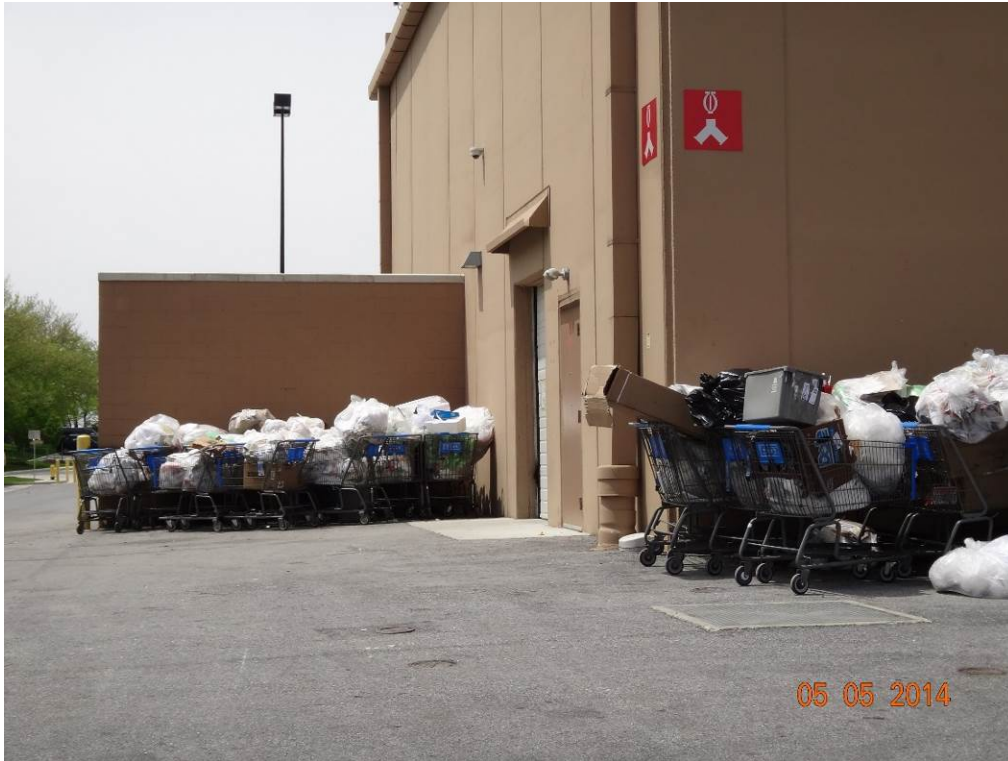
Figure 2. Two rows of shopping carts containing trash
