# Fiscal Year 2021 Annual Report

Illicit Discharge Detection and Elimination

Permit Number: MD0068306

Prepared for  
Anne Arundel County

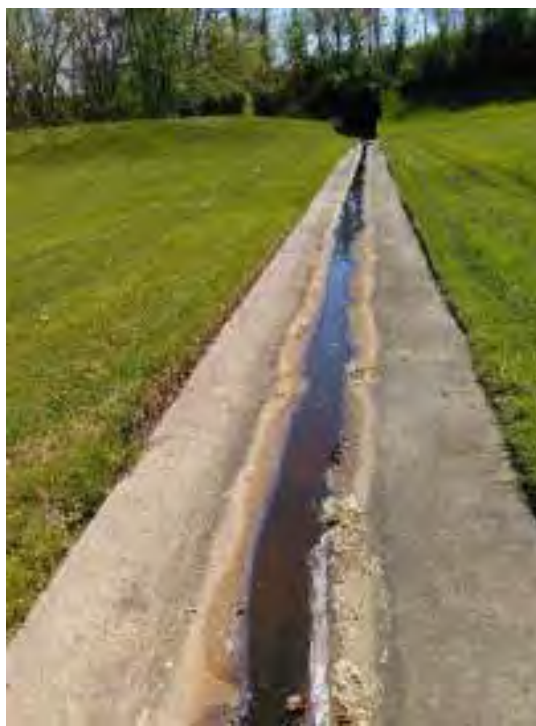
**Figure 2:** Area downstream of Outfall Ko2O016 on 4/20/21.

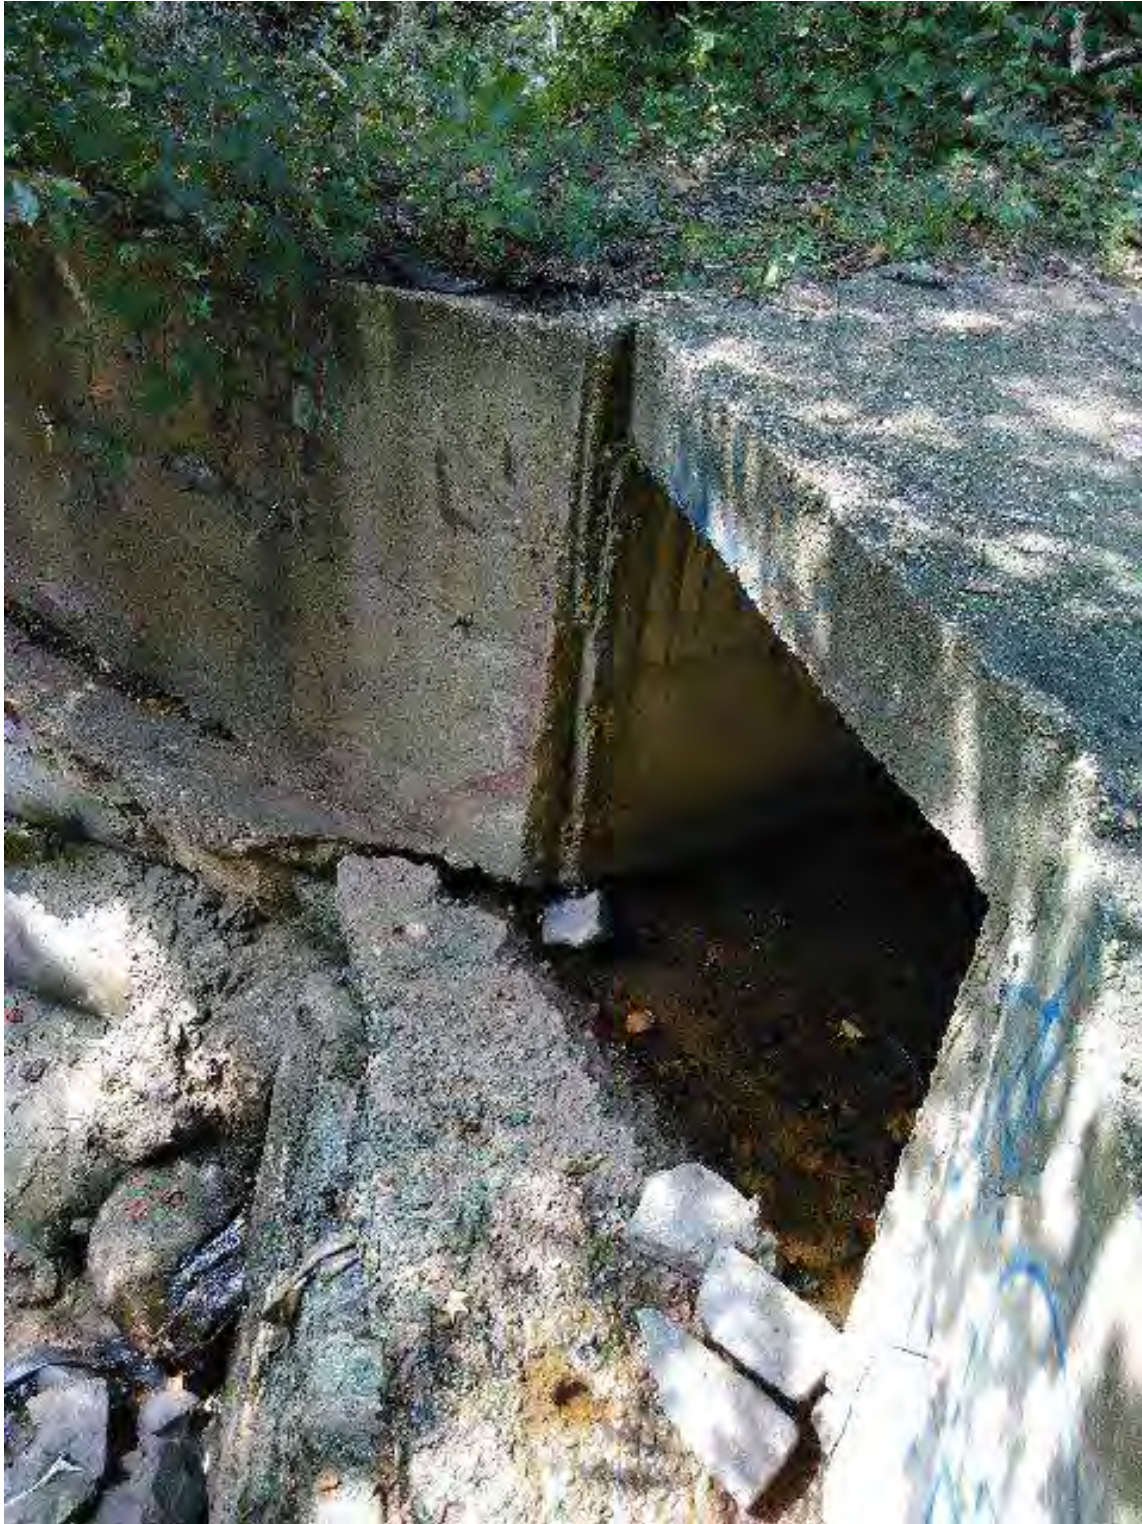
Outfall Mo8Oo24 is located in the North Arundel Health And Rehabilitation Center property near the southwest corner of the building. This outfall is experiencing cracking and spalling and is resulting in significant downstream erosion (Figure 2). The outfall looks to be at the same elevation as the land upstream towards the building, but the downstream area is much lower in elevation, and the flow falls a significant distance before continuing downstream (Figure 3). This area was not accessible for a more detailed photograph. Rip rap is present in the discharge area, but previous erosion looks to have already affected this outfall.

**Figure 2:** Outfall Mo8Oo24

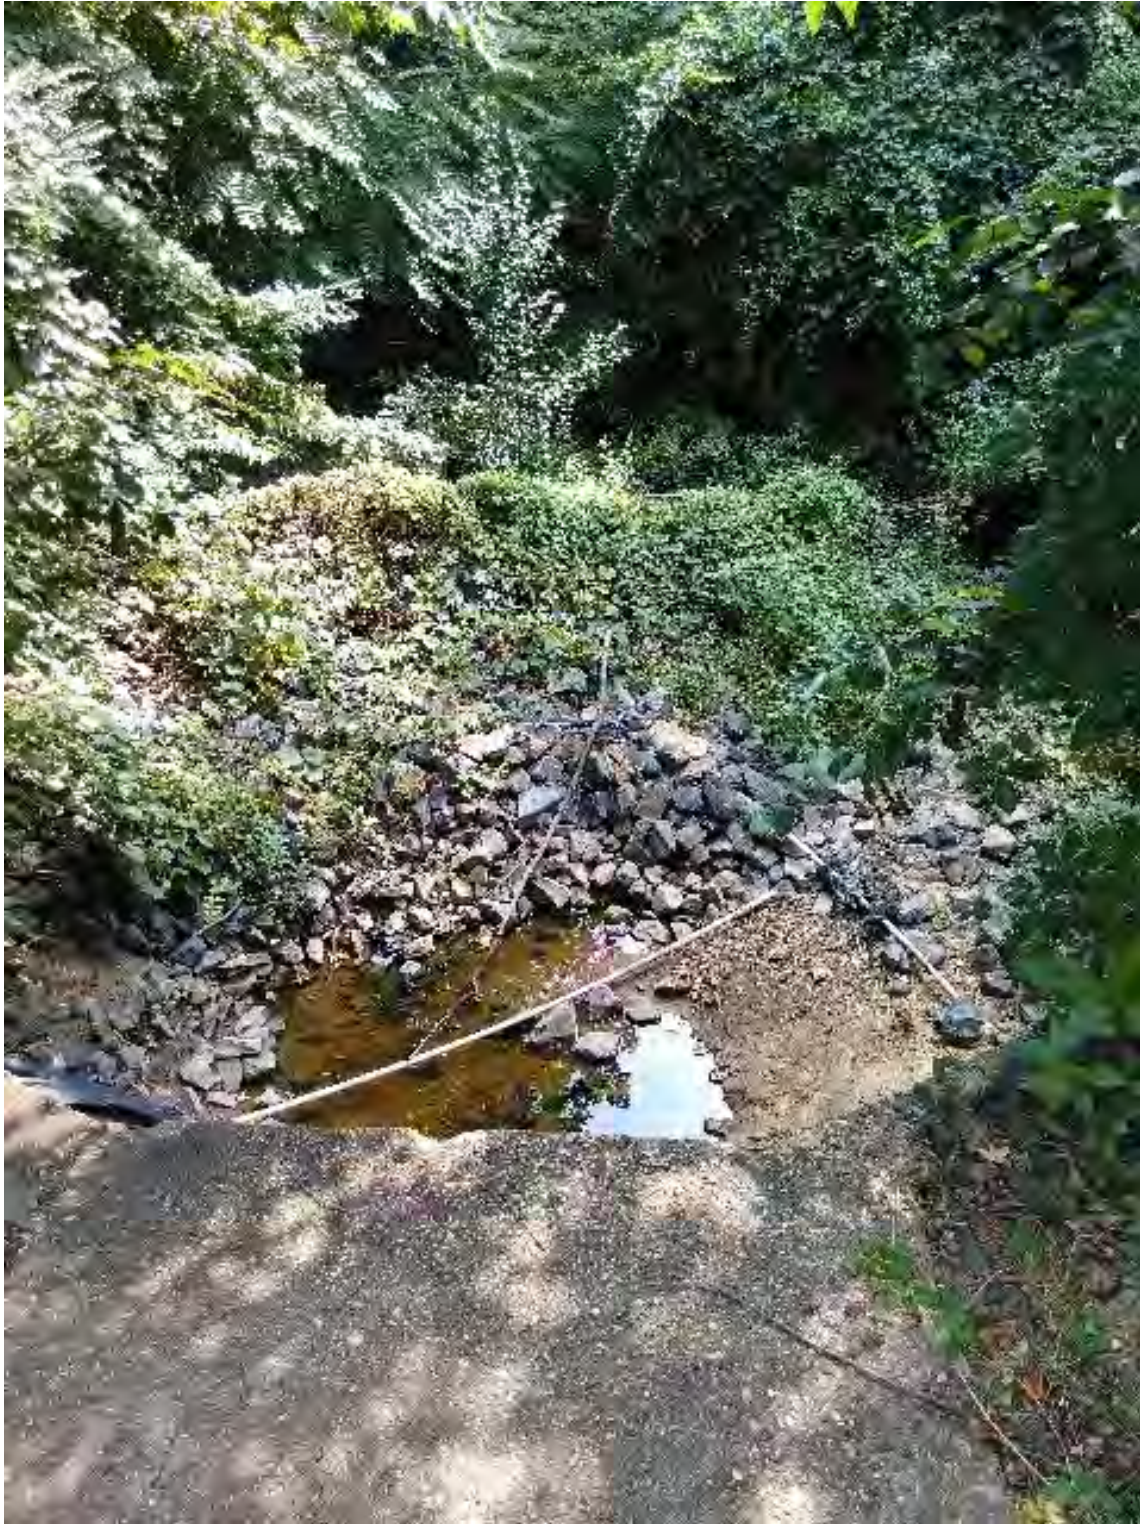
**Figure 3:** Downstream area of Mo8Oo24

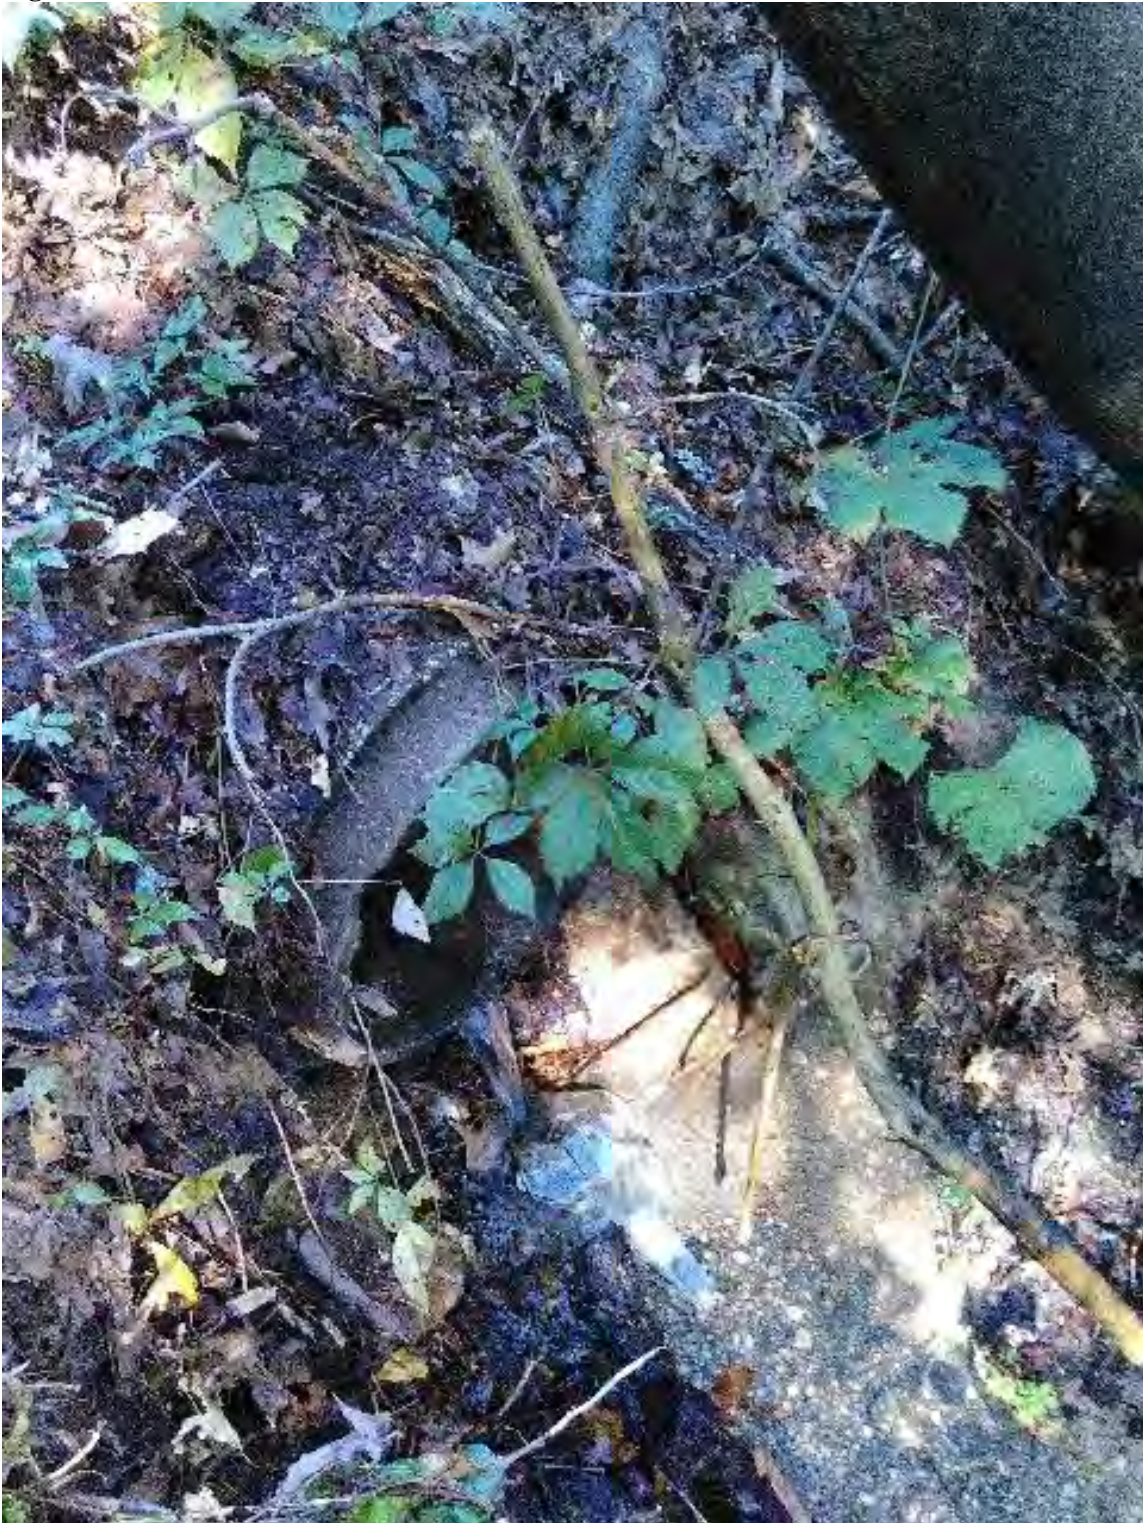
Outfall M09O060 is located within 'The Forest Apartments' complex (Figure 1). The outfall structure is currently stable but its overall condition has been previously degraded (Figure 2). There is evidence of collapsed pipe and severe downstream erosion (3-6 ft) is present (Figure 3).

Figure 2: Outfall M09O060

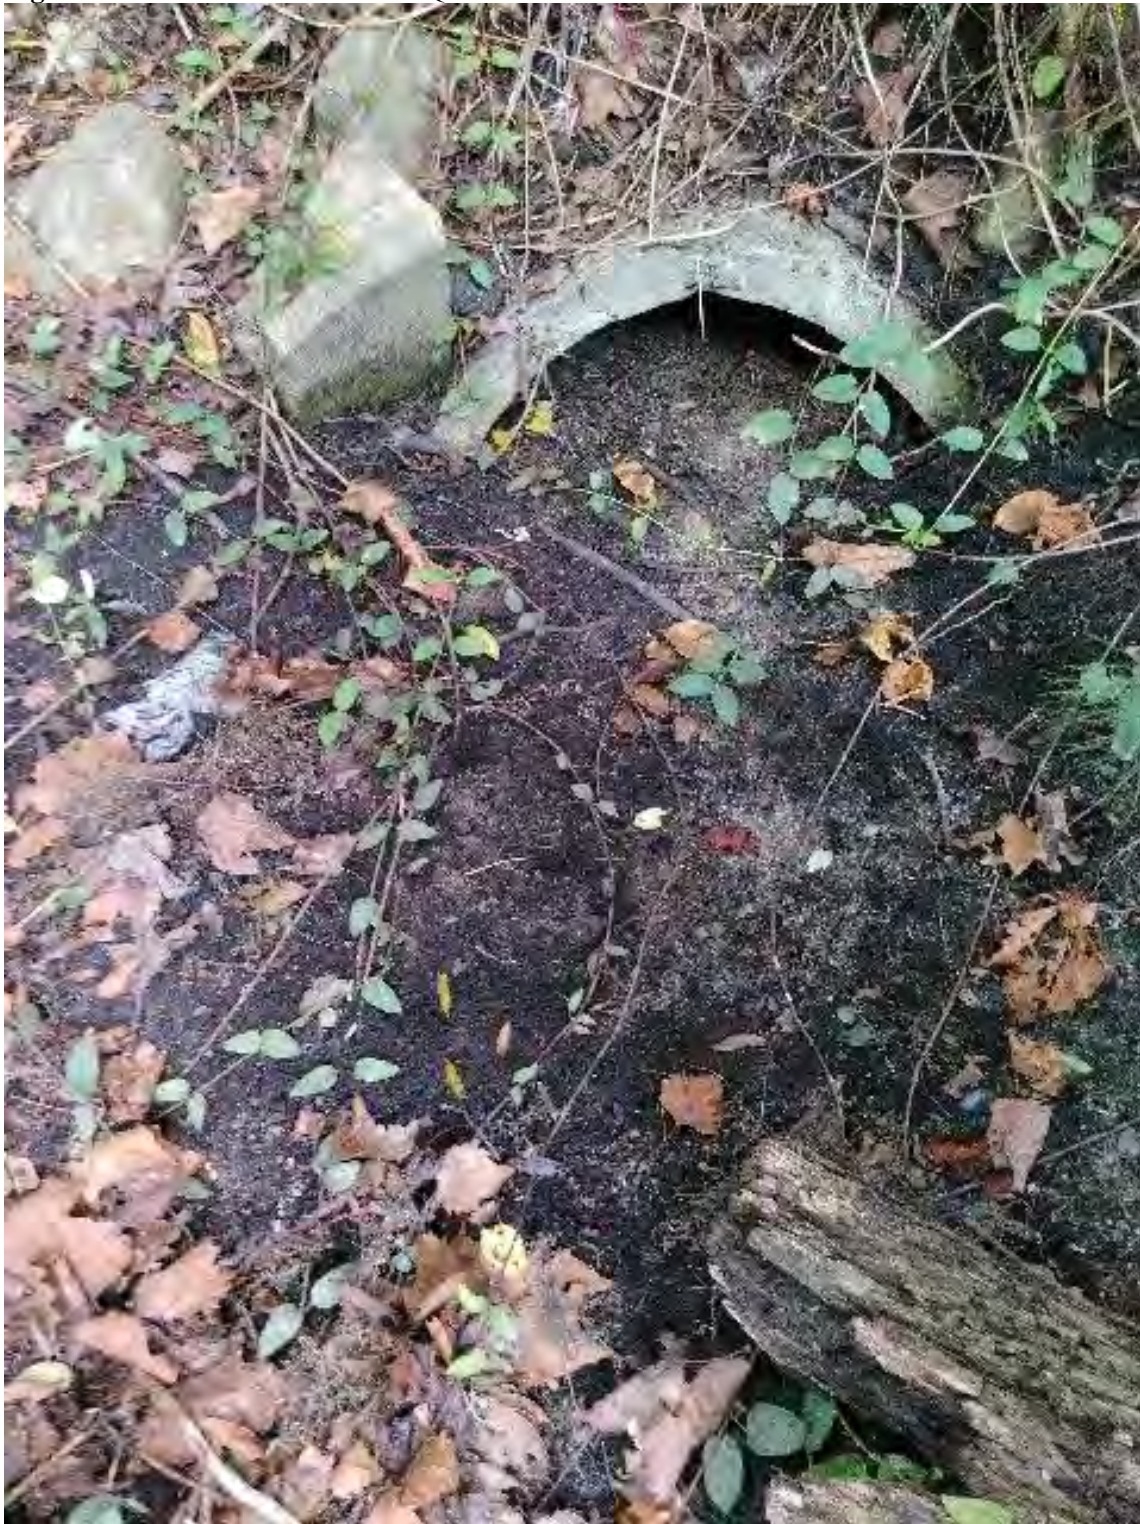
**Figure 2:** Sedimentation of Outfall Q050007

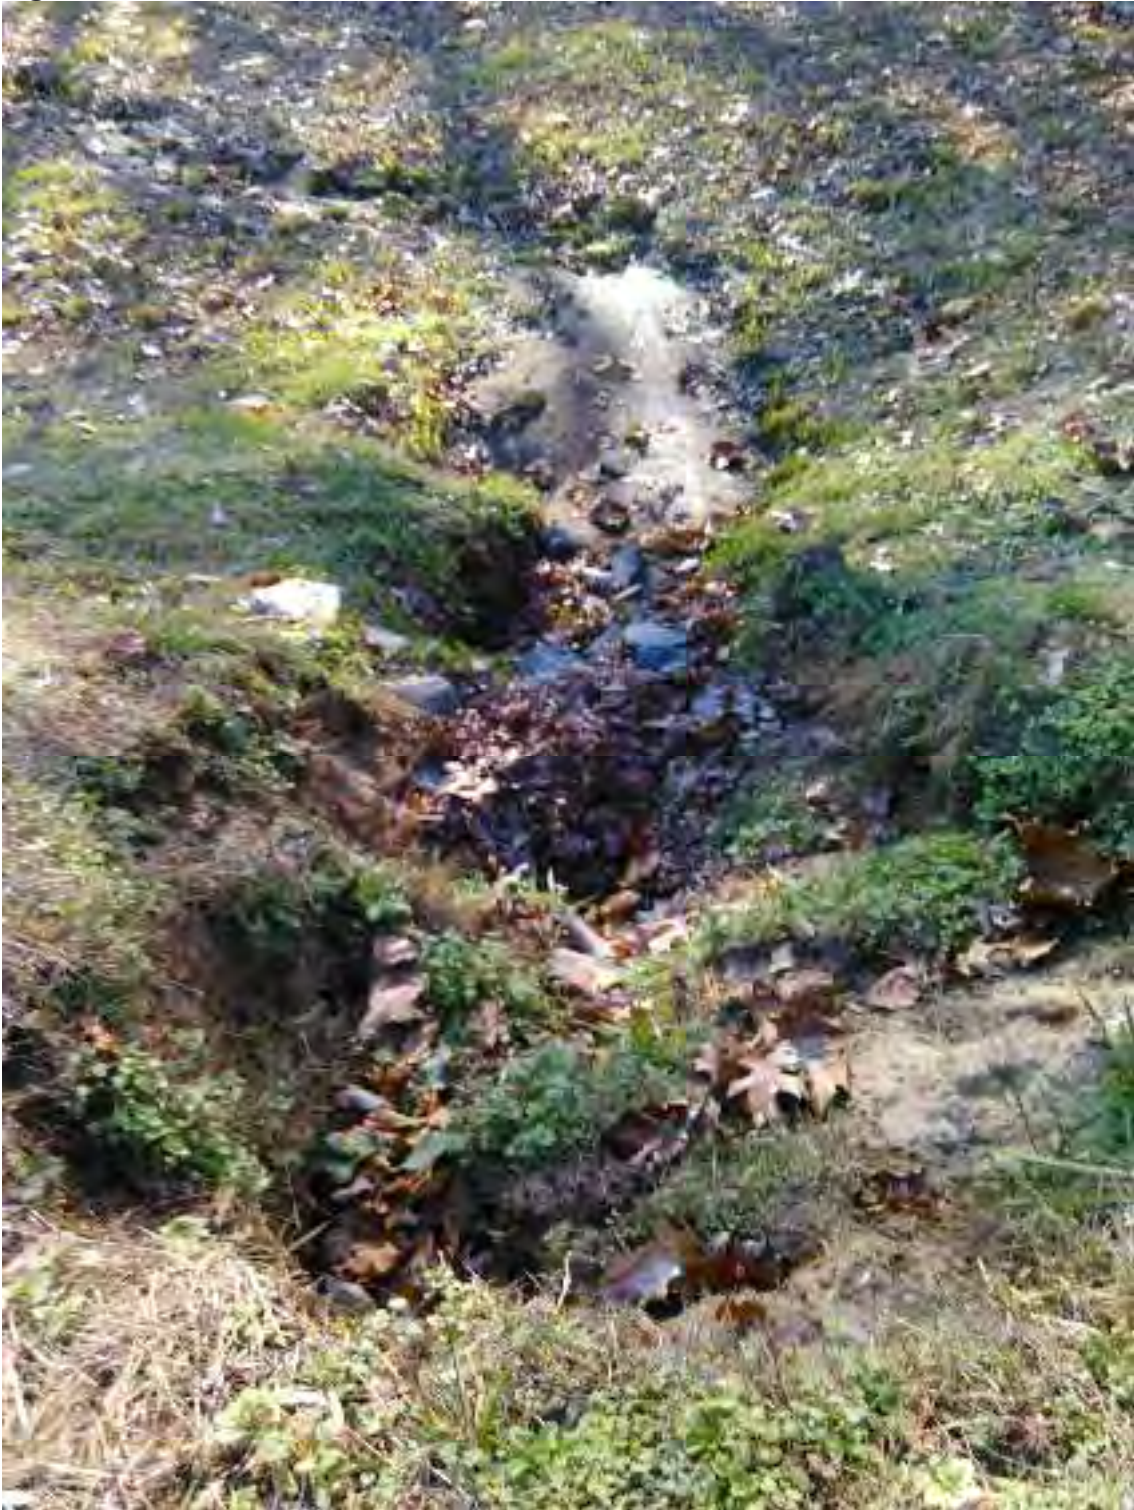
**Figure 3:** Erosion downstream of Outfall T150001

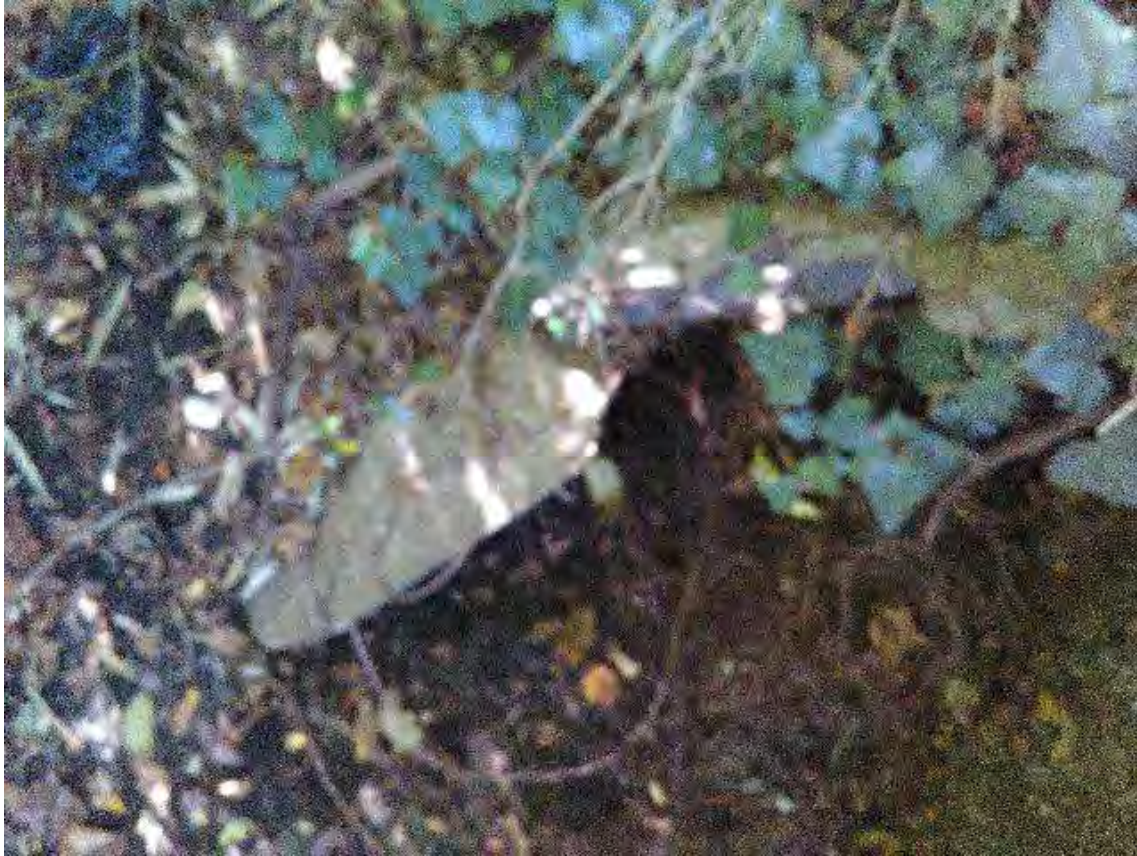
**Figure 3:** Additional photo of U16Oo14.

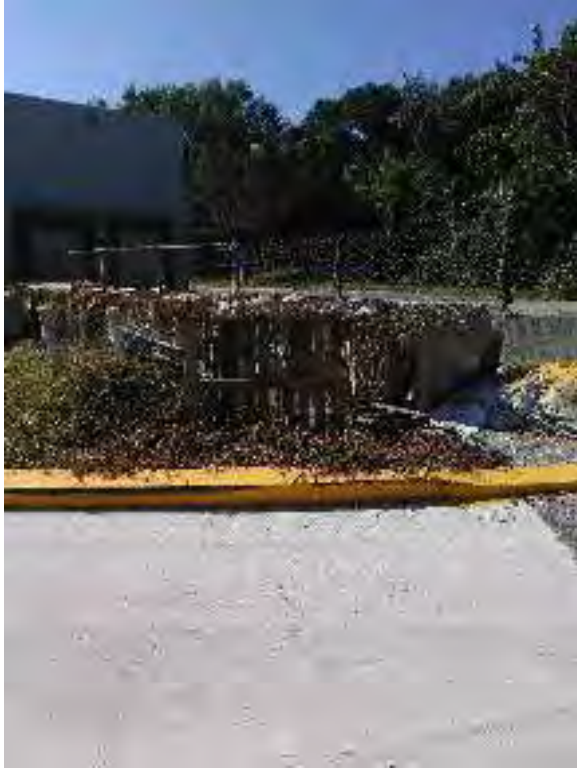
**Figure 2:** Bulk cardboard storage.

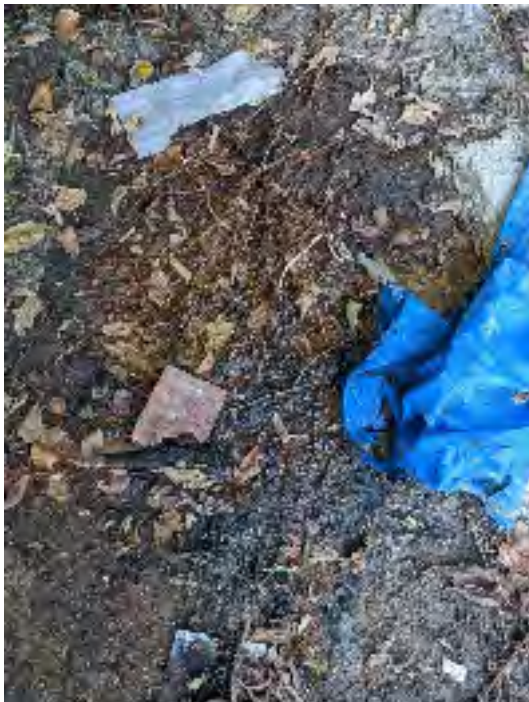
**Figure 3:** Additional buckets of Color release, right hand side of the site

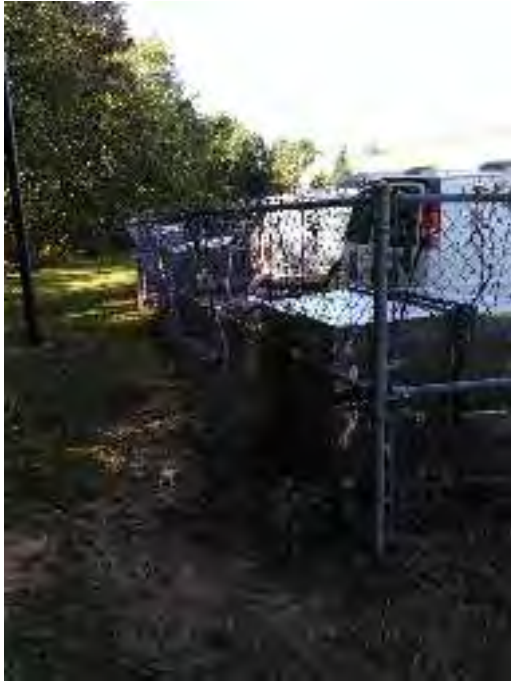
**Figure 2:** Animal cage storage

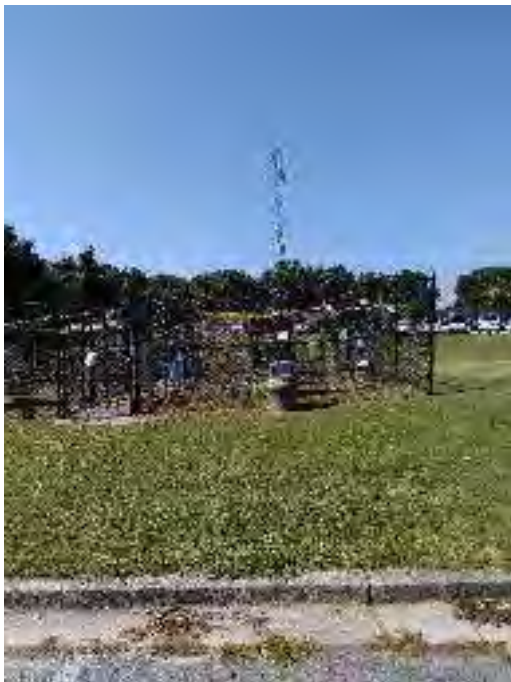
**Figure 3:** animal recreation area and waste disposal

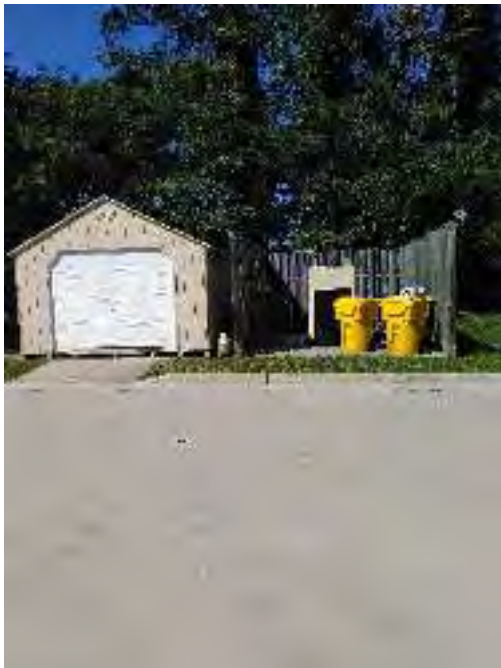
All inlets on the site are in good condition, the dumpster area is clean with no debris (Figure 5), and no other issues were found on the site.

**Figure 5:** Dumpster area

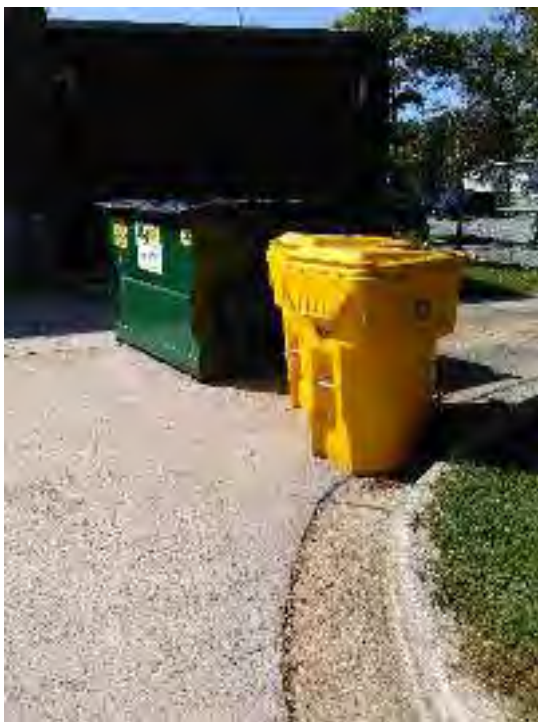
The field teams also noted a dumpster and recycling bin behind the facility, but both were found in good condition with no signs of staining or leakage (Figure 1, green circle). No items of concern observed during the site visit.

**Figure 5:** Dumpster and recycling area in the rear of the facility.

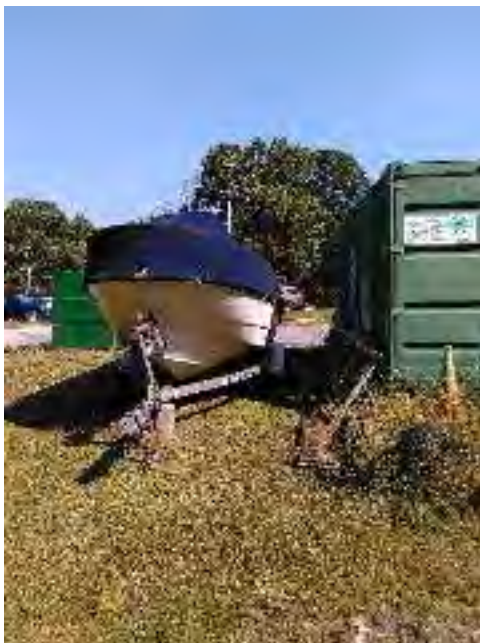
**Figure 5:** Boat storage on Fire Co. 7 property.

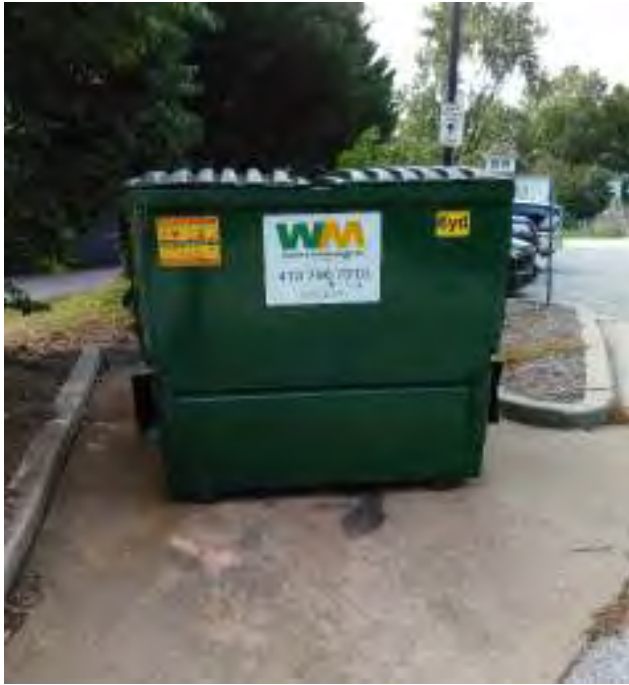
Dumpsters and recycling bins are present behind the station. At the time of the site visit, there was no evidence of the dumpsters or bins leaking and/or waste being improperly disposed of outside the designated containers (Figure 2, Figure 3).

**Figure 2:** Dumpster area behind Brooklyn Fire Co. 31

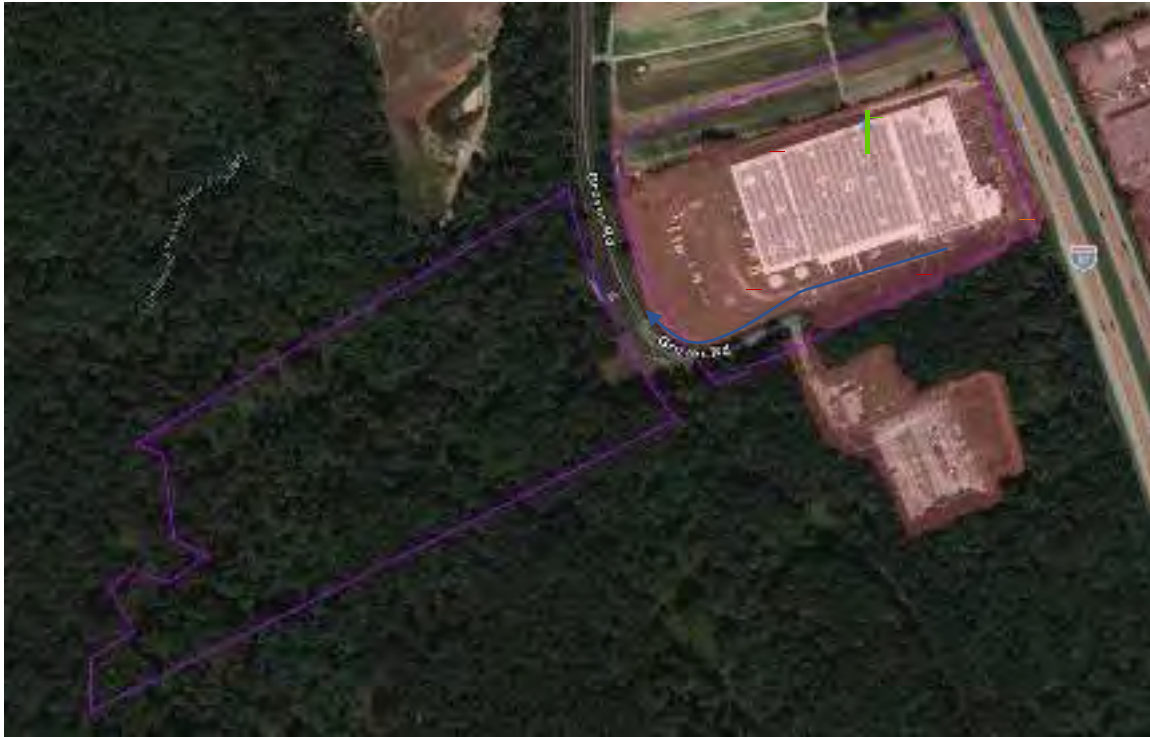
There are multiple bulk solid and/or liquid storage locations on this site that should be addressed. These materials need either to be covered, or moved to a covered location.

**Figure 1:** Aerial map of the County Warehouse

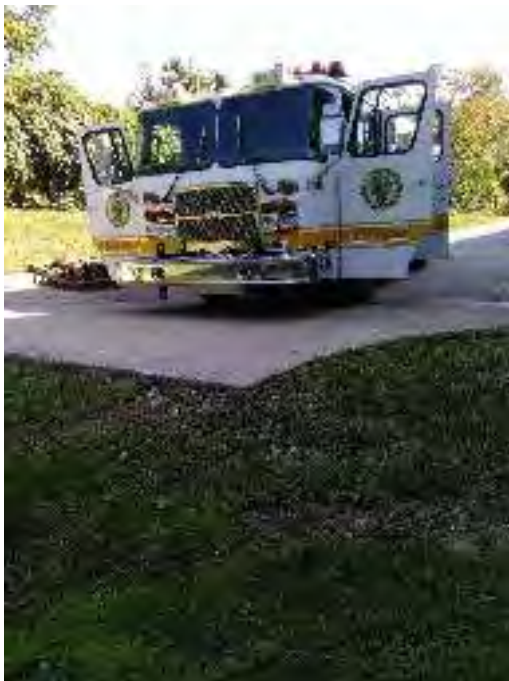
The only outfall located on this site is north of the building and is presumably a roof drain that outlets into the BMP in this location. This BMP is a long, vegetated strip likely a bioretention cell that is assumed to capture roof runoff as well as drainage from the driveway/parking area that runs along the north of the property (Figure 4). This driveway looks to be a washing location for fire engines and drains to the BMP via a storm drain inlet (Figure 5).

Figure 5: Potential washdown activity location.

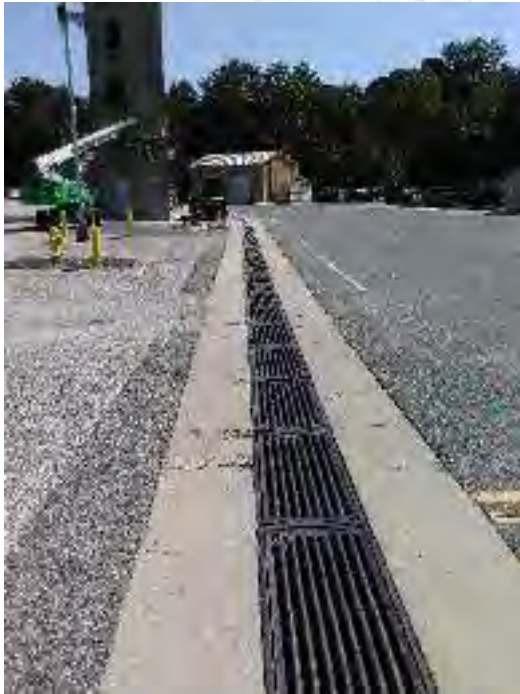
A long trench drain captures flow throughout the site and flows east, likely discharging to receiving waters adjacent to the site. This needs further investigation and confirmation, as the team could not access the nearest outfall and verify the ultimate destination of the runoff. Runoff captured in this drain could contain anything present on the site including partially burnt material (wood, straw), soot, gasoline, oils, washer fluid, firefighting foam, deicing salts, and washwater. See Figure 1 and Figure 2 below.

Figure 2: Trench Drain

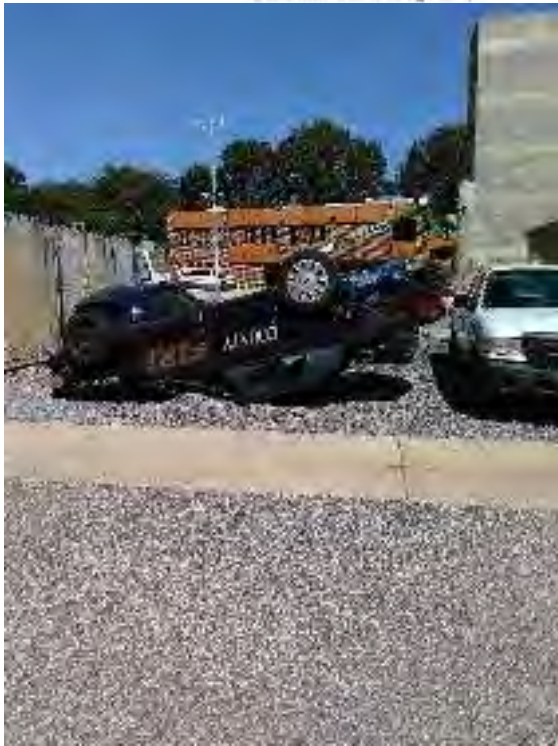
An area of the site appeared to be used for car crash training, involving damaged cars and a “burncar,” all of which could leak pollutants into the pervious gravel below, potentially reaching the groundwater (See Figure 5 and Figure 6).

Figure 6: Flipped car.

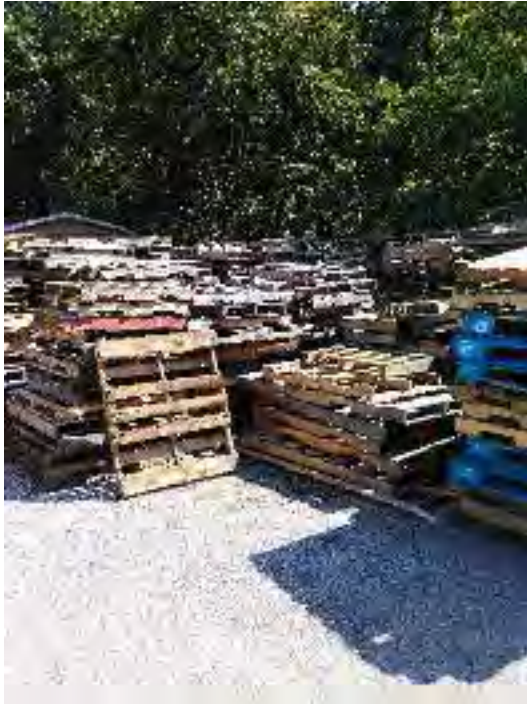
Figure 8: Pallet storage

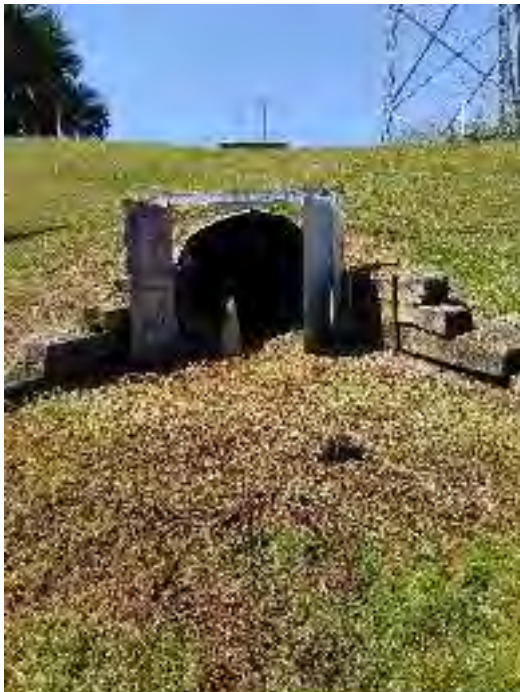
One potential outfall was not investigated due to an apparent lack of any flow or discernable drainage area. This outfall was a large diameter corrugated metal pipe with doors and a safety cone located in front of it (See Figure 10). The upland area was investigated but neither catch basins nor an area readily being drained were found. This outfall was therefore determined to be a training outfall, not a functional drainage feature, and was not investigated further.

Figure 11: Potential confined space training outfall.

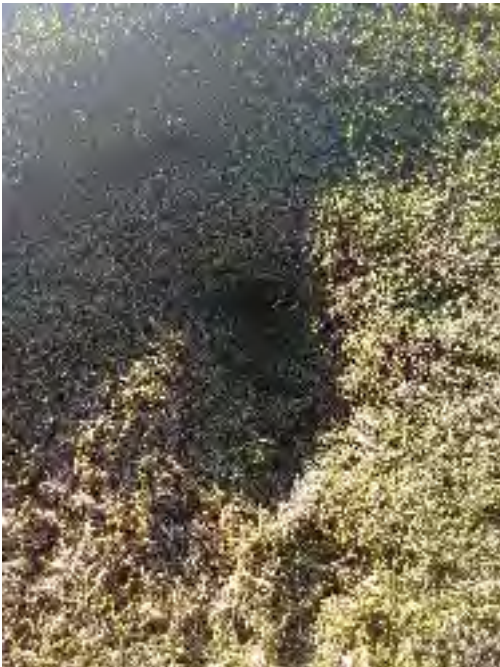
An outfall was also identified onsite that was not in the reference layer, but it is small and no exact drainage area was identifiable. This outfall was dry at the time of the visit (Figure 7).

Figure 7: Undocumented outfall.

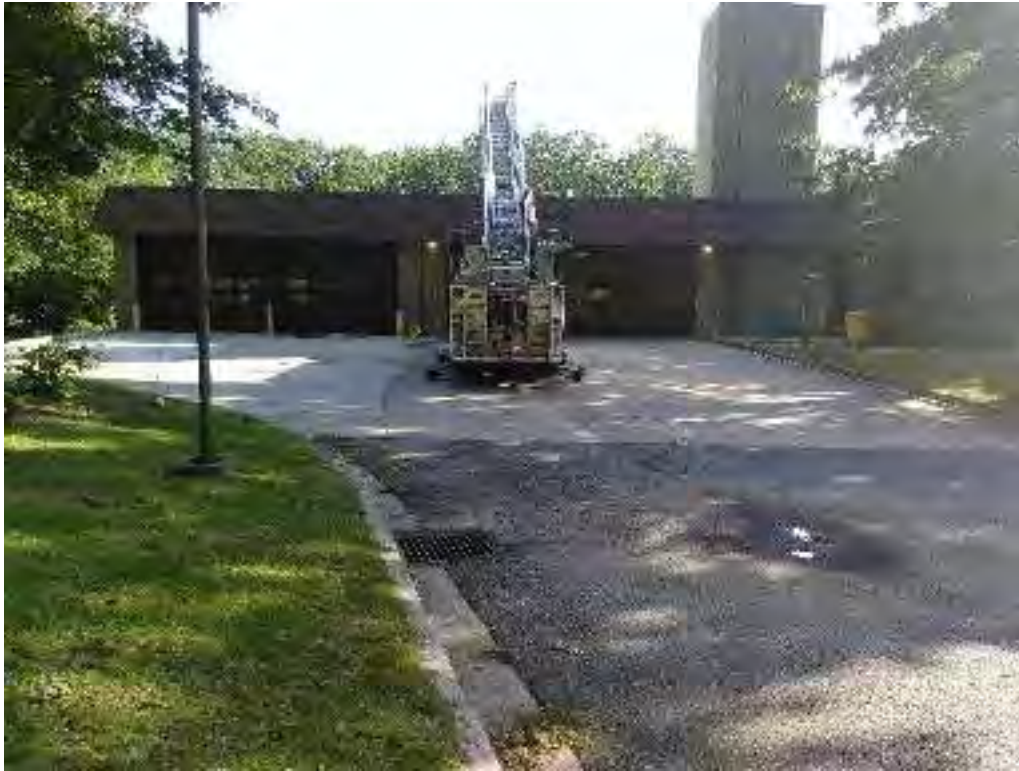
Figure 2: Parking lot inlet and concrete pad where washing occurs

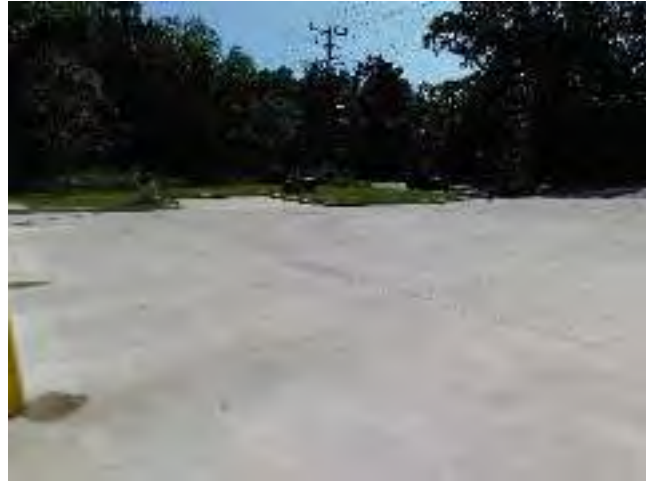
Figure 4: Front drive of Lake Shore Fire Co 20draining

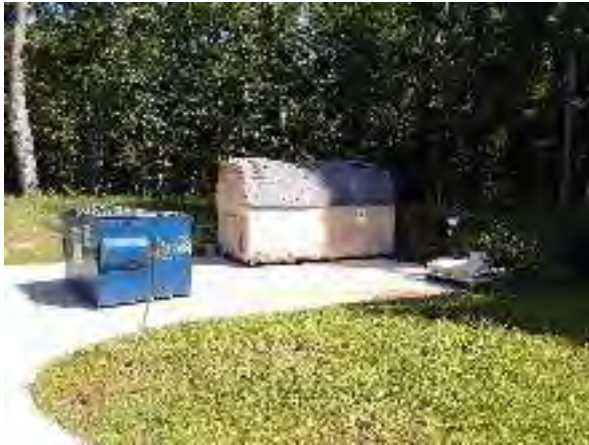
The facility is well kept with no evidence of upland pollution sources present. No sign of improper vehicle washing was observed. The waste disposal and picnic/grill spaces are both clean and well maintained (Figure 6 and 7).

Figure 6: Waste Disposal Area

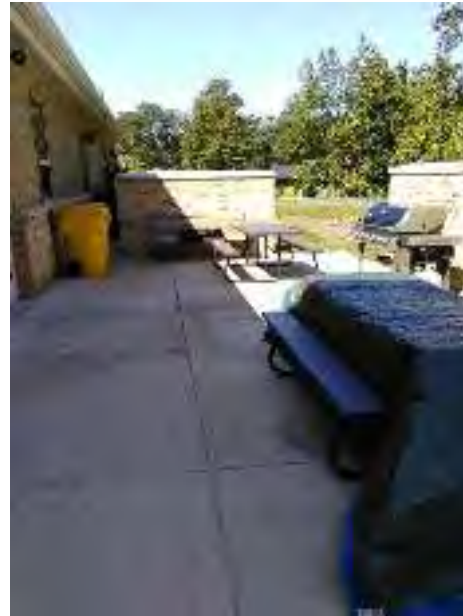
Figure 7: Picnic/Grill Area

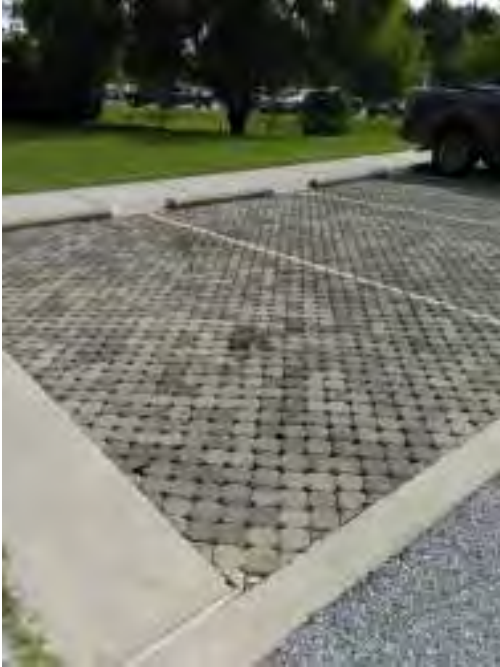
Figure 2: Permeable pavement

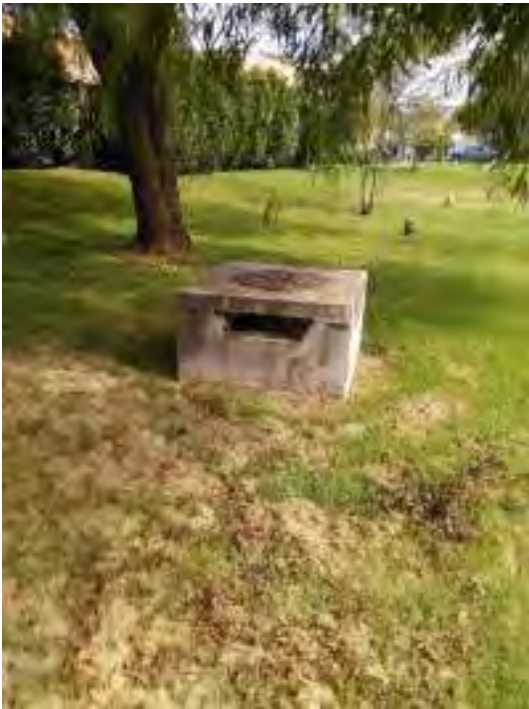
Figure 3: Dry Pond

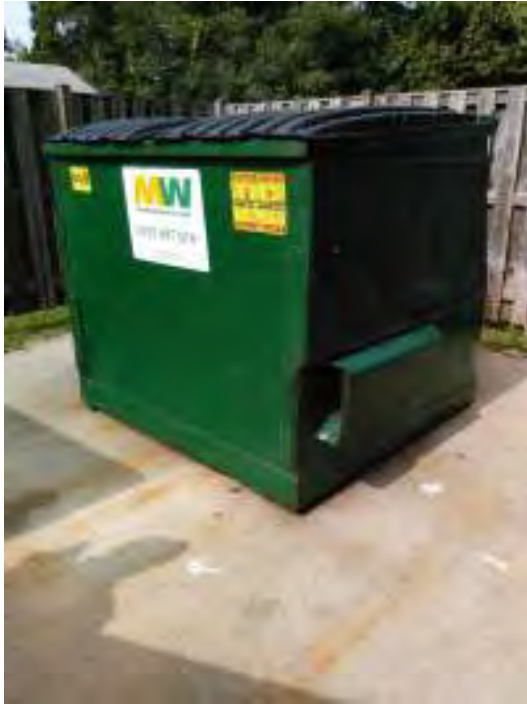
The dumpster and recycling areas are clear with no discoloration or material outside of receptacles (Figure 4). Trench drains located in the front and rear of the building are clear with only minor sedimentation (Figure 5). Washing of trucks likely occurs in the rear of facility but unable to confirm. Firefighting staff confirmed that all potentially hazardous materials (e.g., fire-fighting foam) are stored in roofed facilities located onsite and are protected from weather.

Figure 4: Trash and Recycling Areas

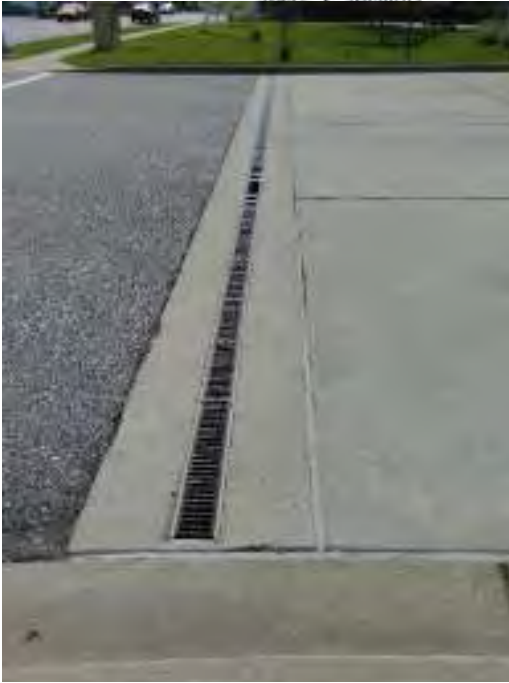
Figure 5: Trench drain

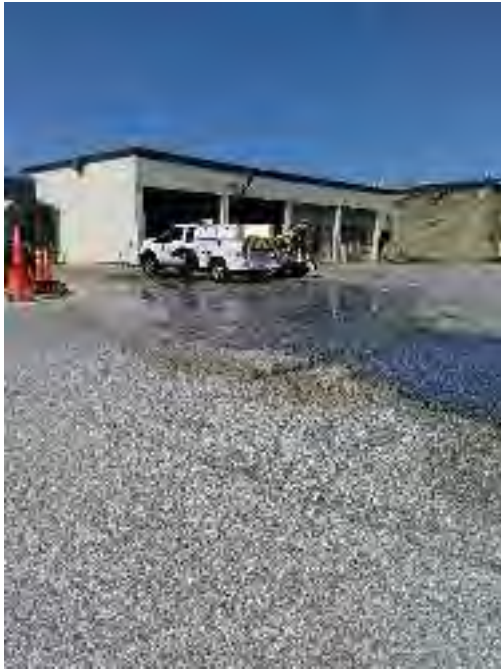
In the fenced area within the Millersville garage there was washdown activity (Figure 2) as well as improper bulk solid storage of parts and tires (Figures 3 and 4) and improper liquid storage (Figure 5).

Figure 2: Washdown activity.

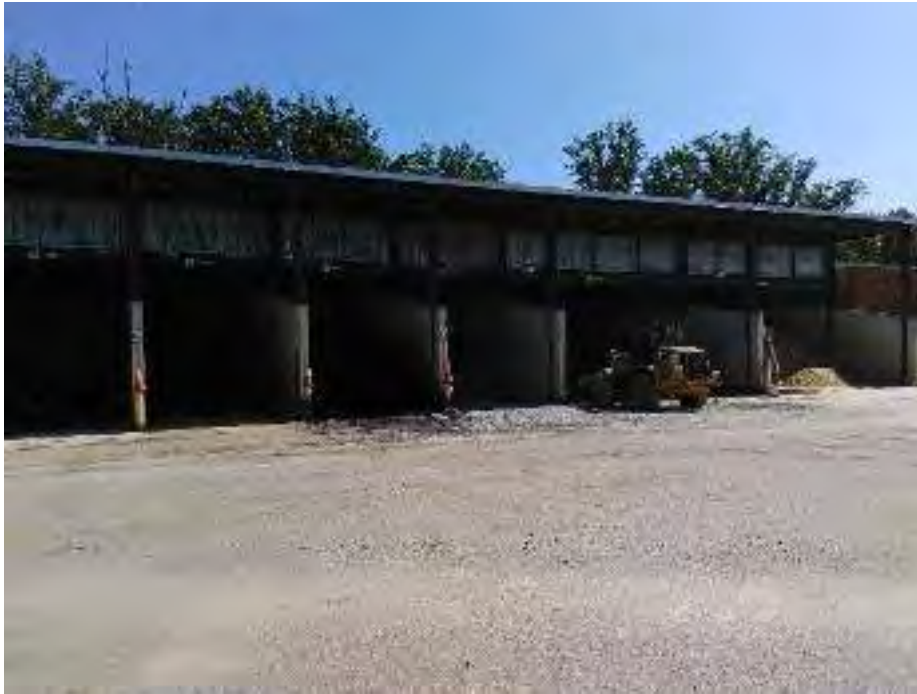
Figure 6: Properly stored bulk solids.

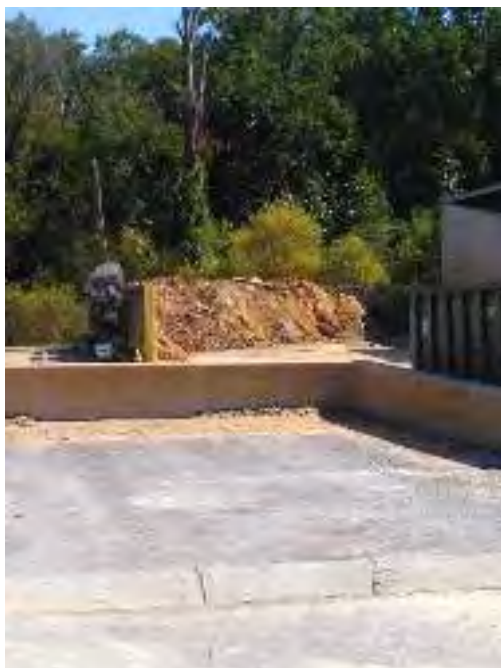
Figure 7: Improper bulk solid storage of sand.

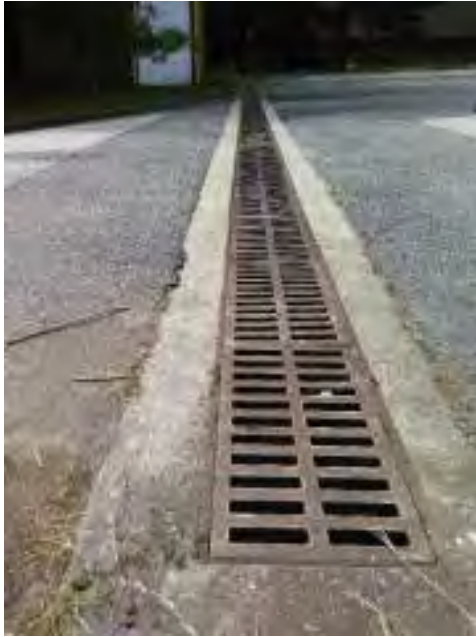
Figure 2: Trench Drain

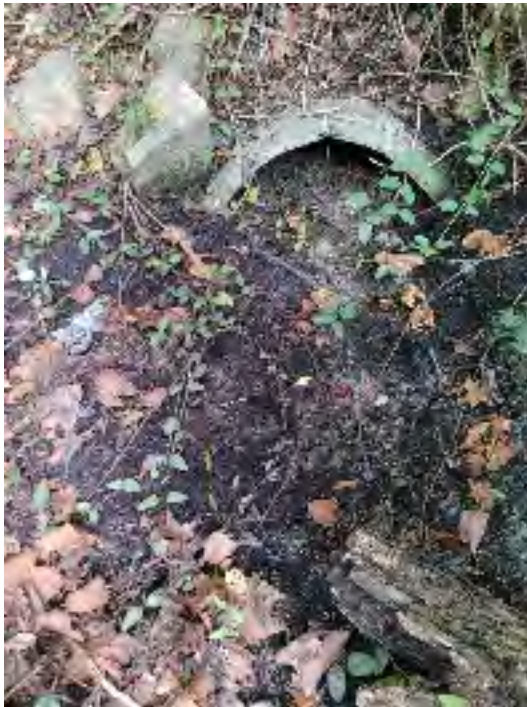
Figure 3: Blocked Outfall

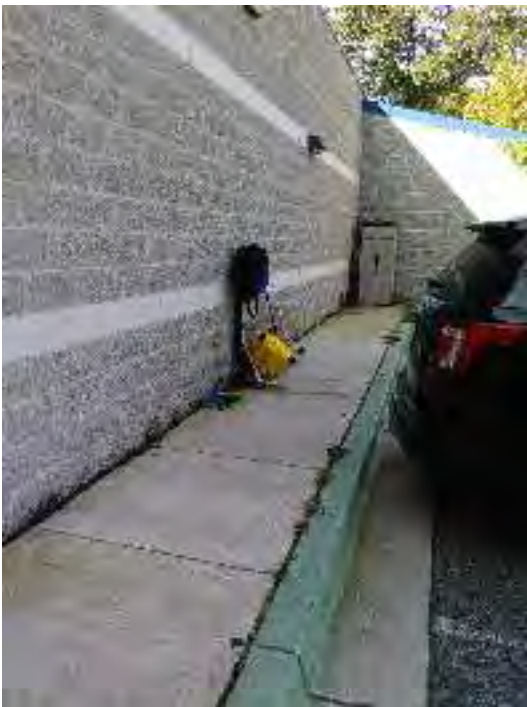
Washing of vehicles occurs in the rear of the facility (Figure 1, yellow circle). Washing water sheet flows to an inlet located near the northwestern corner of the rear parking lot. This inlet is connected to the infiltration trench and any wash water would be captured.

Figure 3: Vehicle washing station located in the secure rear parking lot
