# Fiscal Year 2021 Annual Report

Illicit Discharge Detection and Elimination

Permit Number: MD0068306

Prepared for  
Anne Arundel County

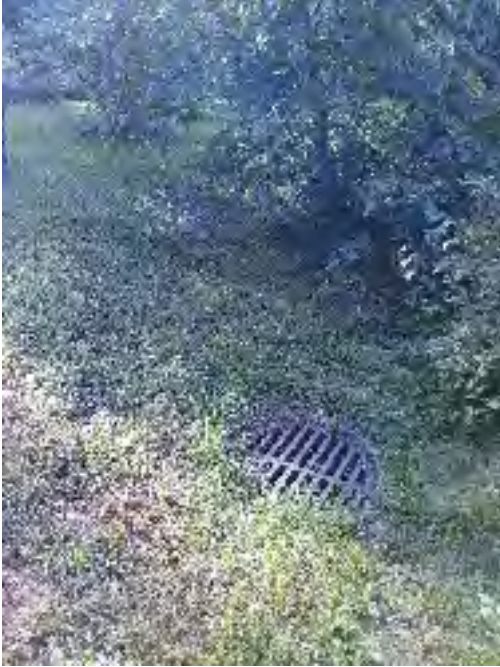
Figure 4: Inlet which portion of the lawn and routes to infiltration practice.

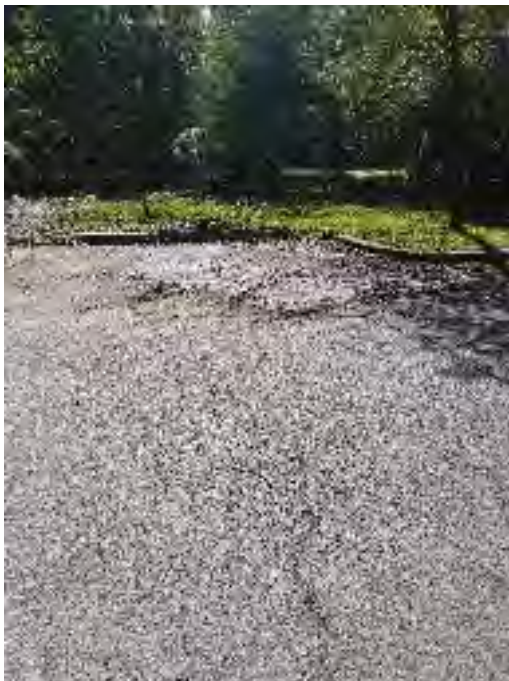
Figure 7: Ponding evidence just north of BMP2.

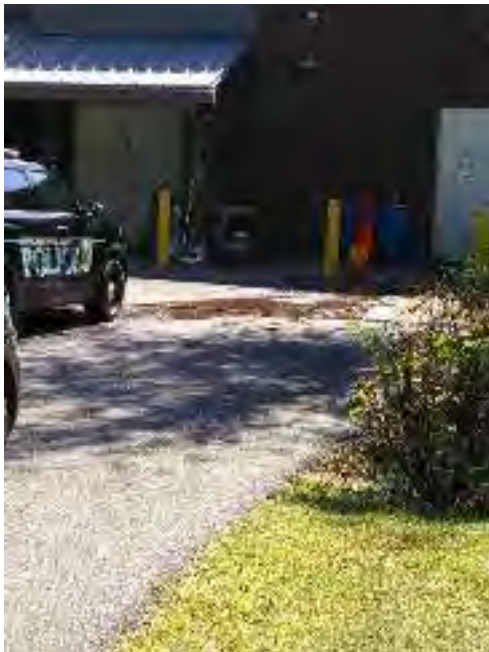
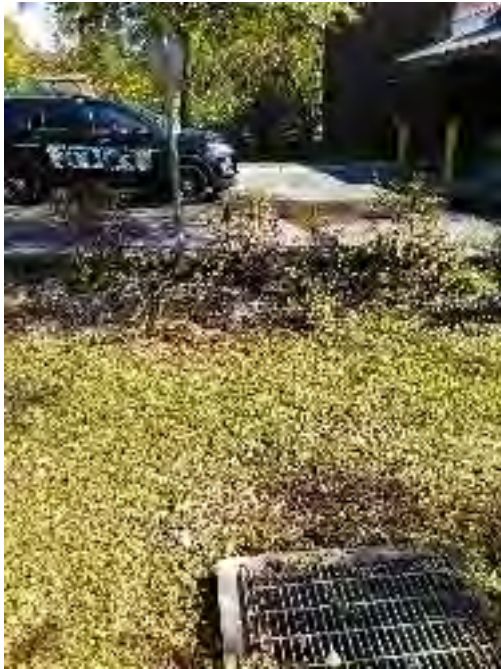
There was also washing activity happening at the time of the visit (Figures 9 and 10)

Figure 9: Washing activity

Figure 10: Washing activity

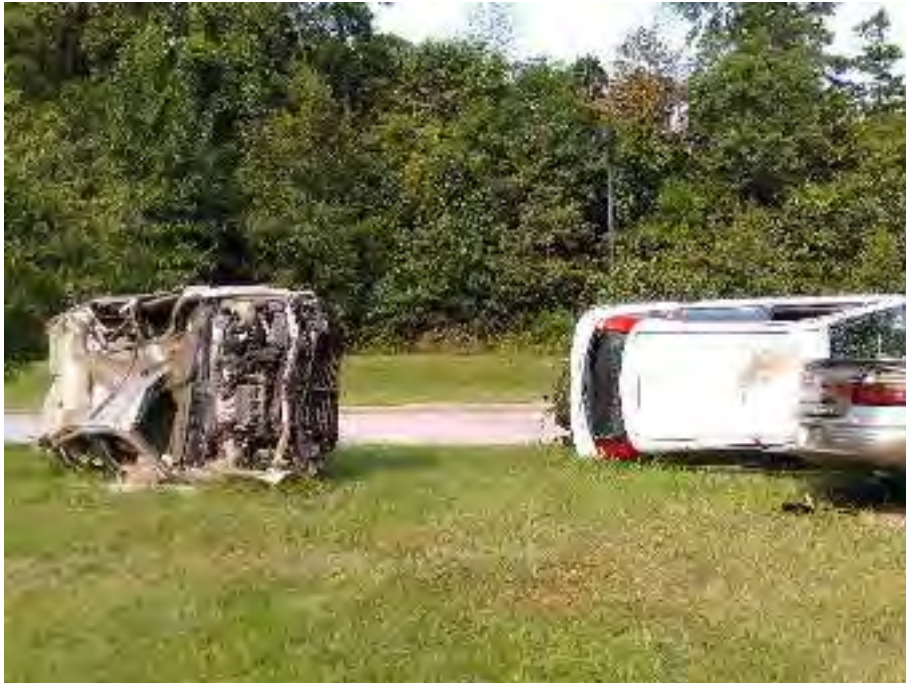
This site also contains a car wreckage training area where several wrecked vehicles are stored (Figures 2 and 3). These vehicles could be sources of rust, oils, washer fluid, and gasoline and should be properly stored or disposed of.

Figure 2: Car wreckage training location.

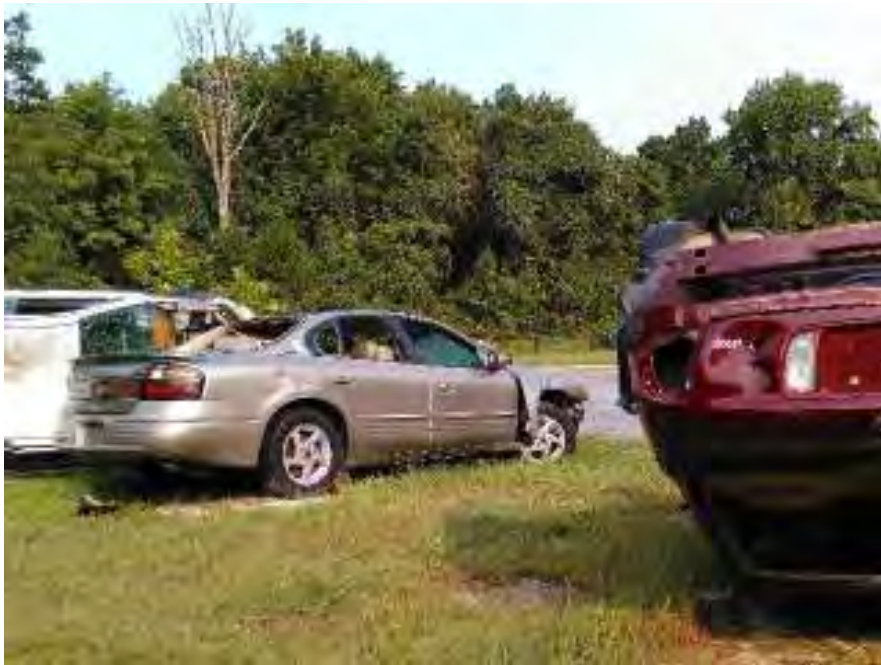
Figure 3: Car wreckage training location.

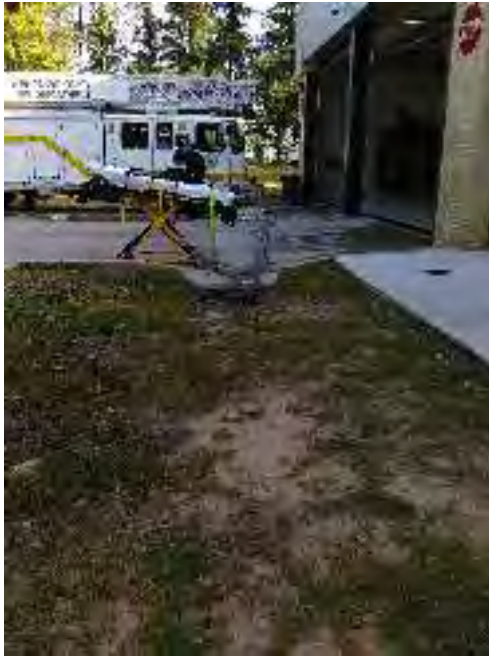
Figure 2: Washing activity during first test.

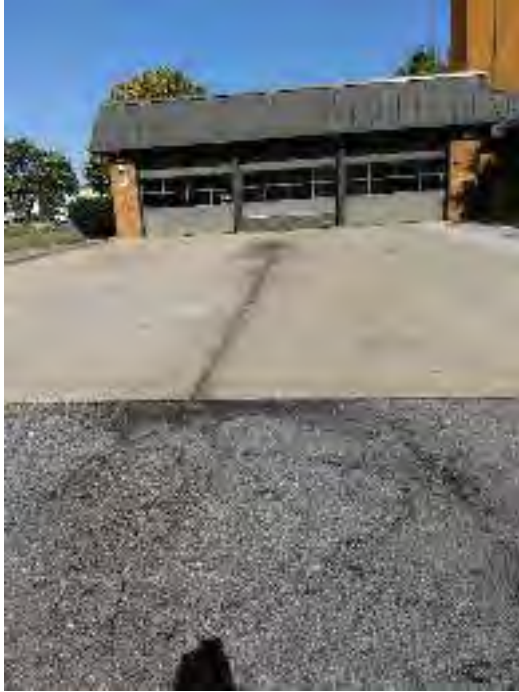
There were no immediate concerns identified on the site. On the rear pad there is evidence of potential wash water, but this could not be confirmed (Figure 2). This site also had what looks to be an air conditioning generator near the building (Figure 3).

Figure 2: Potential washing activity location.

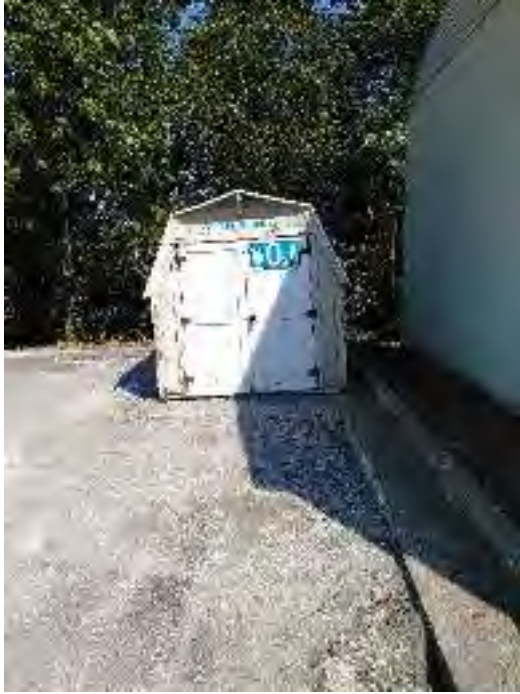
Figure 6: Storage shed in good condition.
